**CG-7 PRESSURE RELIEF**

**PROPANE CYLINDER**

**PERFORMANCE**

**Results and Evaluation**

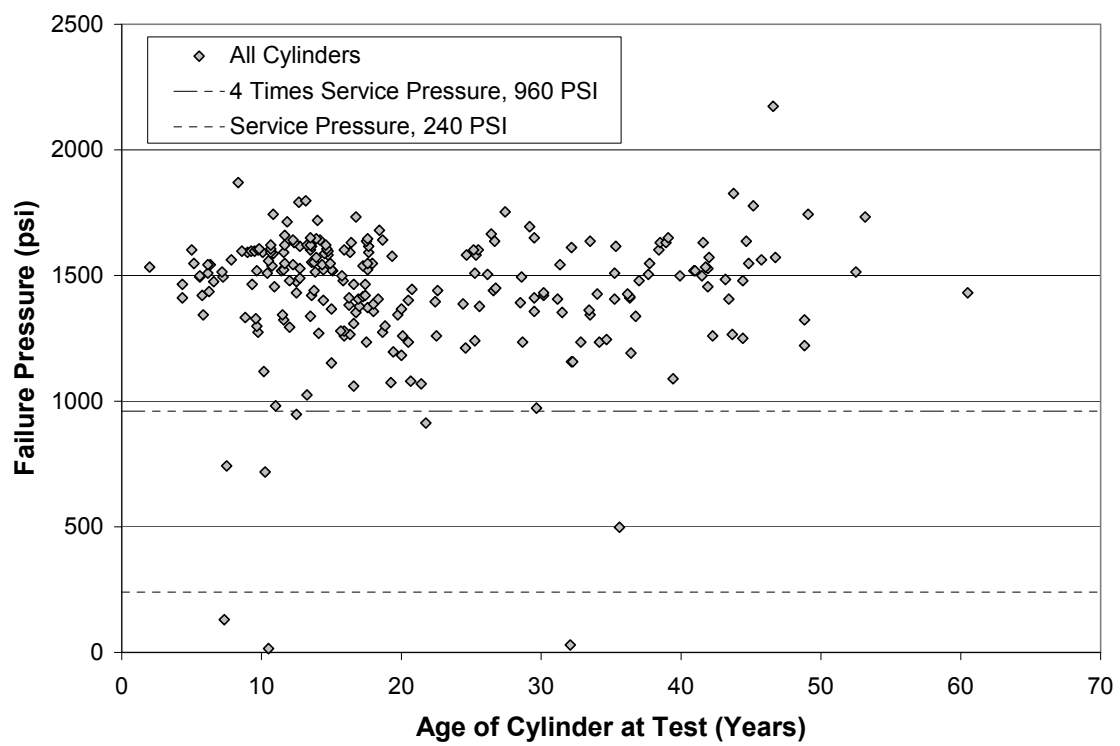
Figure 13. Failure pressure of all cylinders tested as a function of age.

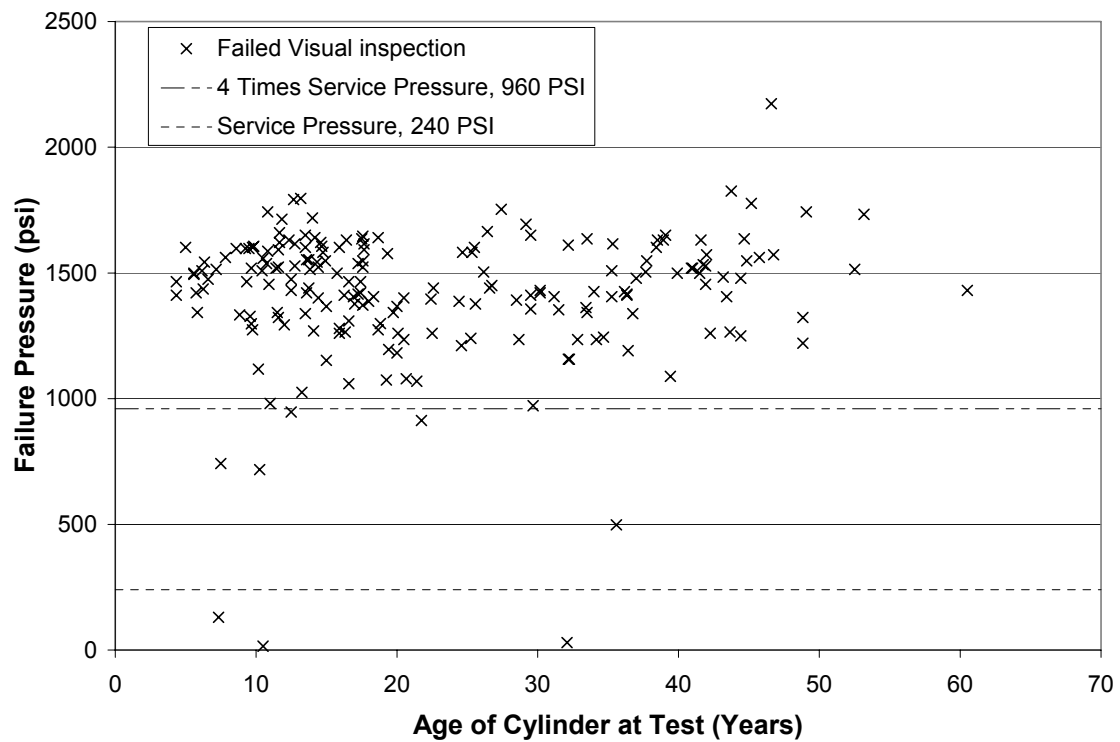
Figure 15. Failure pressure of cylinders that failed visual inspection as a function of age.

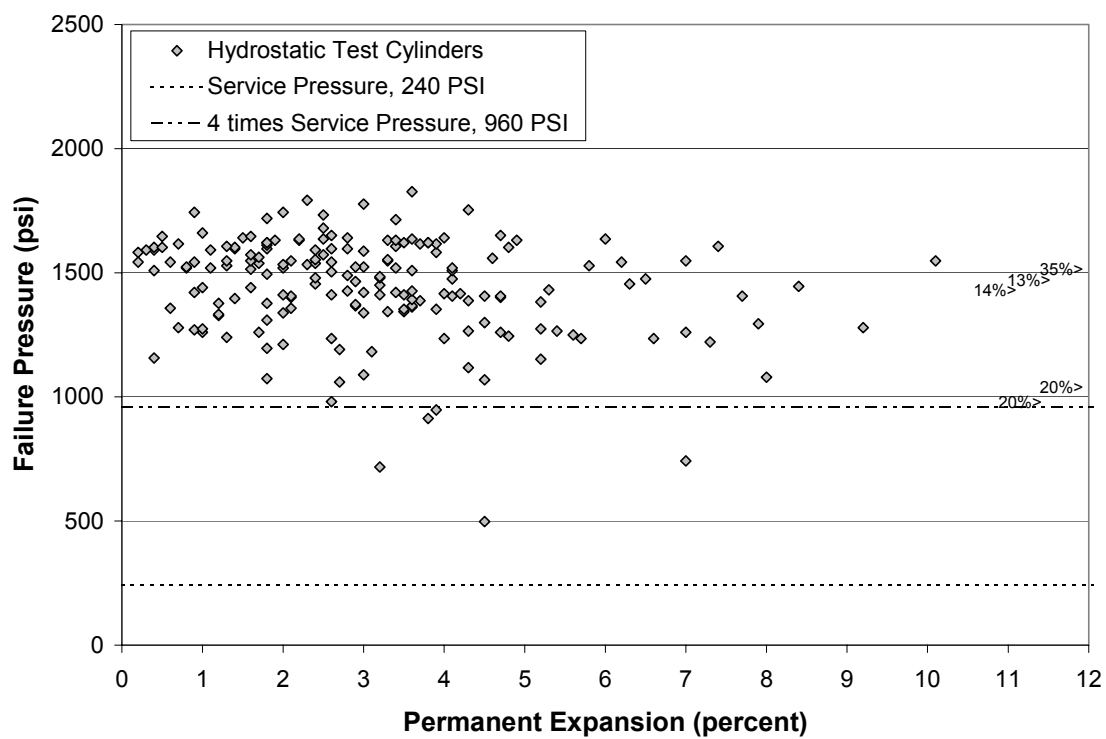
Figure 21. Comparison of cylinder failure pressure to percent permanent expansion measured in hydrostatic test.

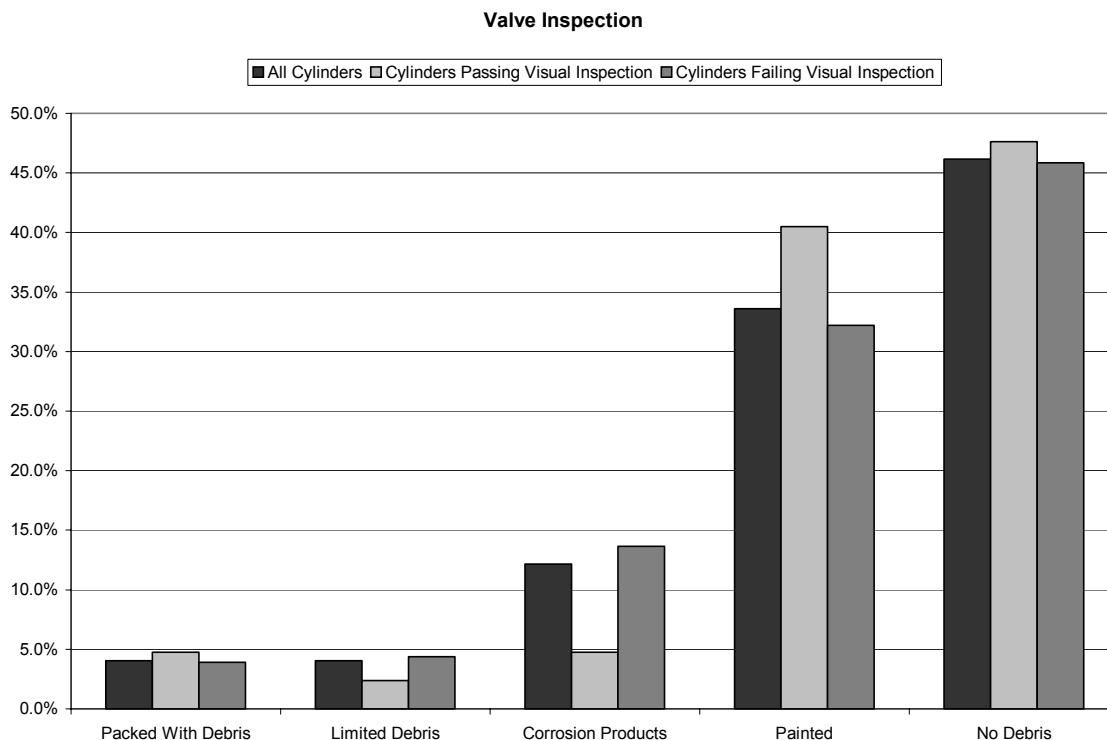
Figure 22 shows the results of the visual inspection of relief valves and compares those from cylinders passing visual inspection to those failing cylinder visual inspection.

Figure 22. Summary and comparison of results of visual inspection of valves from cylinders which passed and failed cylinder visual inspection procedures.

Battelle’s assessment did not show evidence that paint would likely degrade performance. Evidence of corrosion of the relief valve components would, of course, be detrimental, but limited corrosion products from other sources would not be expected to be detrimental as long as they do not interfere with relief valve operation.
