**CG-7 PRESSURE RELIEF**

**PROPANE CYLINDER**

**PERFORMANCE**

**Results and Evaluation**

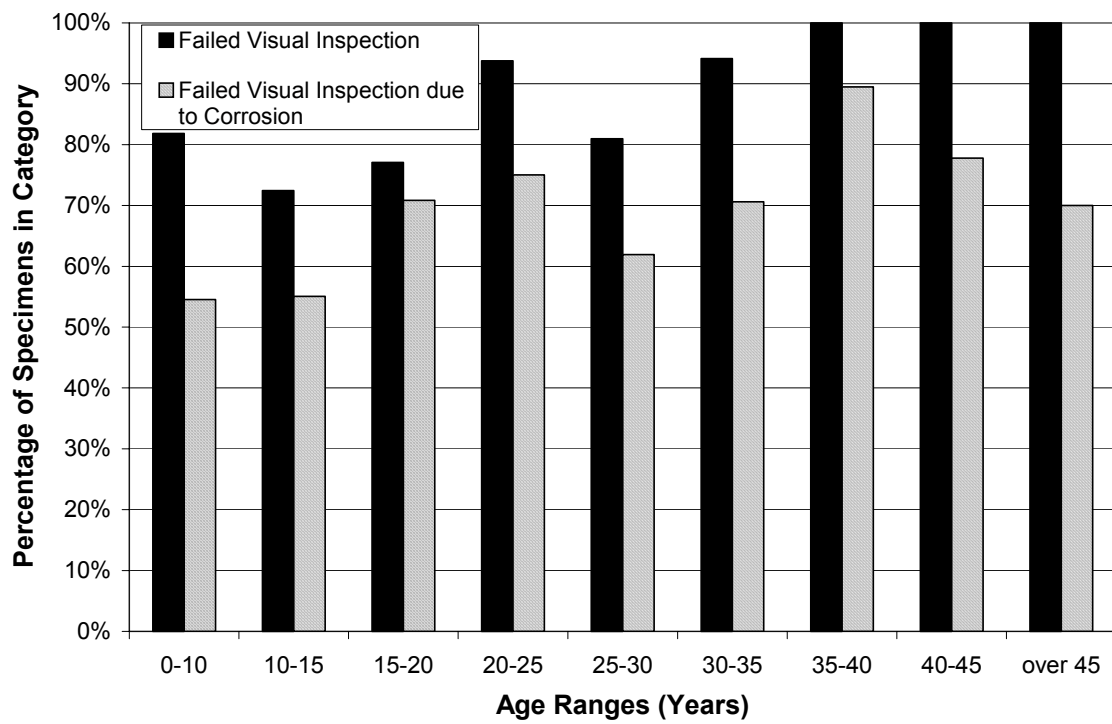
Figure 10 compares the percentage of cylinders in each age bracket that failed visual inspection due to all causes and the percentage of cylinders in each age bracket that failed visual inspection due to corrosion only. When broken down by age, the vast majority of cylinders in each age bracket failed visual inspection and the primary cause of failure in each bracket was corrosion. Although corrosion was the primary cause of visual inspection failure, corrosion did not appear to increase with age. It must be borne in mind that damaged and degraded cylinders were requested for this test program. These results are indicative of poor quality cylinders, but not the population of cylinders in service as a whole.

Figure 10. Comparison of the percentage of cylinders collected in each age bracket which failed visual inspection for all causes and which failed inspection due to corrosion.

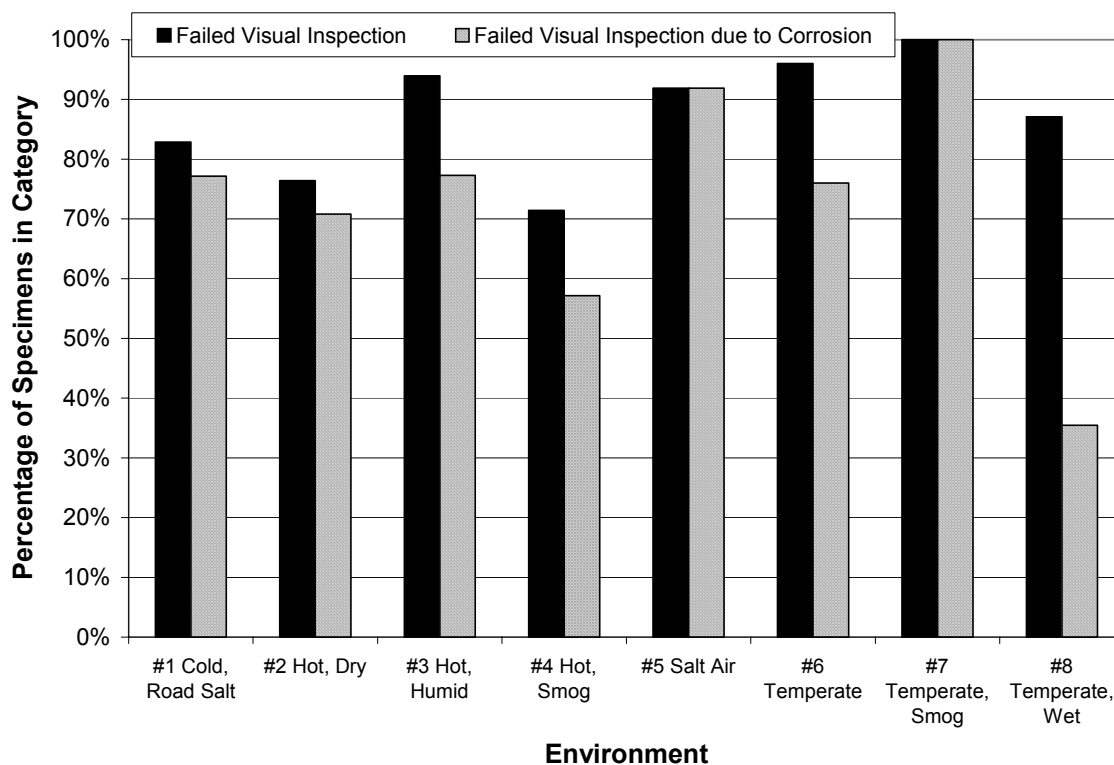
Figure 11 compares the visual inspection results on the basis of the environment where the cylinder was obtained. According to this figure, the percentage of cylinders which failed visual inspection ranged from 71 to 100 percent. The percentage of cylinders failing visual inspection due to corrosion ranged from 35 to 100 percent. Of the eight environments under consideration, it is worthy to note that all of the

specimens from the salt air (Virginia and Florida) environment and the temperate, smog (New Jersey) environments that failed visual inspection did so due to corrosion. In addition, less than half of the cylinders from the temperate, wet (Yuba City, CA) environment failed due to corrosion, whereas the majority failed due to corrosion in other areas.

Figure 11. Comparison of the percentage of cylinders collected from each source environment which failed visual inspection for all causes and those which failed inspection due to corrosion.

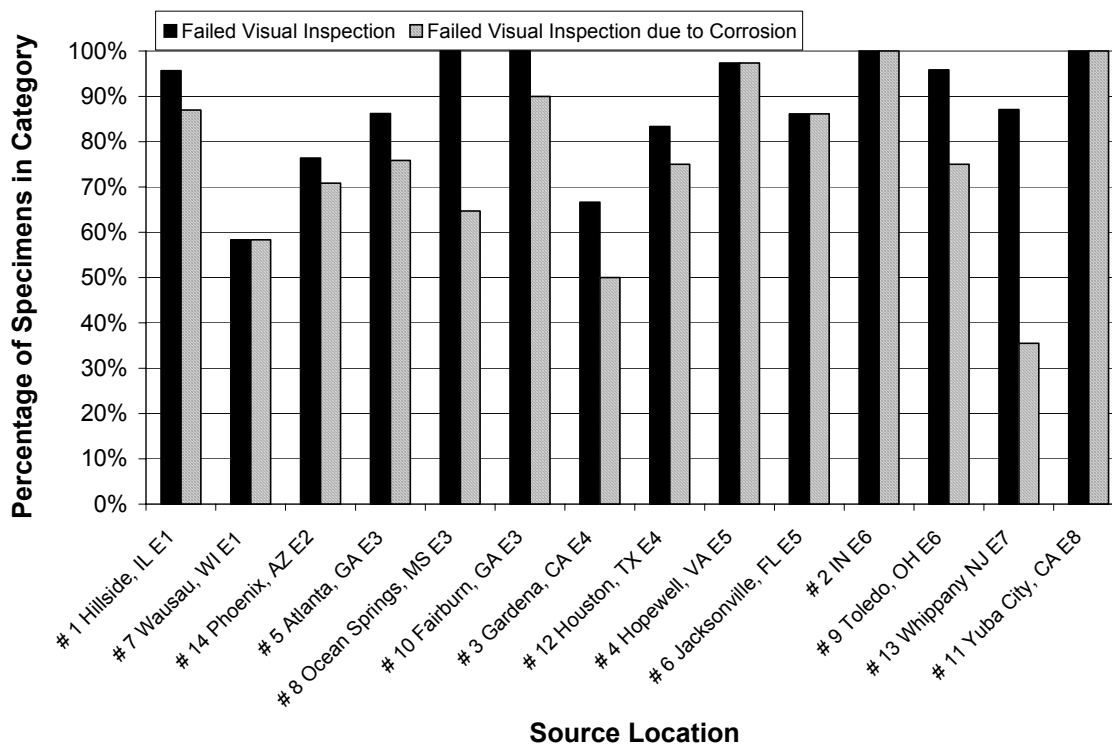
Figure 12. Comparison of the percentage of cylinders collected from each source location which failed visual inspection for all causes and those that failed inspection due to corrosion.

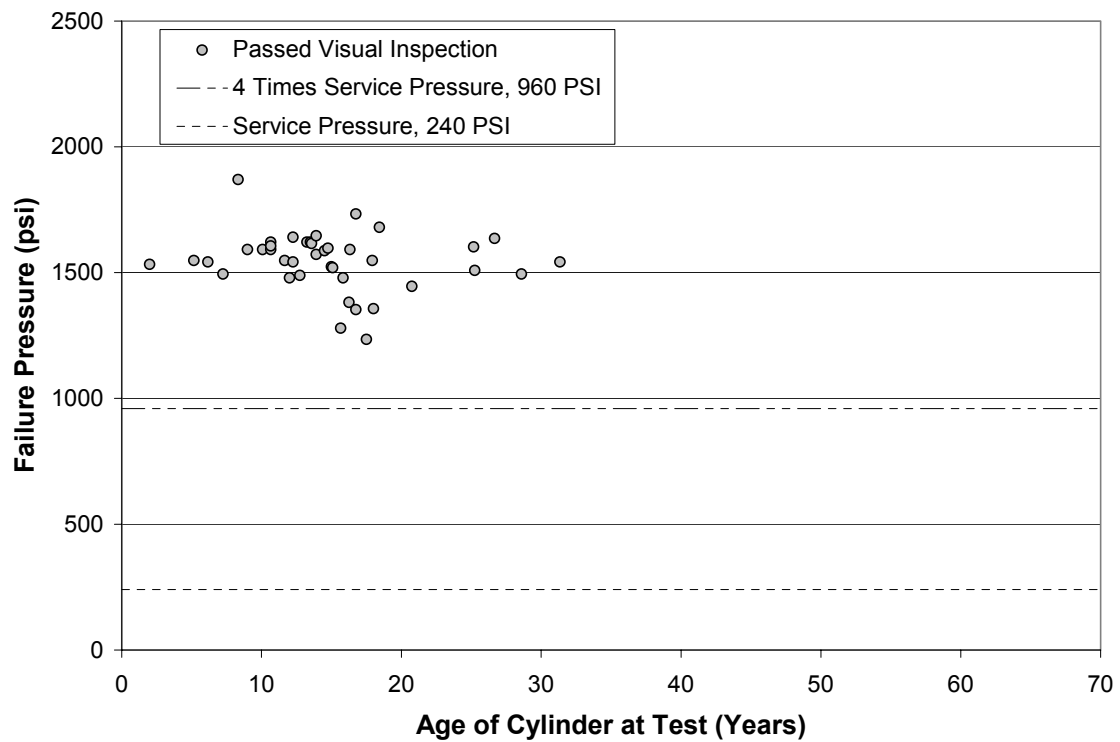
The results in Figure 14 show that all of the cylinders that passed visual inspection failed at pressures above 4 times service pressure. The lowest failure pressure of any cylinder which passed visual inspection was 1235 psi, over 5 times service pressure. Figure 15 shows the failure pressure of cylinders which failed visual inspection. Only 8 cylinders (3.4 percent of test cylinders) failed at pressures below 960 psi. It is important to note that each of those 8 that failed the visual inspection procedure and would have been rejected and removed from service.

Figure 14. Failure pressure of cylinders that passed visual inspection as a function of age.

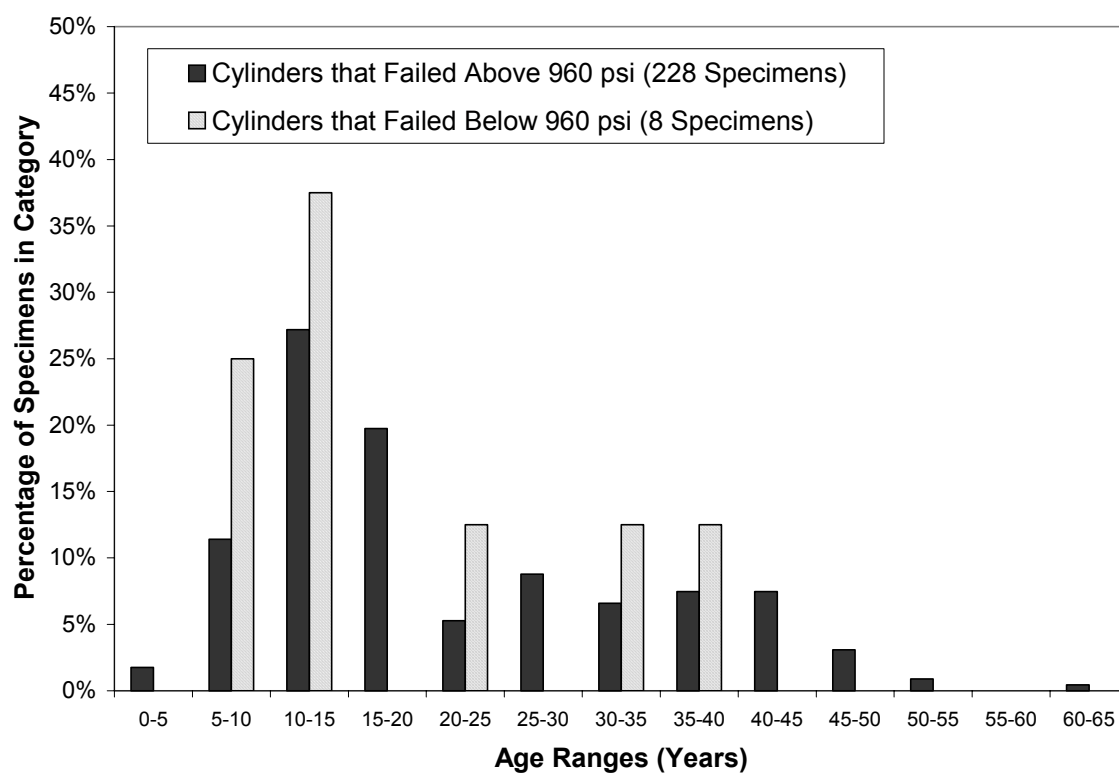
For further examination, Table 2 summarizes the condition of the eight specimens that failed below 960 psi and Figures 16 through 18 compare the burst pressure results on the basis of age, source environment, and source location. The results in Figure 16 show that 25 percent of the cylinders that failed below 960 psi were less than 10 years old and 37.5 percent were between 10 and 15 years old. This suggests cylinders do not degrade continuously with age, but that newer cylinders may be damaged or degraded as much as older cylinders. Figures 17 and 18 indicate that the majority of cylinders that failed below 960 psi were from a single location and environment in Georgia. Table 2 shows that, of the 8 that failed the criterion, 6 were related to corrosion. Five of the 6 failures from the Georgia environment were related to corrosion. The burst test results confirm the visual inspection results that, for this set of propane cylinders, corrosion was the primary cause of degradation.

Figure 16. Comparison of the age distribution of cylinders that failed above and below 960 psi.

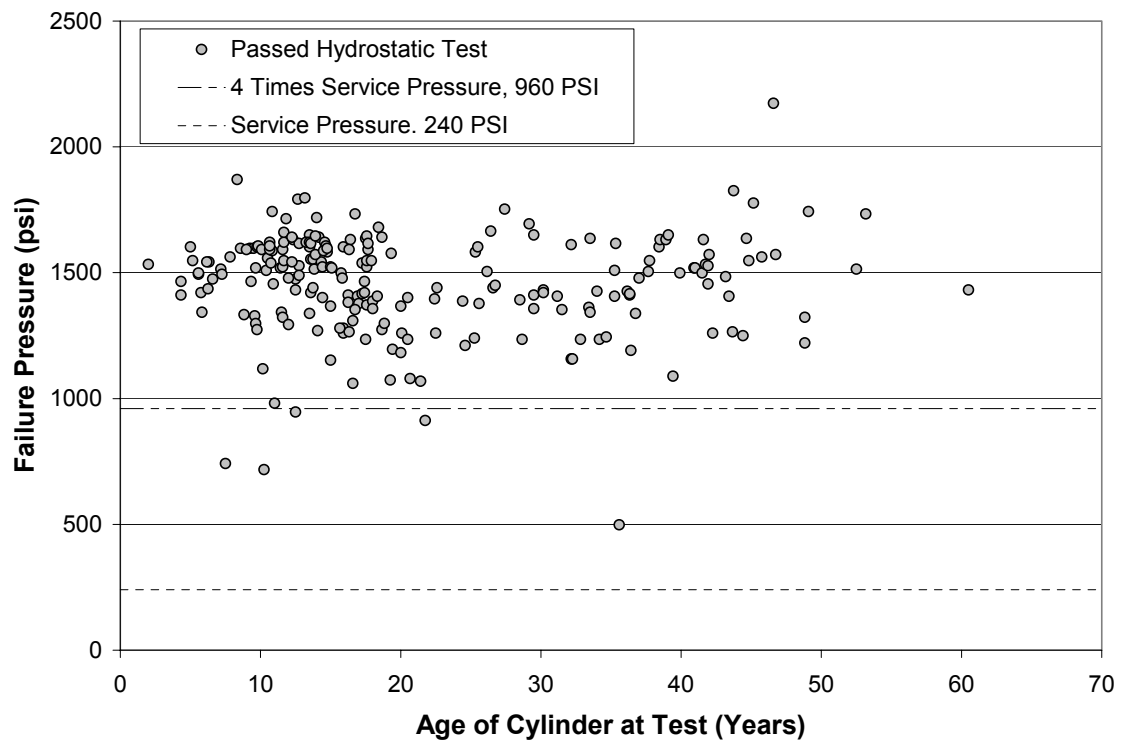
Figure 19 and Table 2 summarize the results for cylinders which passed hydrostatic expansion test. Figure 20 and Table 3 summarize the results for cylinders which failed the hydrostatic expansion test. In examining the results in Figure 19, five specimens which passed the hydrostatic expansion test had failure pressures below 960 psi, meaning they were actually unsatisfactory to remain in service. In examining the results in Figure 20, six specimens that failed the hydrostatic test had failure pressures above 960 psi, meaning they were satisfactory to remain in service.

Figure 19. Failure pressure of cylinders that passed hydrostatic expansion test as a function of age.

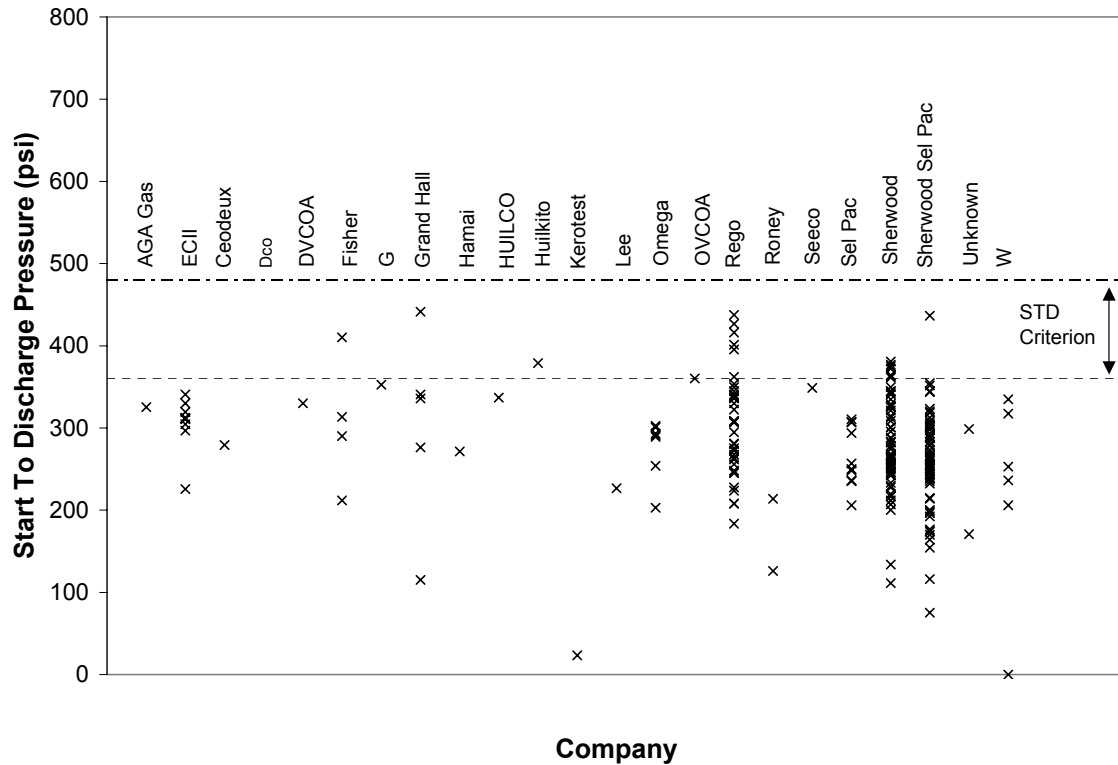
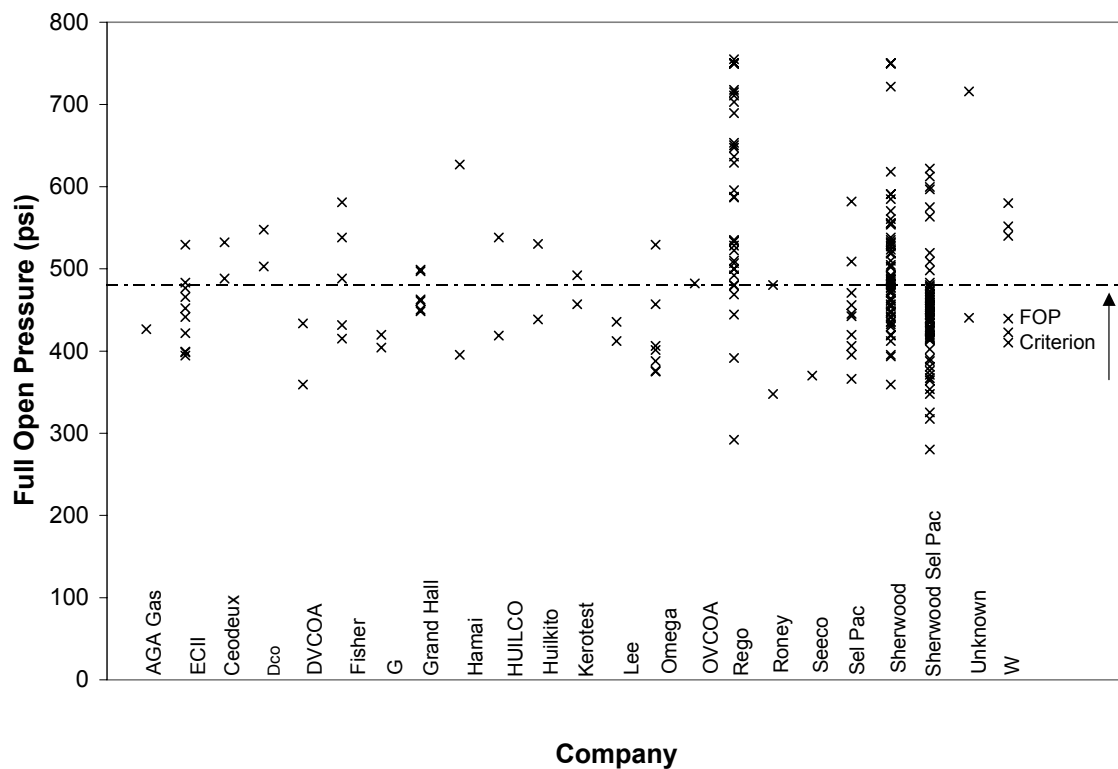
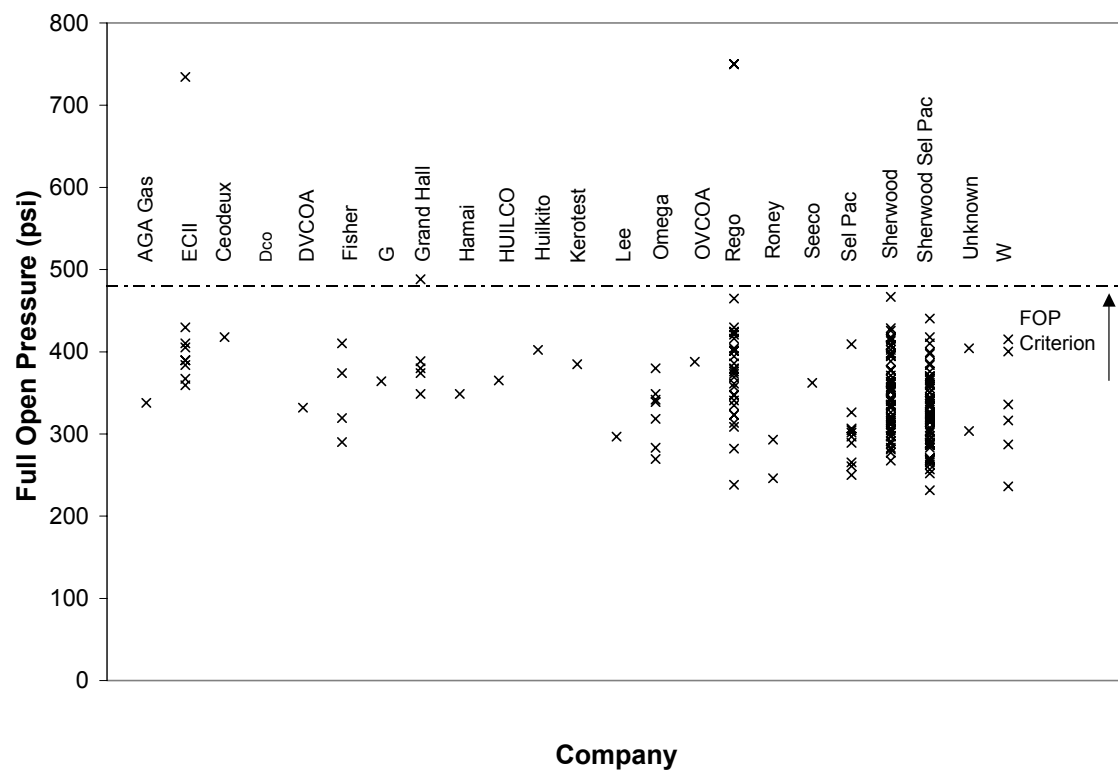
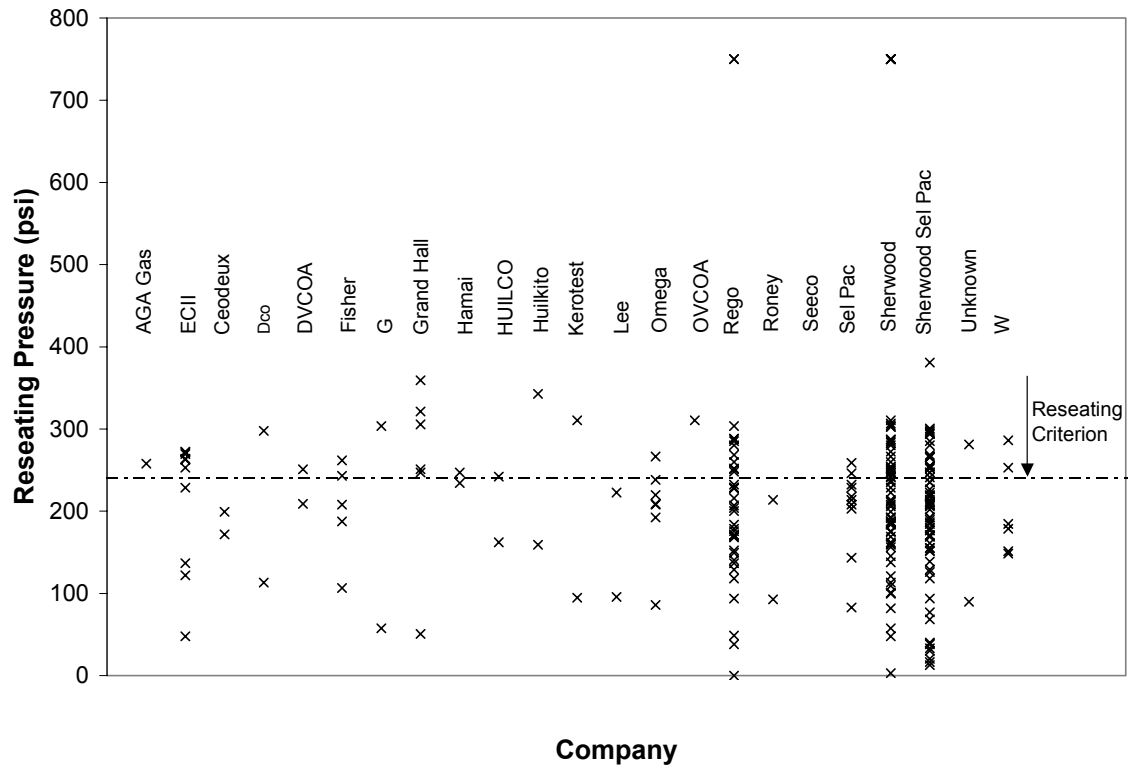
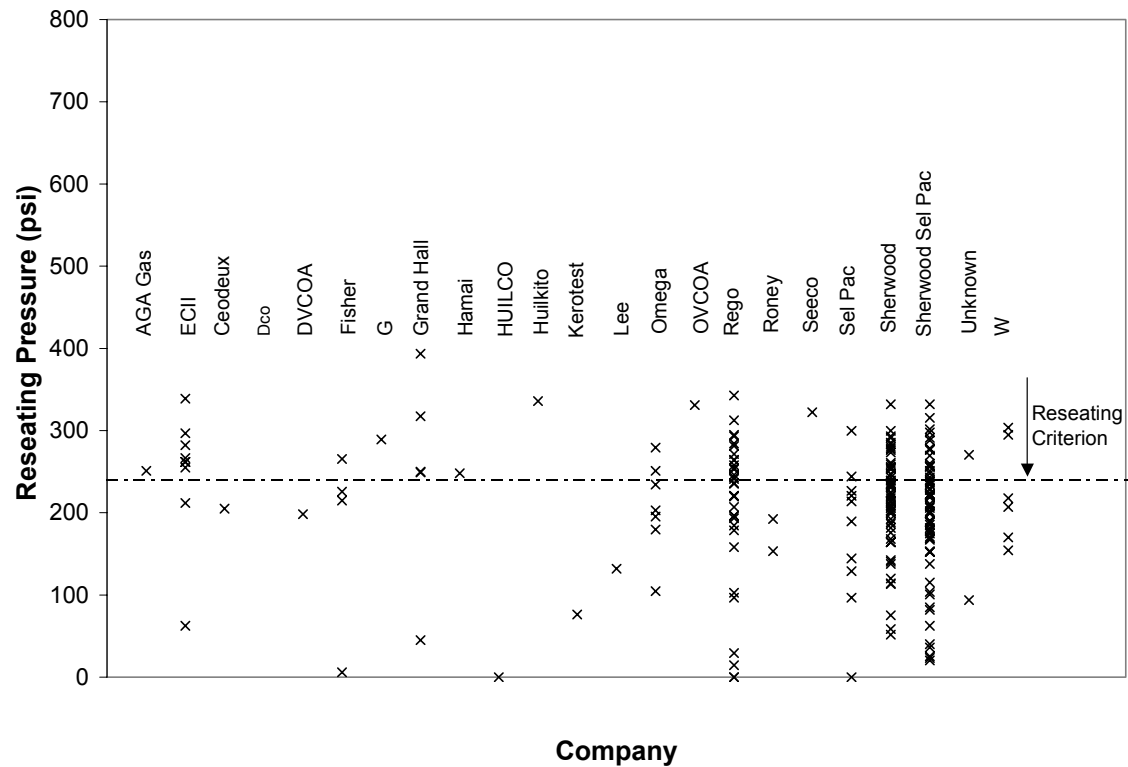
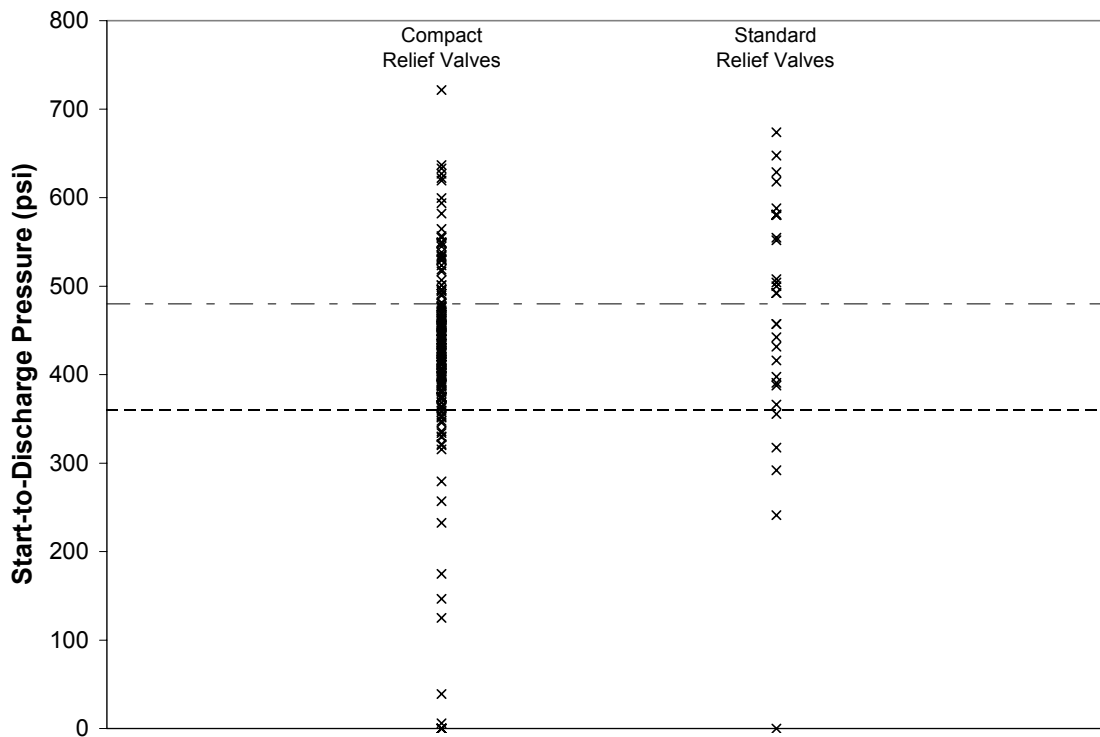
Lastly, the valve manufacturer comparison in Figures 48 through 53 suggests that the manufacturers with the largest number of valves showed the greatest span of results. More Rego, Sherwood and Sherwood Sel Pac valves were tested than the other manufacturers as shown by Figure 9. Roughly 20 percent of the valves tested were from Rego, approximately 30 percent were labeled Sherwood and about 28 percent were labeled Sherwood Sel Pac. Each of these showed similar range of results for start-to-discharge, full open and reseal pressures. While the overall range was similar, more of the Sherwood and Sherwood Sel Pac met the test criteria.

Figure 48. Comparison of the Sequence A start-to-discharge pressure results for different relief valve manufacturers.

Figure 49. Comparison of the Sequence B start-to-discharge pressure results for different relief valve manufacturers.

Figure 50. Comparison of the Sequence A full open pressure results for different relief valve manufacturers.

Figure 51. Comparison of the Sequence B full open pressure results for different relief valve manufacturers.

Figure 52. Comparison of the Sequence A reseating pressure results for different relief valve manufacturers.

Figure 53. Comparison of the Sequence B reseating pressure results for different relief valve manufacturers.

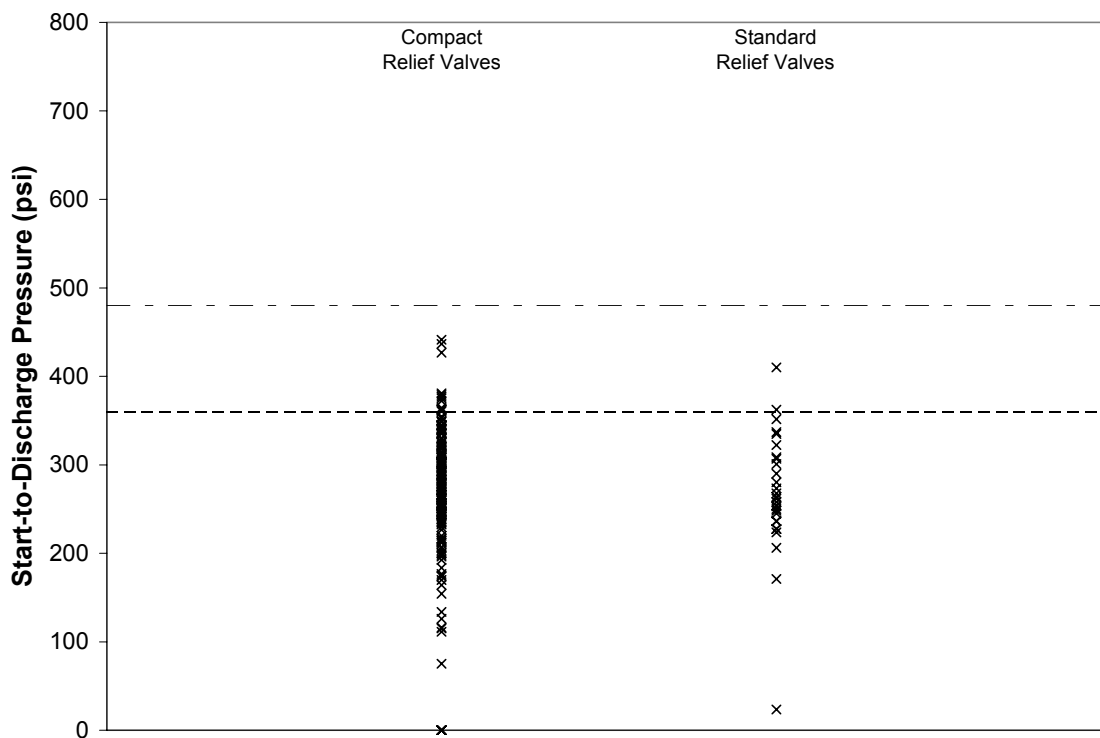
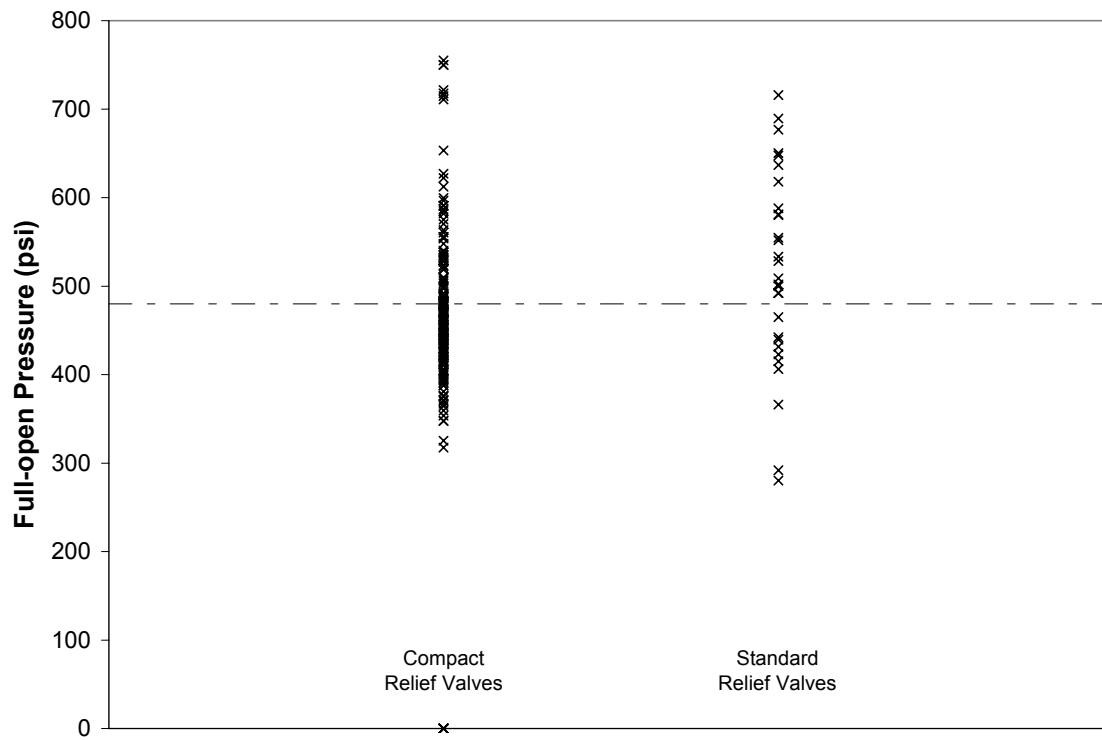
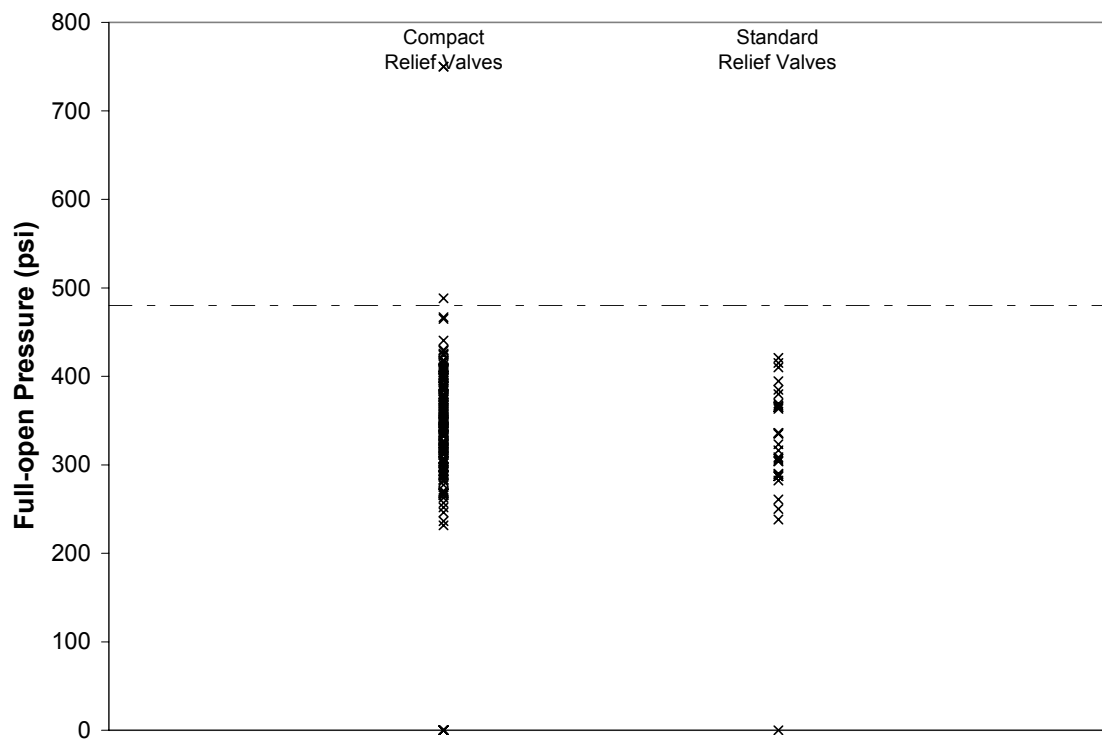
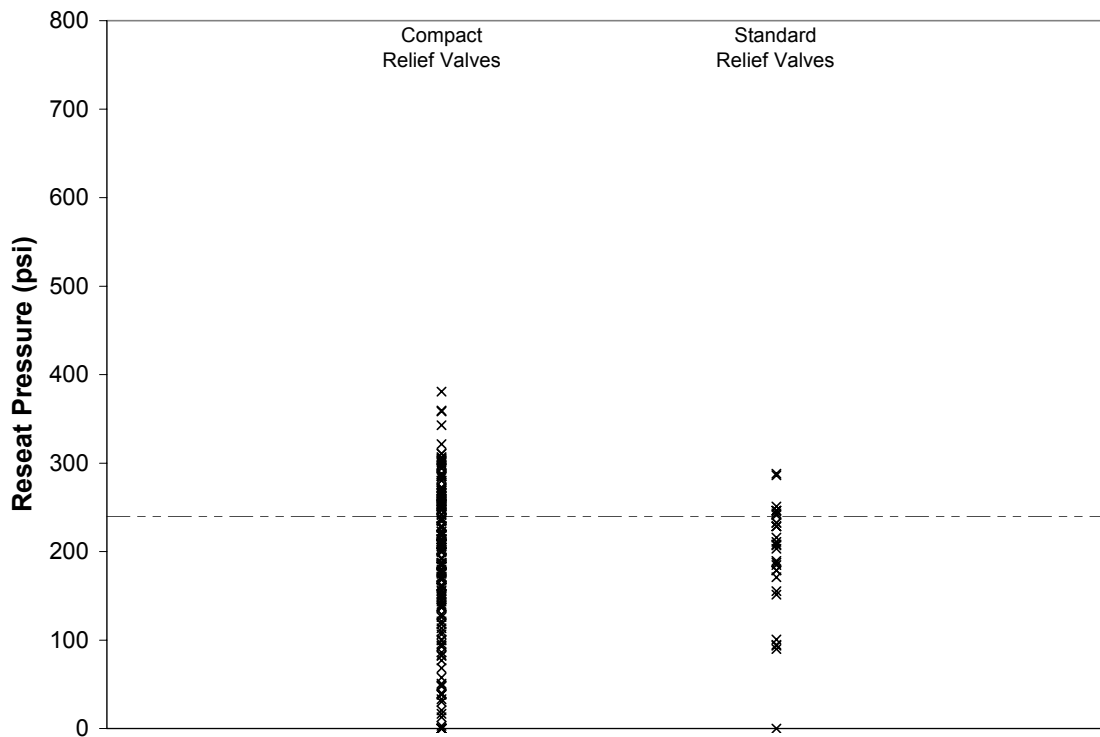
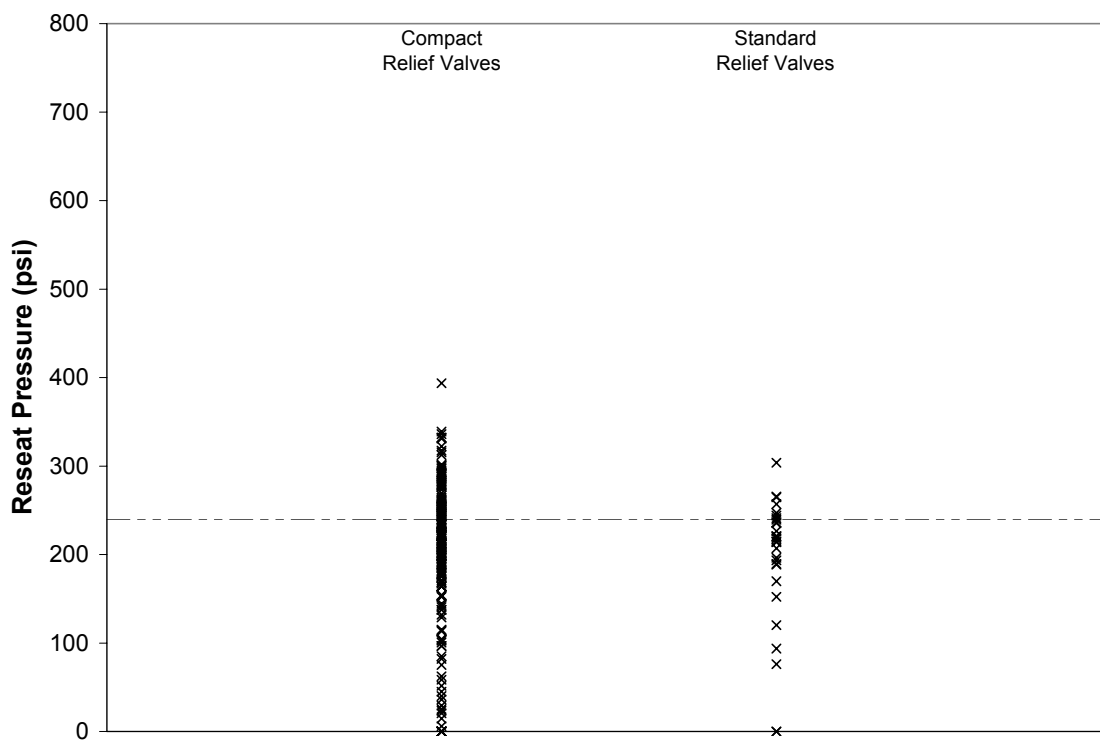
As noted earlier in this report, the majority of relief valves tested were “compact” having a bore diameter of the order of 7/16 inch. Some of the older “standard” relief valves tested had a large bore with a diameter of the order of 5/8 inch. All of the relief valves that opened met the minimum flow rate criterion required by CGA S-1.1. Figures 54 through 59 compare the start-to-discharge, full-open and reseal results for compact and standard relief valves. The data in the figures don’t appear to indicate major distinctions between the performance of the compact and standard valves. Many more compact valves were tested than standard, and, consequently, they appear to have more scatter. However, any apparent differences are more likely the result of the number of each tested than actual differences in performance.

Figure 54. Comparison of the Sequence A start-to-discharge pressure results for compact and standard relief valves.

Figure 55. Comparison of the Sequence B start-to-discharge pressure results for compact and standard relief valves.

Figure 56. Comparison of the Sequence A full-open pressure results for compact and standard relief valves.

Figure 57. Comparison of the Sequence B full-open pressure results for compact and standard relief valves.

Figure 58. Comparison of the Sequence A reseal pressure results for compact and standard relief valves.

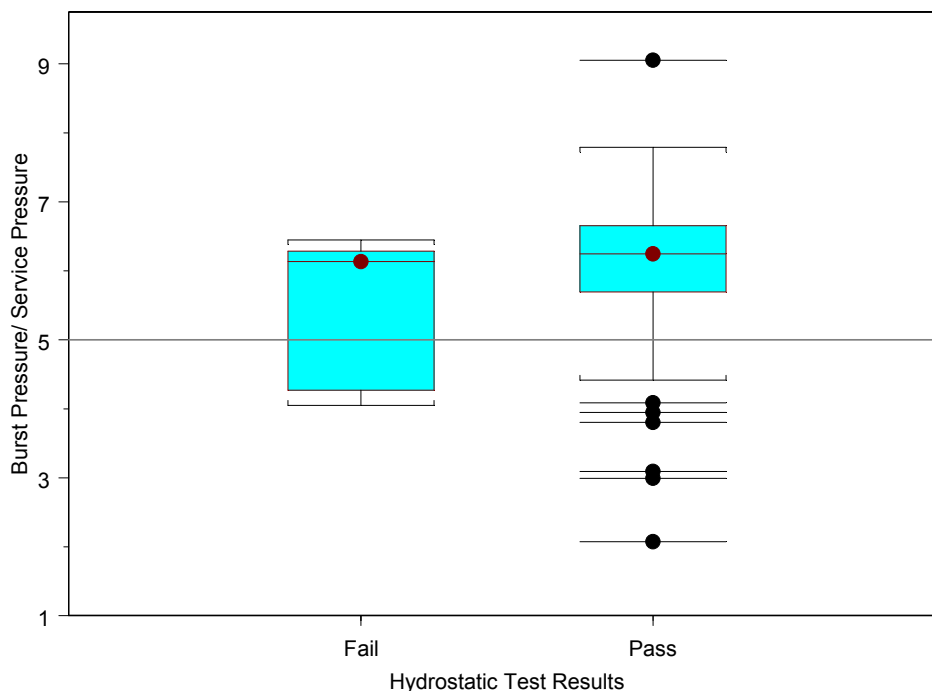
Margin of Safety: Hydrostatic Test

Again, margin of safety is the ratio of failure pressure to service pressure (240 psi). The “typical” or median failure pressure to service pressure ratio for cylinders failing hydrostatic testing is 6.13, while the median of the cylinders passing testing is 6.25.
