Volume 1: Technical Report and Results

PERFORMANCE, DURABILITY, AND SERVICE LIFE OF LOW PRESSURE PROPANE VAPOR REGULATORS

VOLUME 1 – TECHNICAL REPORT AND RESULTS

Battelle Applied Energy Systems
505 King Avenue
Columbus, Ohio 43201-2693

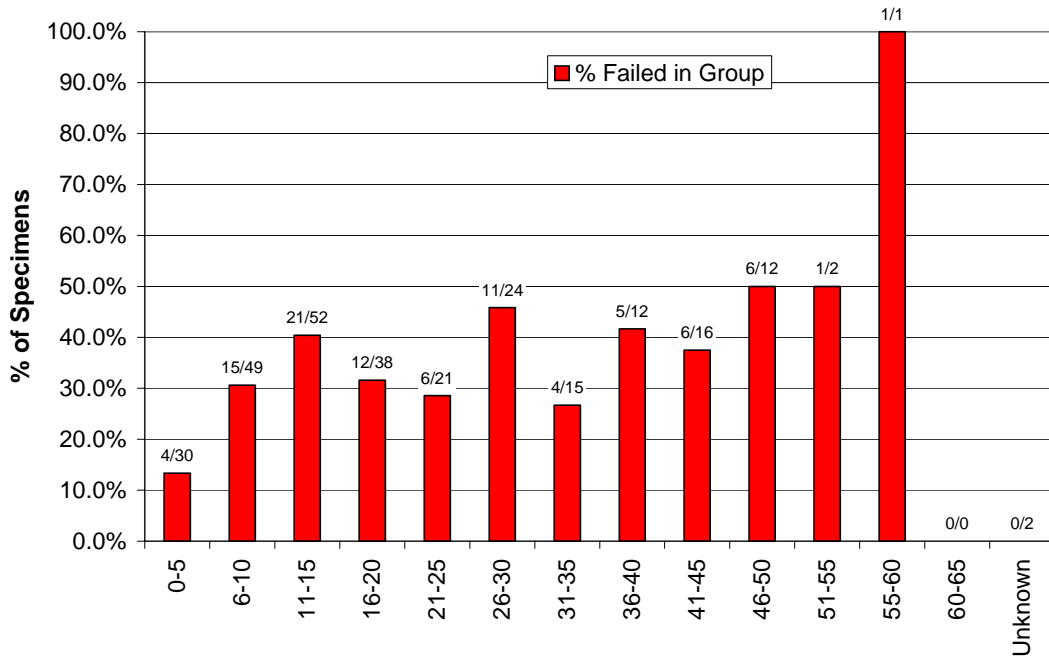
Figure ES-1 shows the percentage of regulators that failed to meet the test criteria. As can be seen, these failure rates do not increase with statistical significance. This figure shows a large failure percentage for the age group of 55 to 60 years, however the sample set for this age group was one unit. A caution must be made about the failure rates presented in this report:

Figure ES-1. Regulator failures by age.

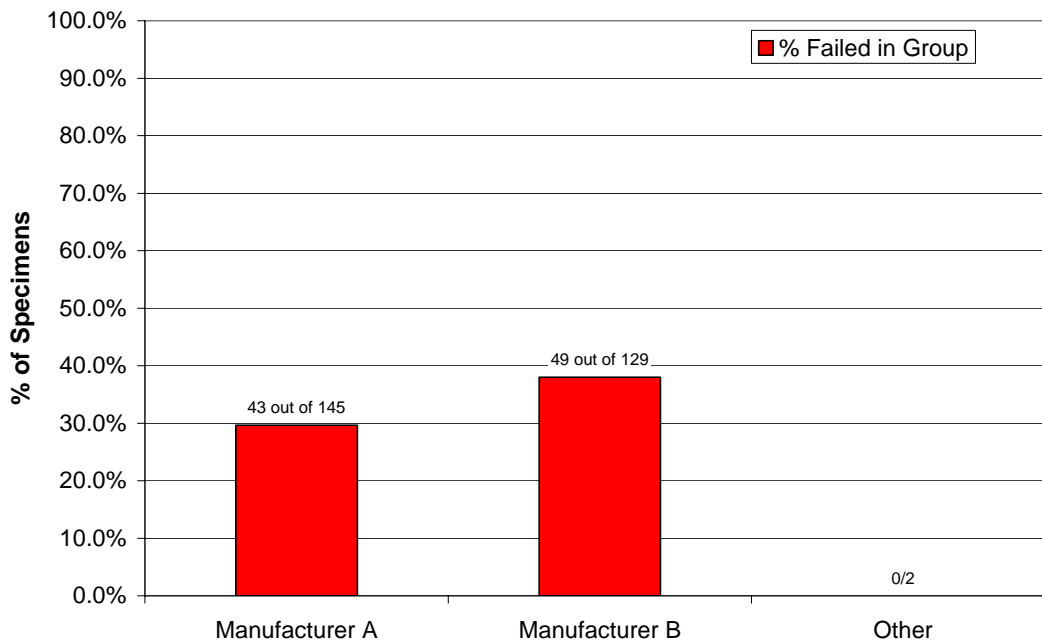
As previously mentioned, the numbers of regulators tested were fairly evenly distributed between two manufacturers, “A” and “B”, with over 125 of each manufacturer’s units tested. Figure ES-2 shows a summary of the failed regulators. Roughly 53 percent of the regulators tested were from Manufacturer A and approximately 47 percent were from Manufacturer B. Each of these showed similar range of results for lock-up, start-to-discharge, and reseal pressures. While more of the Manufacturer A regulators met the test criteria, this difference is fairly small.

Figure ES-2. Regulator failures by regulator manufacturer.

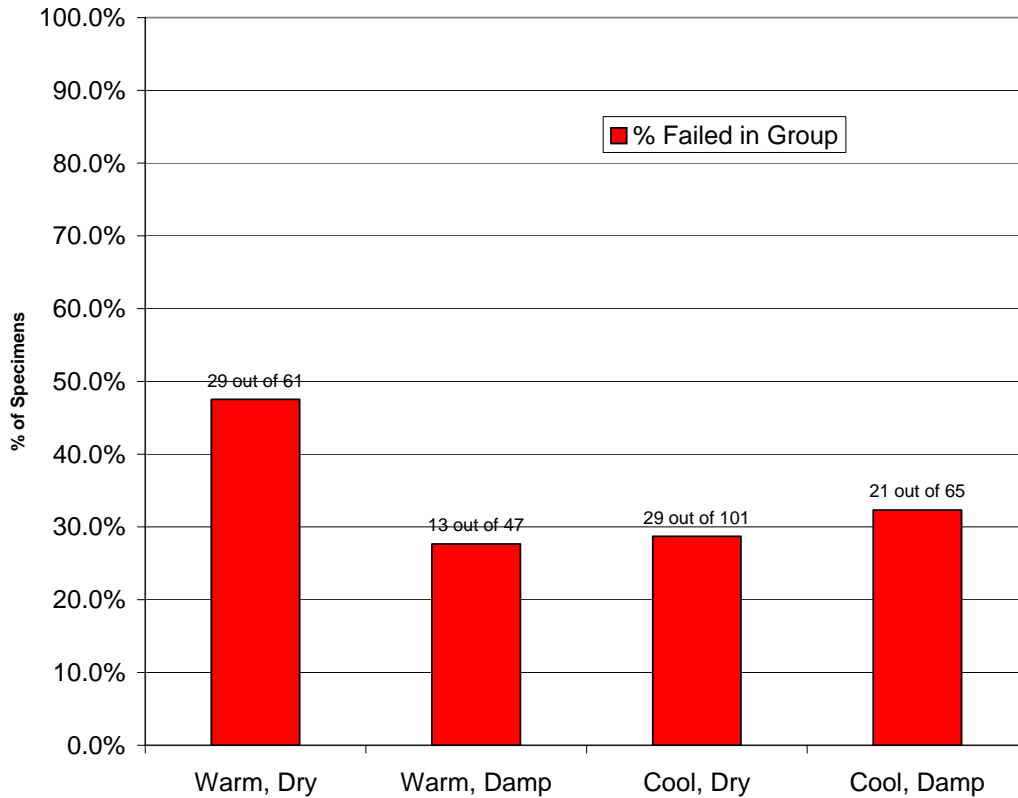
Figure ES-3, which shows the number of failed regulators for the four environmental conditions, shows a higher percentage of failures from a warm, dry environment. With the number of samples being reasonably significant (much greater than ten units), the fact that nearly half of the warm, dry regulators failed to meet the test criteria is also significant. While internal and external corrosion may be considered a significant failure mechanism, drying or hardening of the elastomeric components may be more significant.

Figure ES-3. Regulator failures by regulator environment.

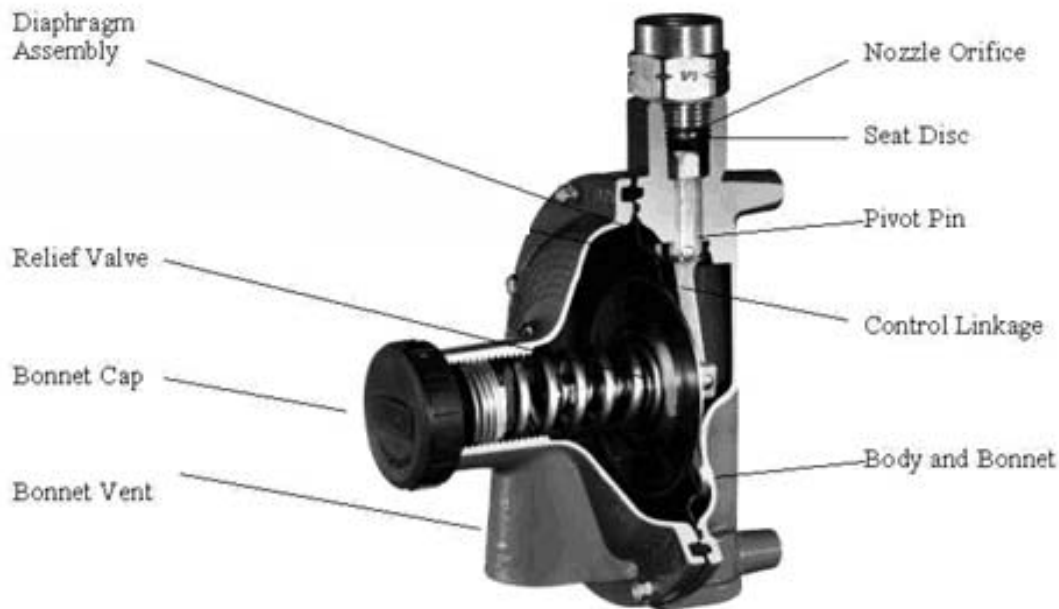
Figure 1. Components of a typical regulator.¹

Components of a typical regulator are shown in Figure 1.

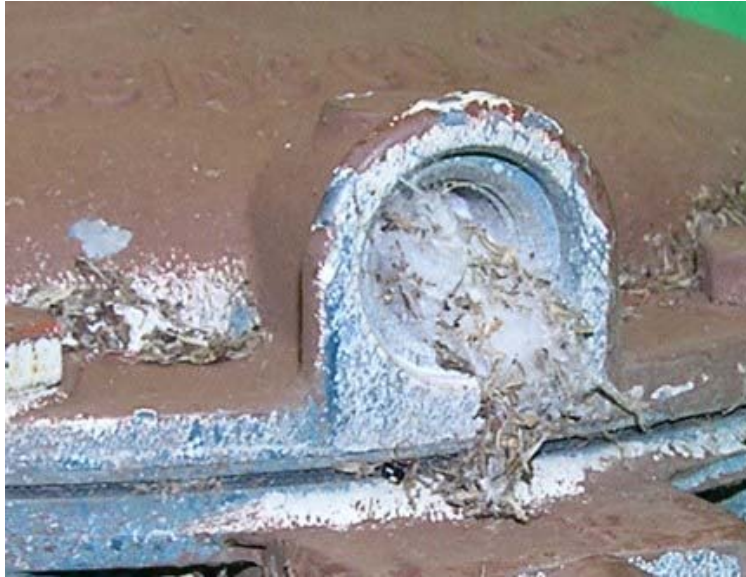
Figure 76. Regulator 711 — blocked pressure relief.

Findings from the failure analysis indicate a few possible trends as to why some regulators did not meet the test criteria. In particular, the second-stage regulator 711 did not relieve because of excessive dirt and spider webs blocking the relief opening (Figure 76). This is not a manufacturing issue but rather a maintenance or installation issue and would not be indicative of

any problems related to regulator age, environment, or manufacturer. This problem is not expected for regulators that are properly inspected and maintained.

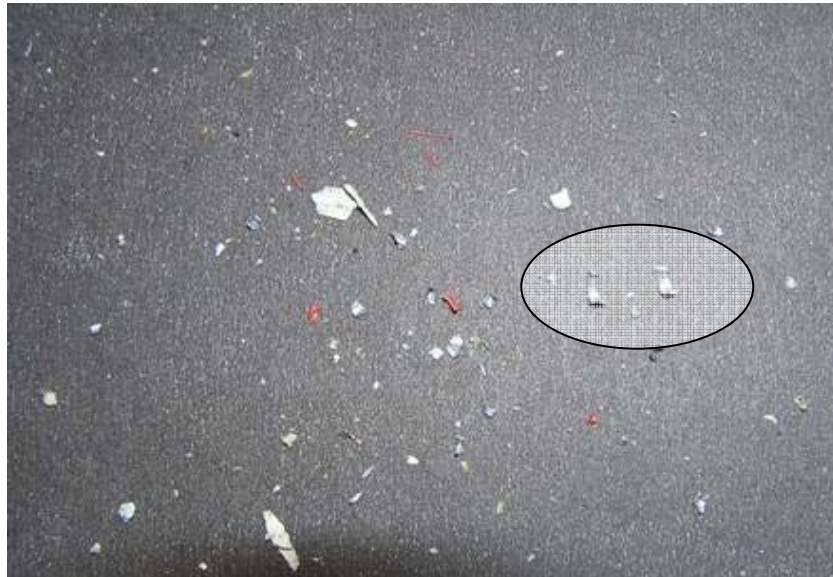
Figure 77. Regulator 571 — machining turnings found inside regulator.

For the regulators that were disassembled and analyzed, debris within the regulator body was the single most common potential cause for high regulator lock-up and/or leaks through the PRD (regulators 13, 72, 353, and 571). Some of the debris found appears to be corrosion products (from piping or containers), but other debris appears to be related to regulator manufacturing. For example, first-stage regulator 571 contained machining turnings inside the body of a regulator, with some pieces stuck on the control disk seat (Figure 77, circled). This debris was too large to get through the inlet screen of the regulator and appeared to be from the regulator manufacturing process.

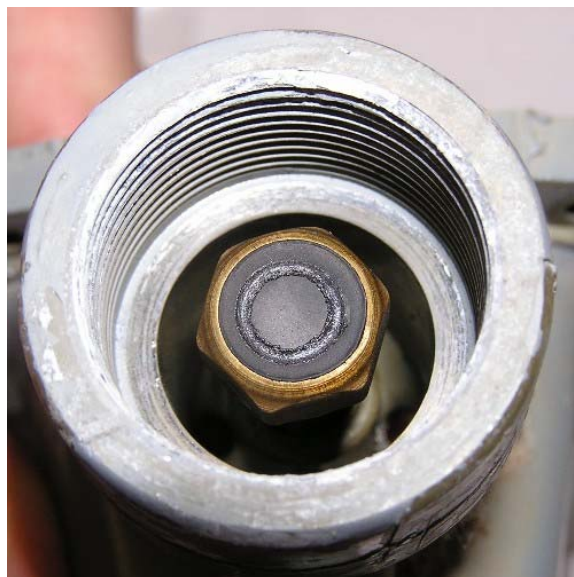
Figure 78. Regulator 383 — seat disc.

Other regulators (42 and 383) showed some damage to the regulator seat disc which could have led to high lock-up pressures. For example, single-stage regulator 383 appeared to be in good condition during initial external and internal (visual through the bonnet opening) examinations. However, when examined more closely significant degradation of the seat disc was found (Figure 78). The seat disc appeared to have material losses more significant than what would be expected solely from the compression set. Compression set is the permanent deformation of an elastomer after it has been compressed for an extended period of time. In addition, a significant amount of debris was found between the orifice and seat disc which could be attributed to the material lost from the seat disc. While this degradation is significant, this regulator was 43 years old when removed from service. This unit was in service well beyond the recommended service life of either the 15-year period or the more recent periods of 20 or 25 years.

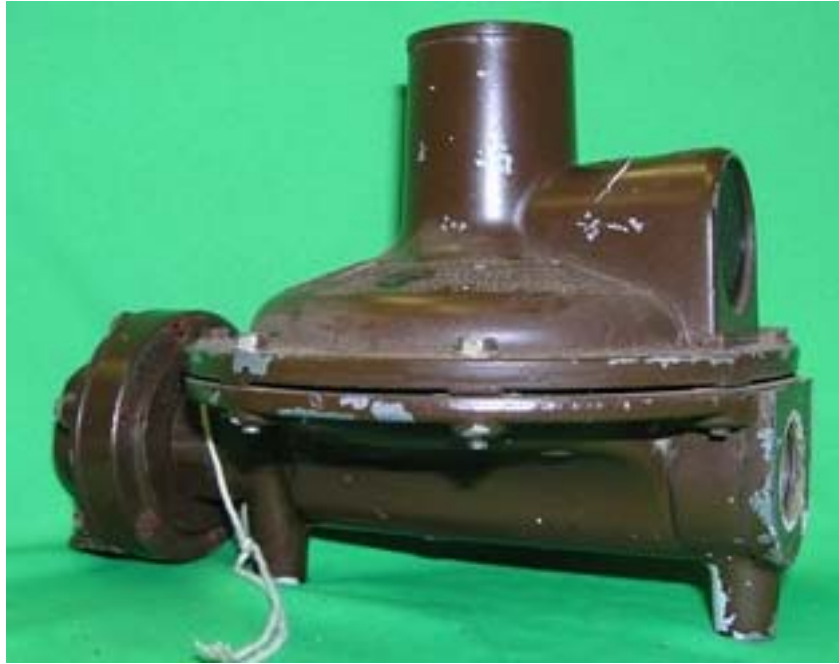
Figure 2: Regulator #13

The outside of the regulator body is in good condition. There is some chipped and scratched paint on the surface, but no major damage to the body. The vent screen is in place and clear.

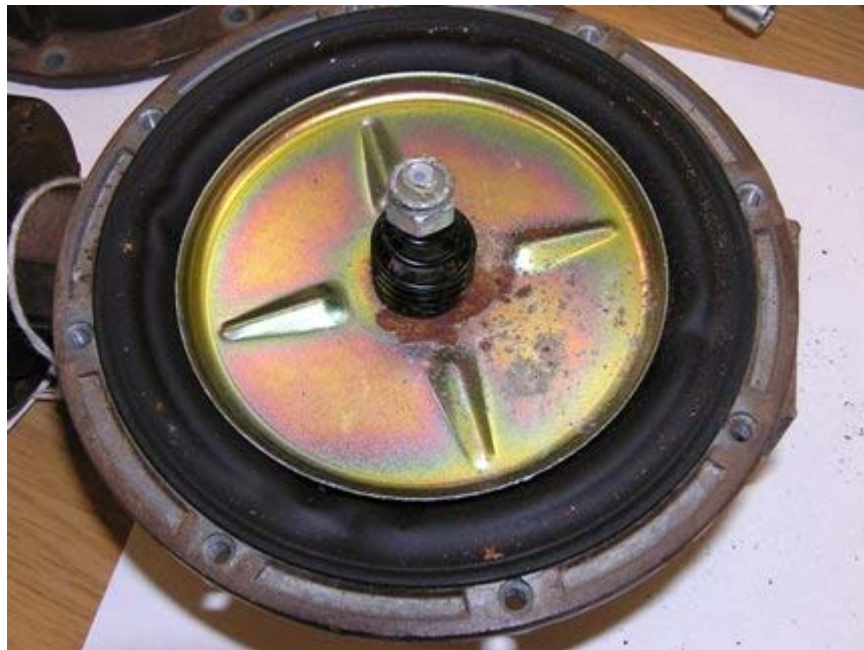
Figure 3: Top of Second-Stage Portion (Regulator #13)

The inside of the second-stage portion of this regulator was fairly clean, as shown in Figure 3. There was a small amount of dirt and corrosion on the diaphragm plate and small amounts of debris on the upper surface of the diaphragm. There was also some corrosion on the bottom of the adjustment spring plate as shown in Figure 4.

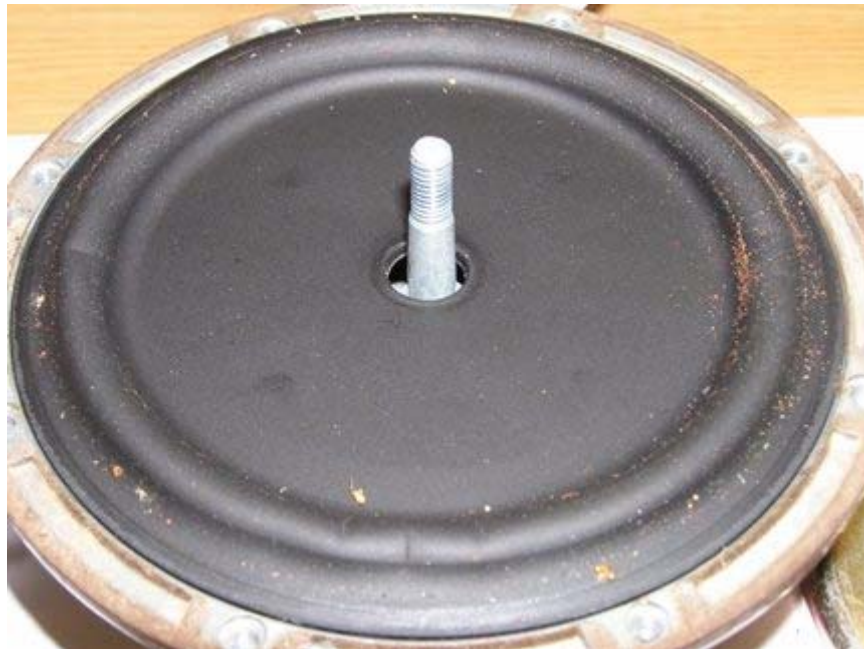
Figure 5: Top of Second-Stage Diaphragm (Regulator #13)

The diaphragm itself was in excellent condition. A few creases were observed on the top surface of the diaphragm, most noticeably at 6 o'clock in Figure 5. However there was no evidence of cracking or fatigue due to the creases. Some oily residue was observed on the lower surface of the diaphragm, most apparent where the diaphragm contacts the body as shown in Figure 6. There was no evidence that the oil damaged the integrity or functionality of the diaphragm. The sealing surfaces of the diaphragm, both with the body and the PRD, were clean and in good condition.

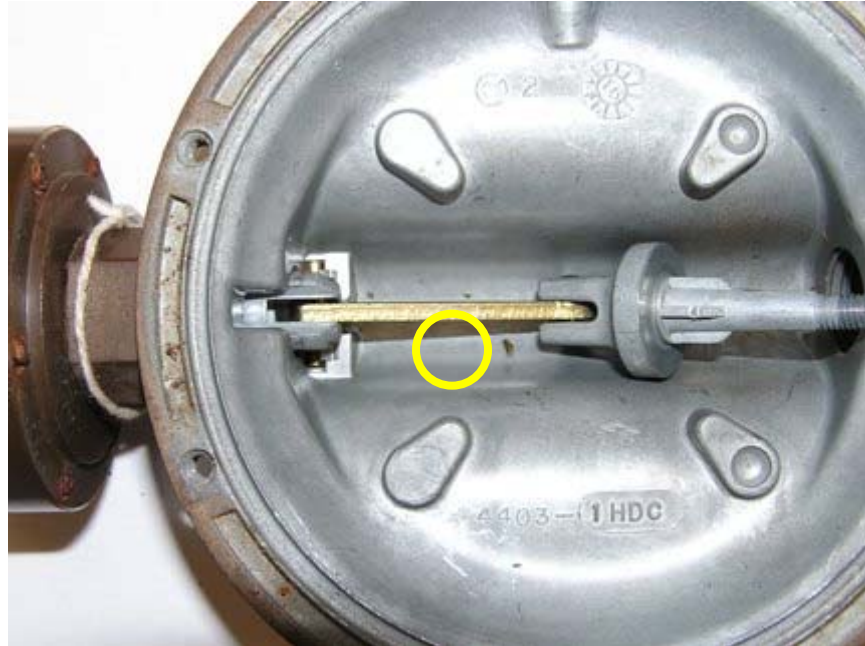
Figure 7: Bottom Body of Second-Stage (Regulator #13)

The lower half of the body of the second-stage portion of the regulator was remarkably clean. There were a few large chunks of some foreign material in the bottom half of the body. The largest of these is circled in Figure 7 and shown in more detail in Figure 8. The material was suspected to be remnants of pipe dope used during the installation of the regulator. The coloring of the material was similar to that of the pipe dope found on the outlet threads of the regulator. Additionally, like dried pipe dope, the chunks of material could be crushed to a fine powder by applying sufficient force. It is worth noting that for the second-stage inlet to be fully closed, the PRD stem is raised. For full-open, the PRD stem is lowered (and most likely to have its motion inhibited by the debris). So it is possible the debris blocked the opening of the second-stage, resulting in a maximum flow of 65 scfm (Figure 1) rather than the 80 scfm target.

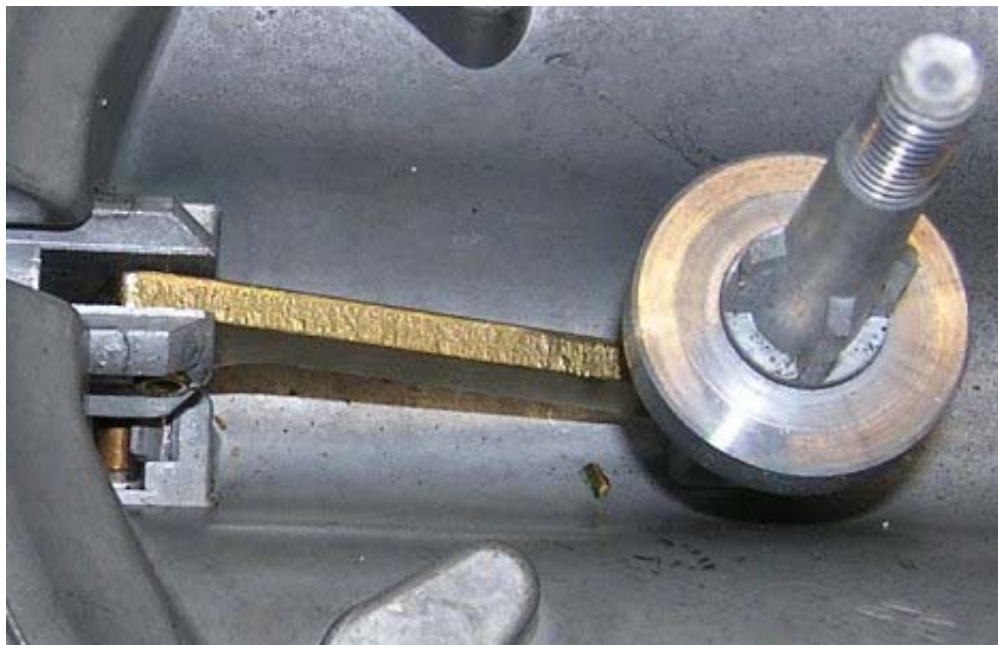
Figure 8: Close-up of Debris in Bottom Body of Second-Stage (Regulator #13)

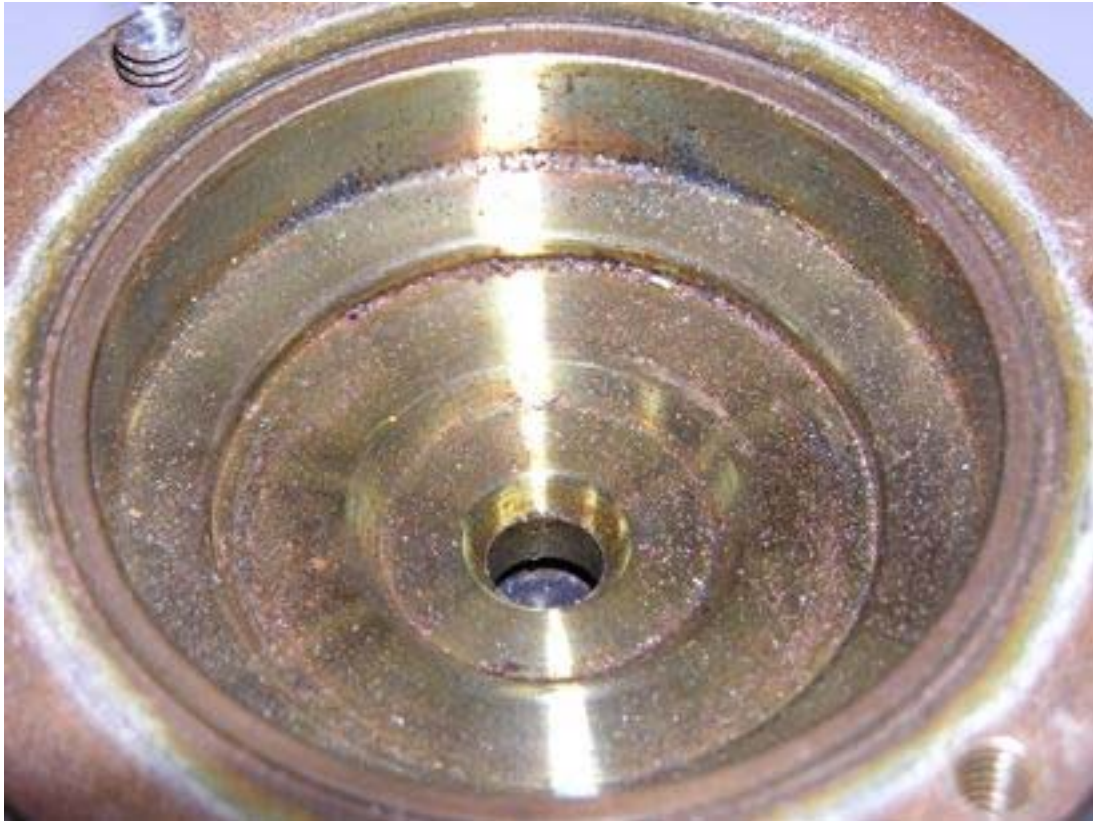
Due to the construction of the linkage assembly, it was impossible to remove the assembly and inspect the seal on the rubber inlet. No major wear or cuts were observed by the limited inspection. As with the rest of the body, a small amount of debris and metal shavings from an undeterminable source were found on the rubber.

Figure 9: Inlet to the Second-Stage (Outlet of the First-Stage) (Regulator #13)

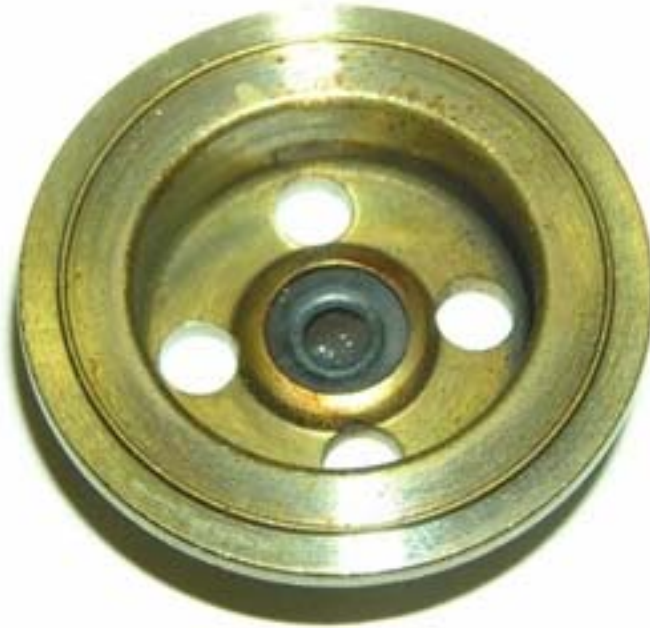
Figure 10: First-Stage Plate (Regulator #13)

The first-stage plate is shown in Figure 10. A small amount of debris was found on the rubber face. Given it's somewhat shielded location in the assembly, it is more probable (but cannot be guaranteed) that the debris had been on the rubber face while the regulator was assembled. There was no debris, nor imprints of where debris had been, on the seal line of the rubber.

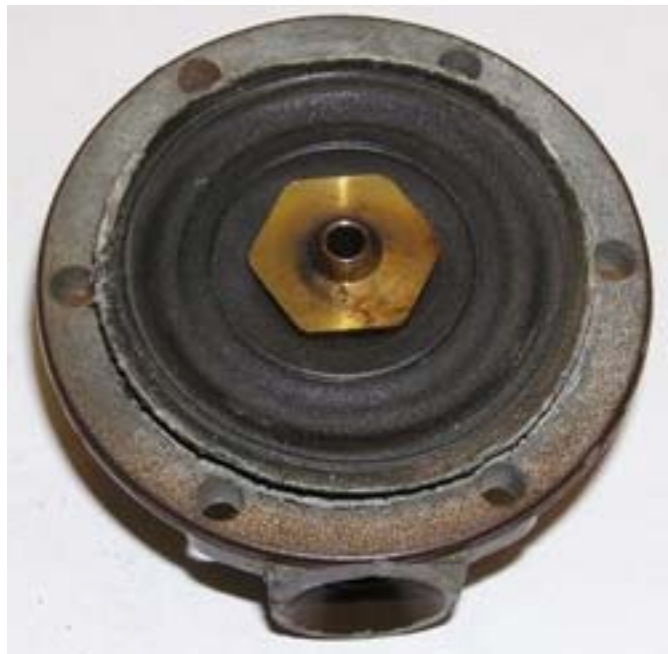
Figure 11: First-Stage Outlet (Regulator #13)

The first-stage diaphragm is shown in Figure 12. The diaphragm was less flexible than the second-stage diaphragm. Clear indentations were left on the diaphragm on all sealing edges. A small tear in the diaphragm on the inlet side was observed (at 3 o'clock in Figure 12). The tear did not extend through the sealing edge of the pass through (Figure 11). The diaphragm appeared to be constructed of a woven layer sandwiched by rubber layers. The

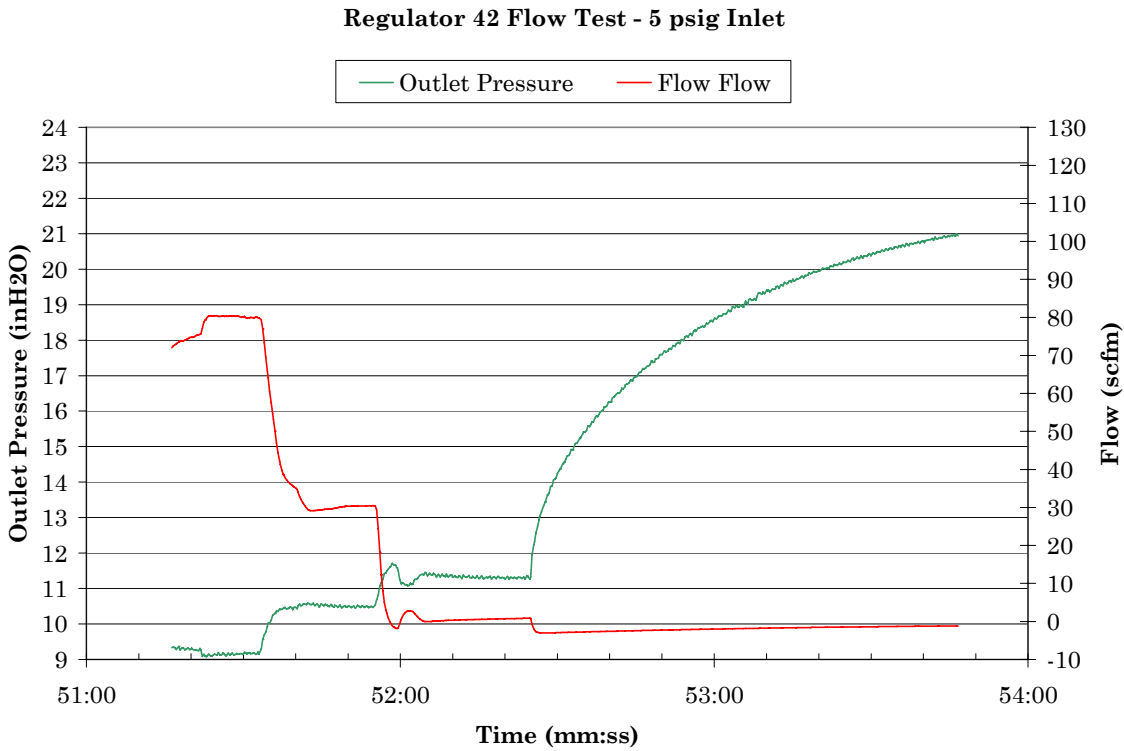
This second-stage regulator failed testing due to slow lockup and high lockup pressures. A typical flow test plot is shown in Figure 1. At lockup the outlet pressure increases to a steady value around 22 inH2O.

Figure 1: Regulator #42 Flow Test, Low Inlet Pressure

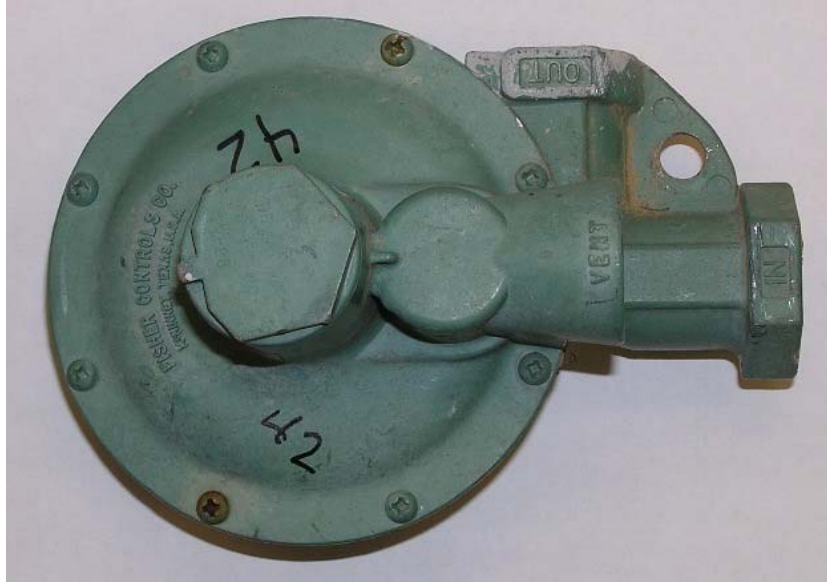
Figure 2: Regulator #42

The regulator body is in good condition, as shown in Figure 2.. There were small amounts of dirt on the body and slight corrosion on or around the screws that hold the two halves of the body together.

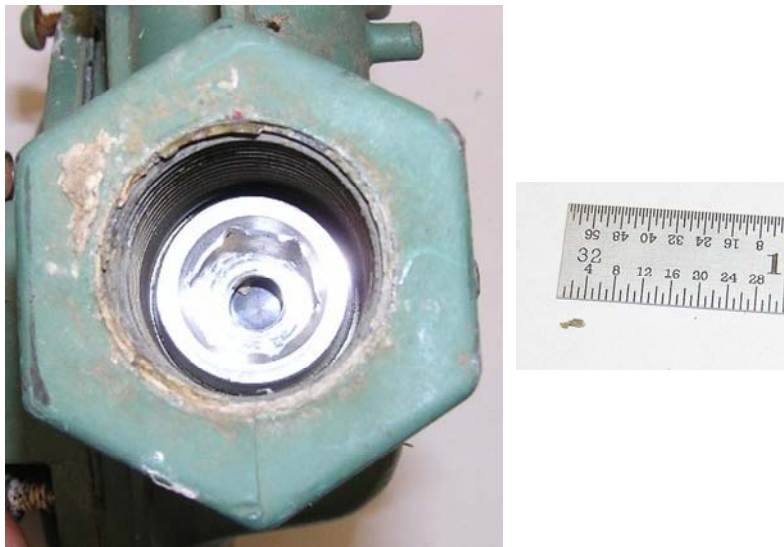
Figure 3: Debris Found on Inlet of Regulator #42

A small piece of debris was observed on the inlet seat disc as shown in Figure 3. The piece of debris was removed and measured to be approximately 1/8" x 1/16" x 1/32". Based on the amount of pipe dope on the regulator inlet (Figure 3) it is quite possible this piece of debris is simply a small fragment of dried pipe dope that fell into the inlet after testing was completed, and therefore not the root cause of the failure.

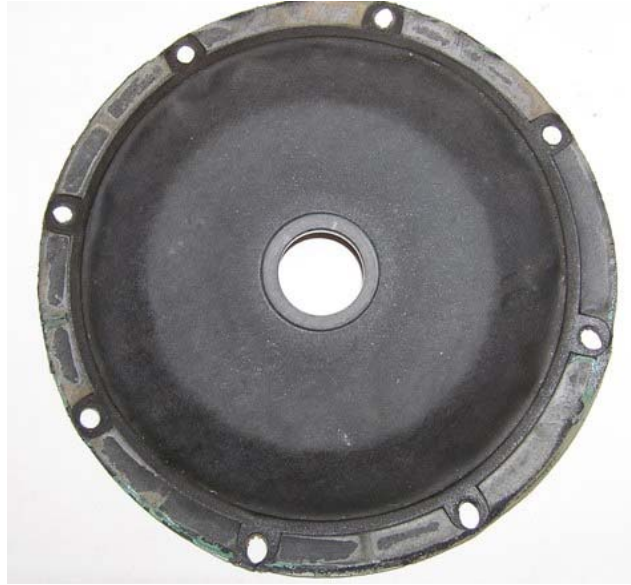
Figure 5: Underside of Regulator #42 Diaphragm

The underside of the diaphragm was found to be in good condition, as shown in Figure 5. The sealing interface between the PRD stem and the diaphragm was in excellent condition. A clear, uniform mark of the interface was observed. There were no indications of any potential leak paths through this seal.

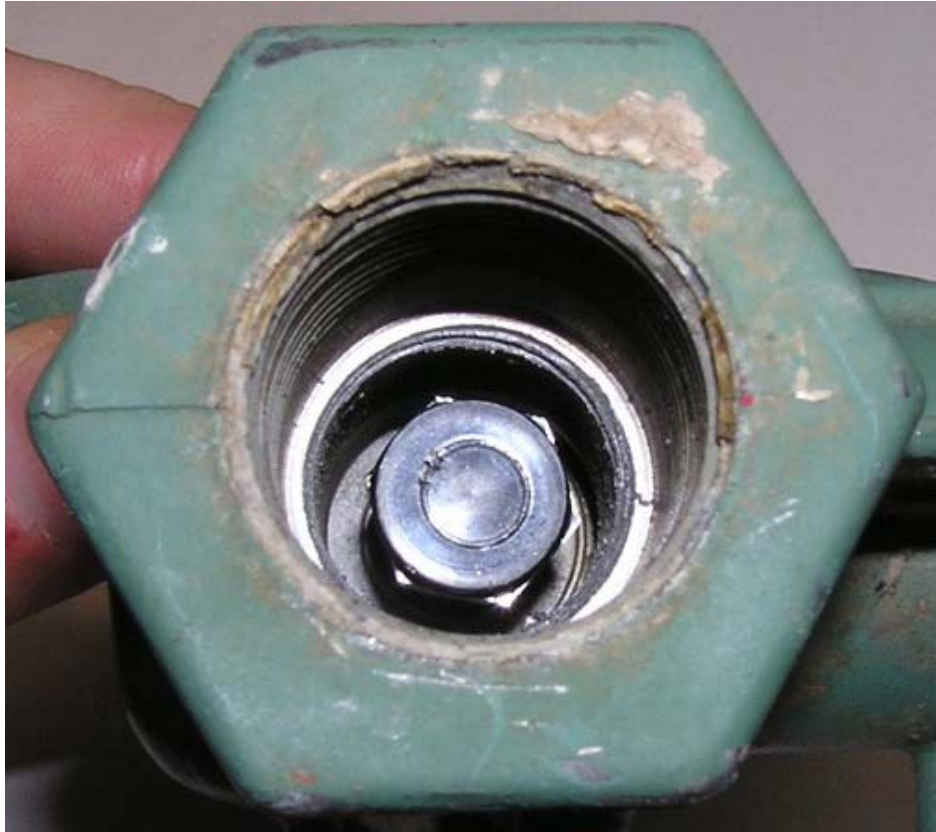
Figure 6: Damage to Inlet Seat Disc of Regulator #42

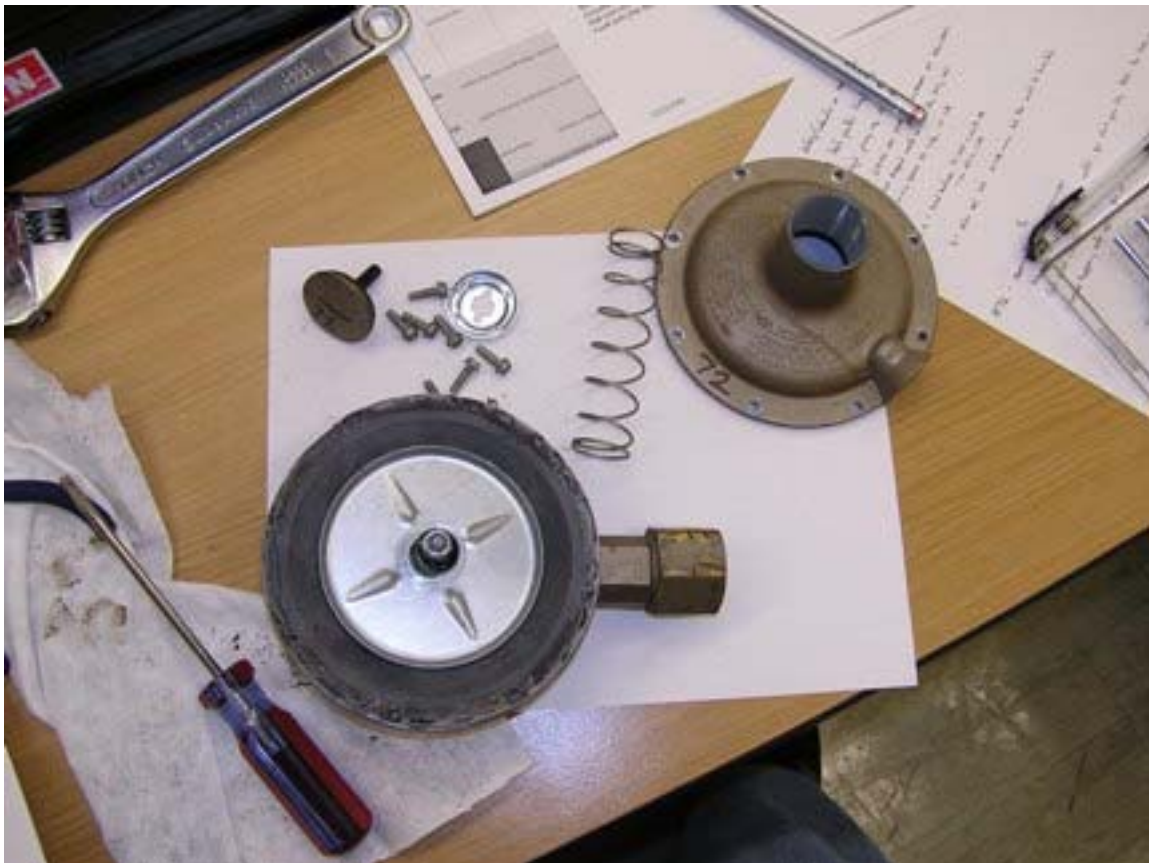
Figure 1: Regulator #72

The outside of the regulator body is in good condition. There are no signs of damage or abuse. The regulator functionality was tested before any disassembly or modifications were done. Air was blown through the regulator at lung pressure. When the outlet was open, all the sensible flow left the regulator through the outlet; no leakage through the PRD was found. If the outlet was covered, a small amount of air leaked through the PRD. As the inlet pressure was increased, the leak through the PRD stopped. Due to the small capacity of human lungs, it is possible that leakage through the PRD occurred while the outlet was open. But since the volumetric flow was so low, no discernible flow through the PRD could be observed.

In summary, at low inlet pressures the regulator leaked through the PRD. As the inlet pressure increased, the leak sealed.

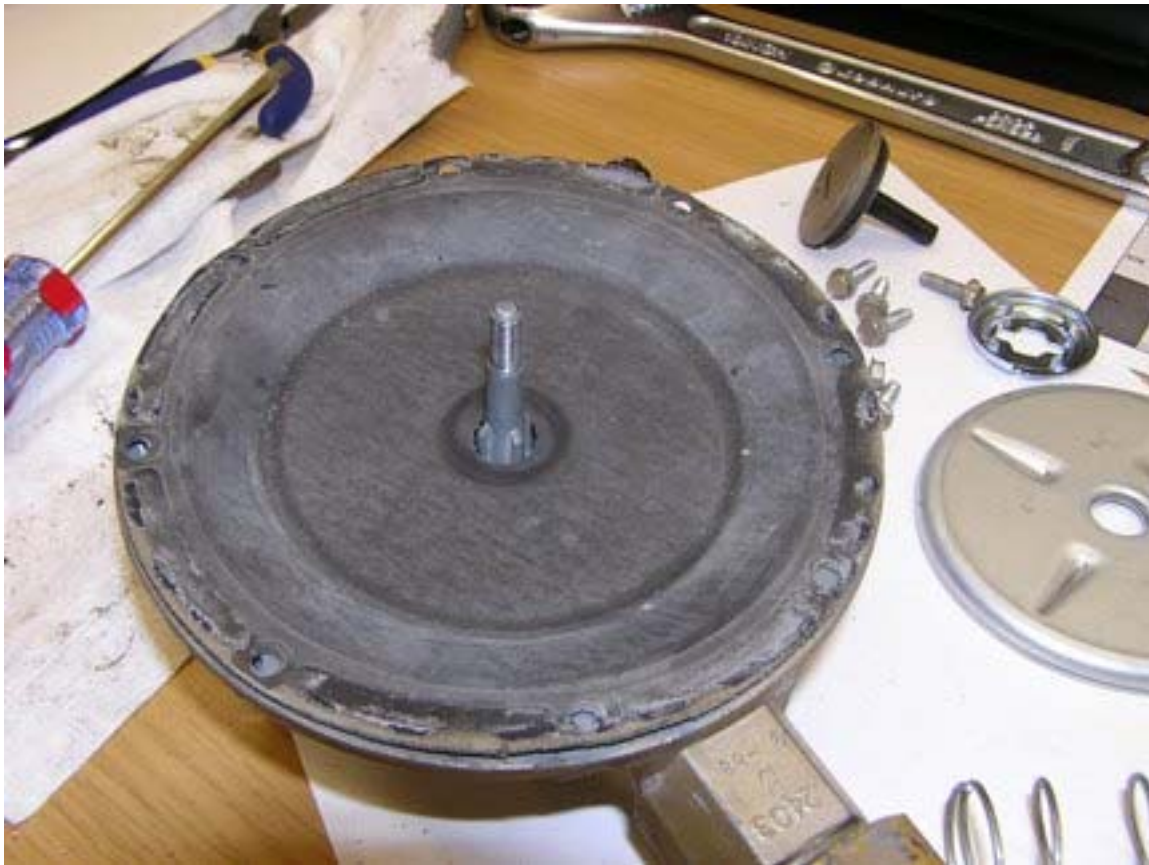
The diaphragm plate was removed and the upper surface of the diaphragm was inspected (Figure 2). The diaphragm appeared in good condition. No tears, cuts, holes, or any other indication of leakage was found. Small amounts of dirt and other debris were found on top of the diaphragm, but no large or sharp pieces were noted.

Figure 2: Top of Diaphragm (Regulator #72)

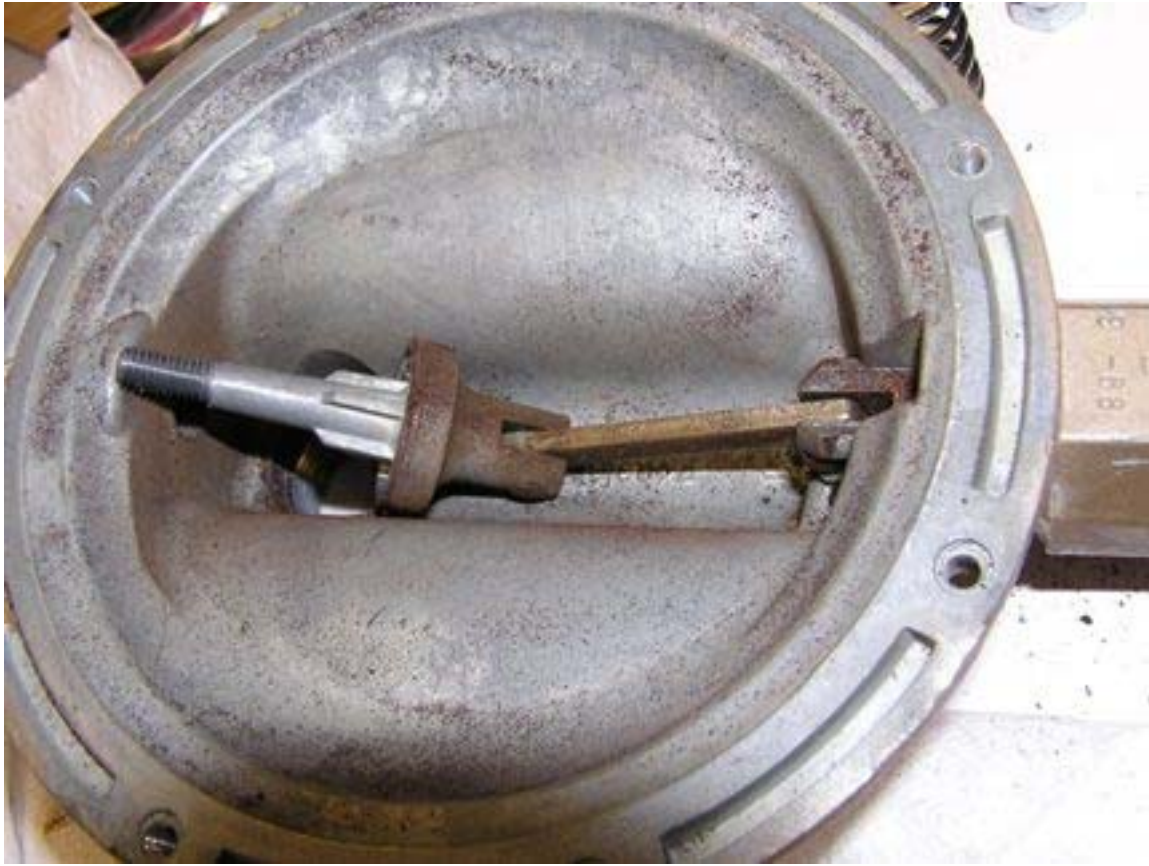
Figure 3: Bottom Half of Body (Regulator #72)

The diaphragm was separated from the control linkage and the bottom was inspected. There was a noticeable amount of rust or other debris in the bottom half of the regulator body and on the bottom of the diaphragm (Figure 3). The suspected source is the bell-shaped portion of the control linkage.

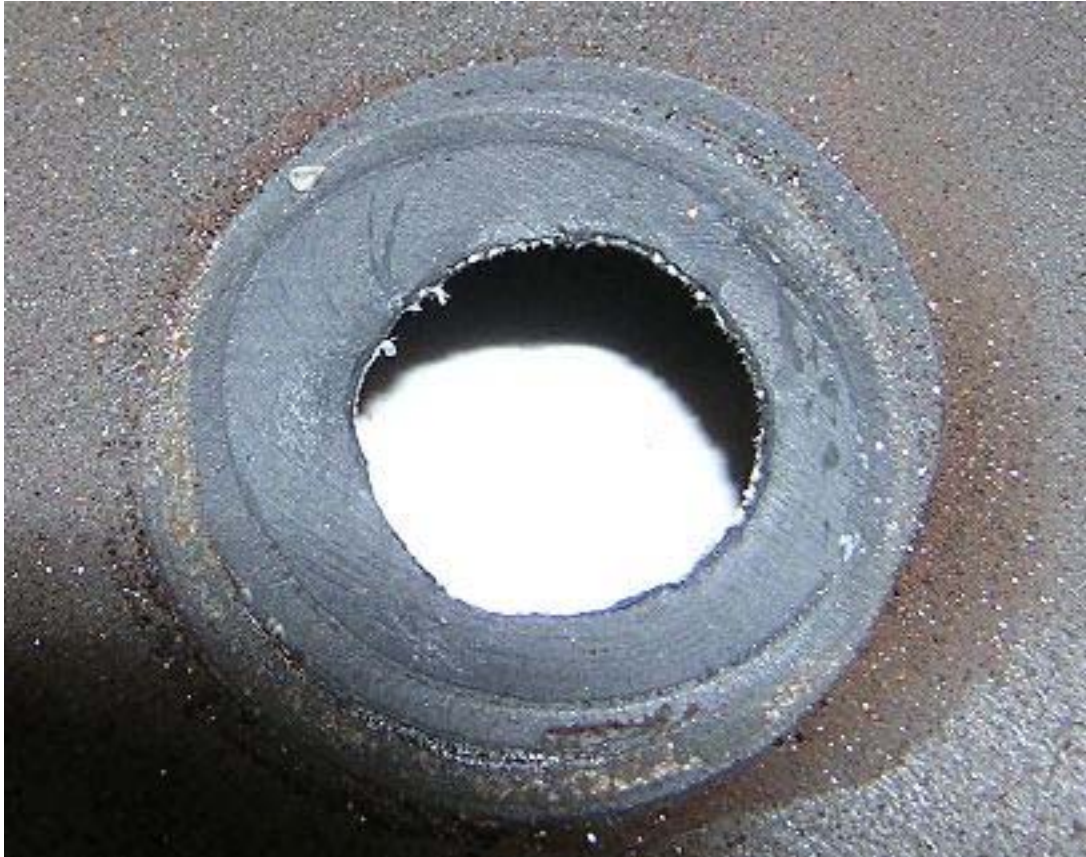
Figure 4: Debris on Seal Between Diaphragm Bottom and Control Linkage

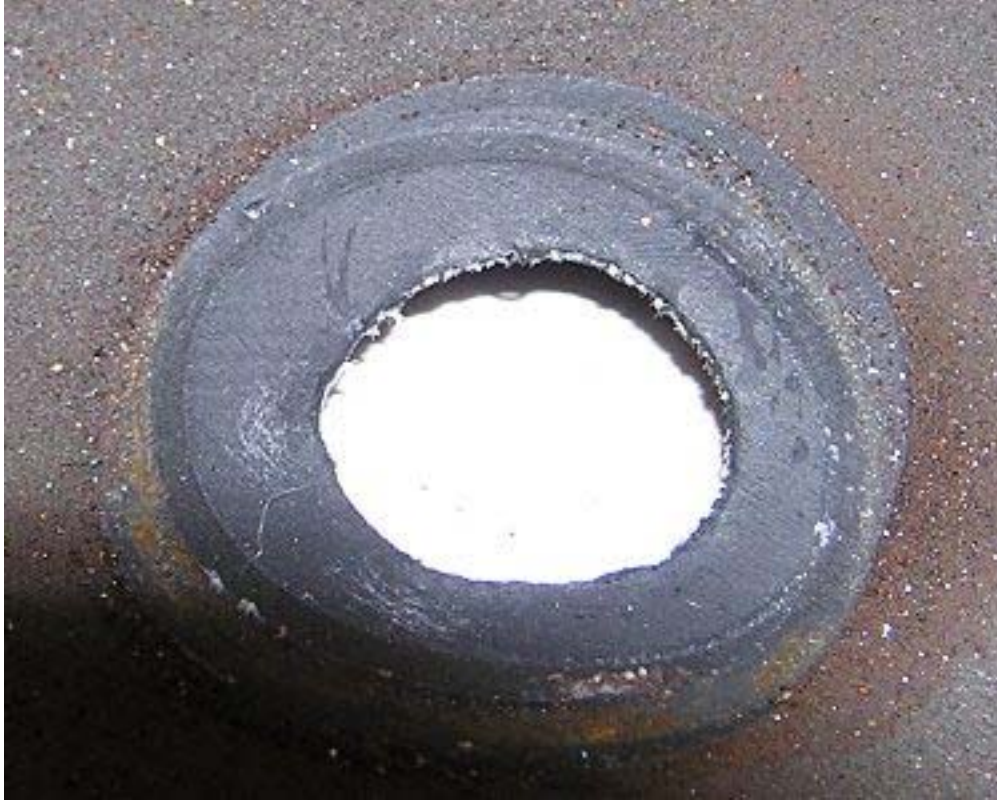
Figure 5: Removed Debris on Seal Between Diaphragm Bottom and Control Linkage

Near the central hole where the control linkage passes through the diaphragm two observations were noted. Firstly a small, sharp-edged, translucent piece of debris was found. The debris could have been glass, plastic, or another material. The debris was located on the sealing face between the control linkage and the bottom of the diaphragm. Note its location in Figure 4. Additionally, two distinct circles are observed where the seal between the diaphragm bottom and the control linkage. Both of these circles coincide with the location of the translucent debris, indicating that it was perhaps a pivot point for the shift.

The piece of translucent debris was removed and saved. A distinct impression was left on the diaphragm where the piece of debris was located (Figure 5).

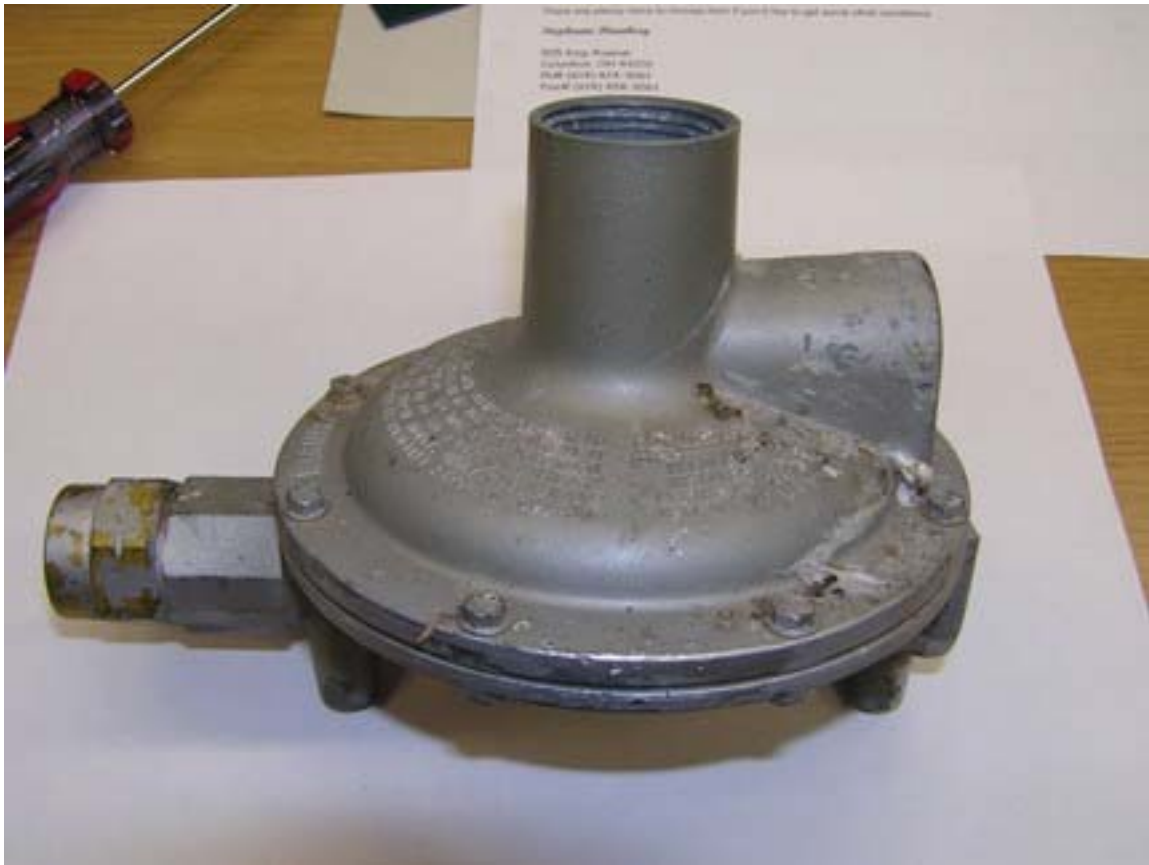
The assembled body of Regulator 353 was in good condition. There was a fair amount of dirt and insect webs on the outside of the body. The vent screen was in place, and only some small debris was found on the rubber diaphragm that covers the vent. Silver paint coated the body near the regulator inlet, outlet, and vent. Additional silver paint can be seen on the outside edge of the two halves of the body in Figure 1.

Figure 1: Regulator #353 (Cap Removed)

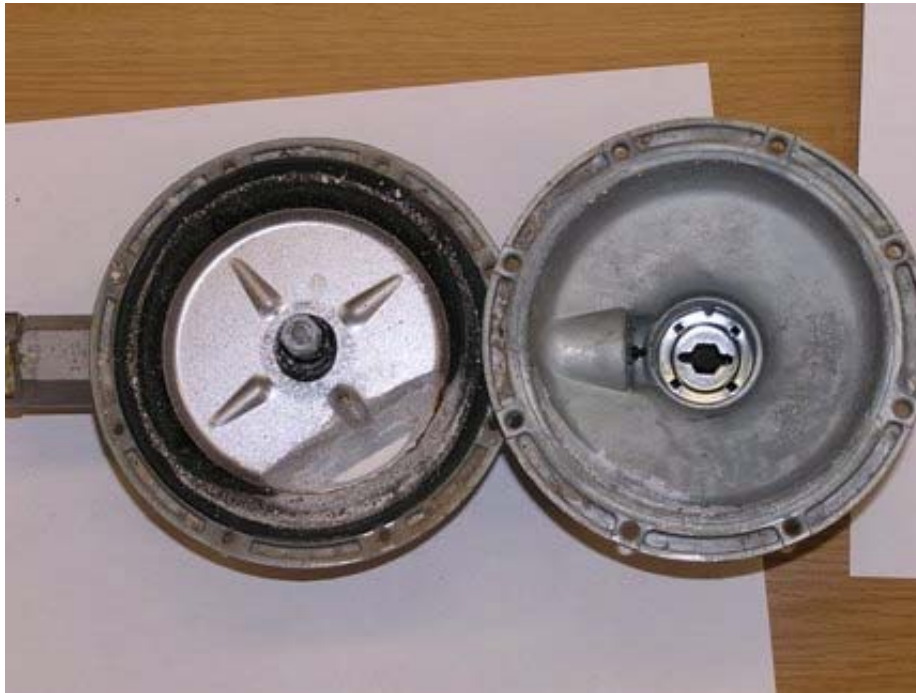
In addition to the residue from the pool or foreign substance, there was a substantial amount of other debris, flakes, and particles on the inside of the regulator body.

Figure 2: Inside of Regulator #353 Body

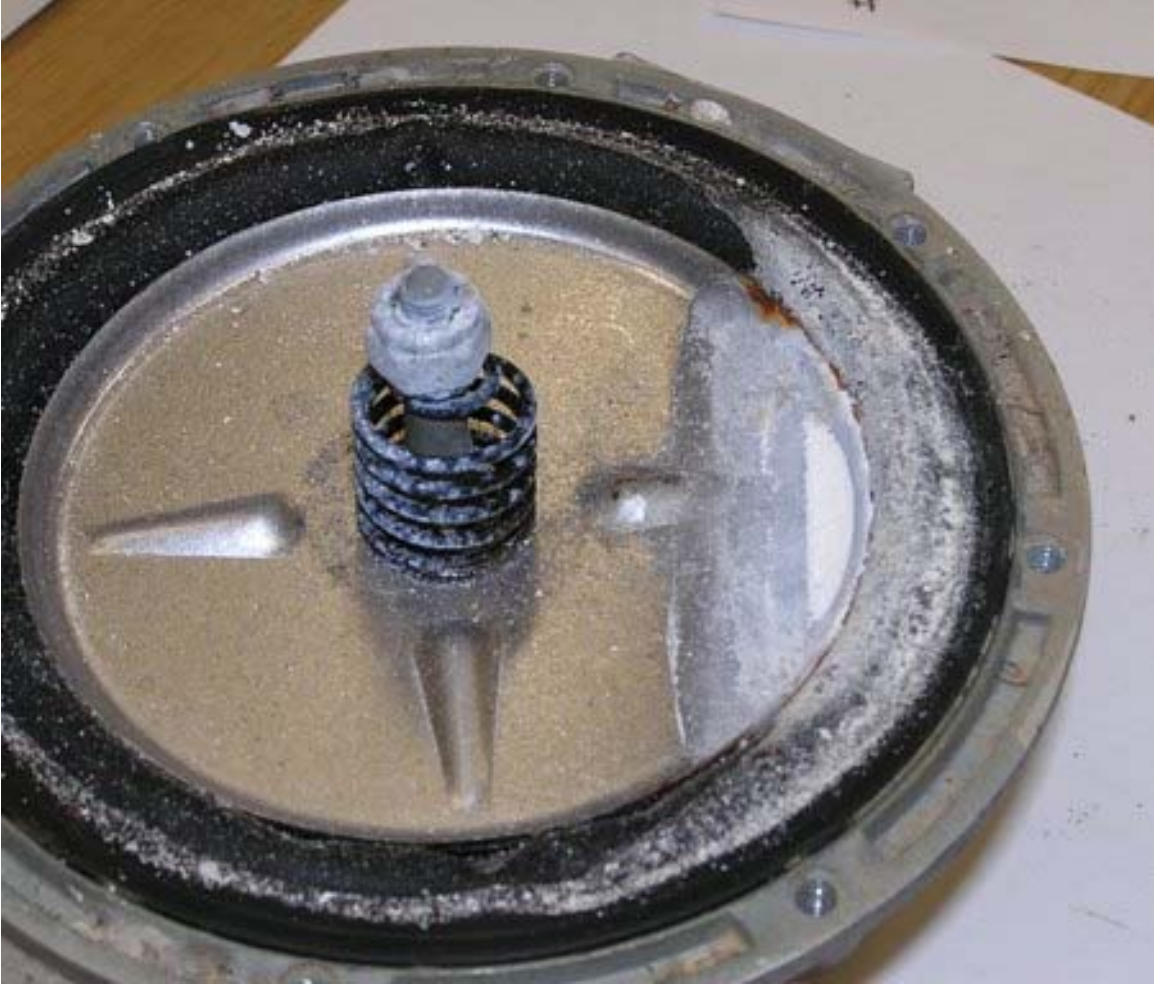
Figure 3: Corrosion and Residue on Plate (Regulator #353)
