Volume 1: Technical Report and Results

PERFORMANCE, DURABILITY, AND SERVICE LIFE OF LOW PRESSURE PROPANE VAPOR REGULATORS

VOLUME 1 – TECHNICAL REPORT AND RESULTS

Battelle Applied Energy Systems
505 King Avenue
Columbus, Ohio 43201-2693

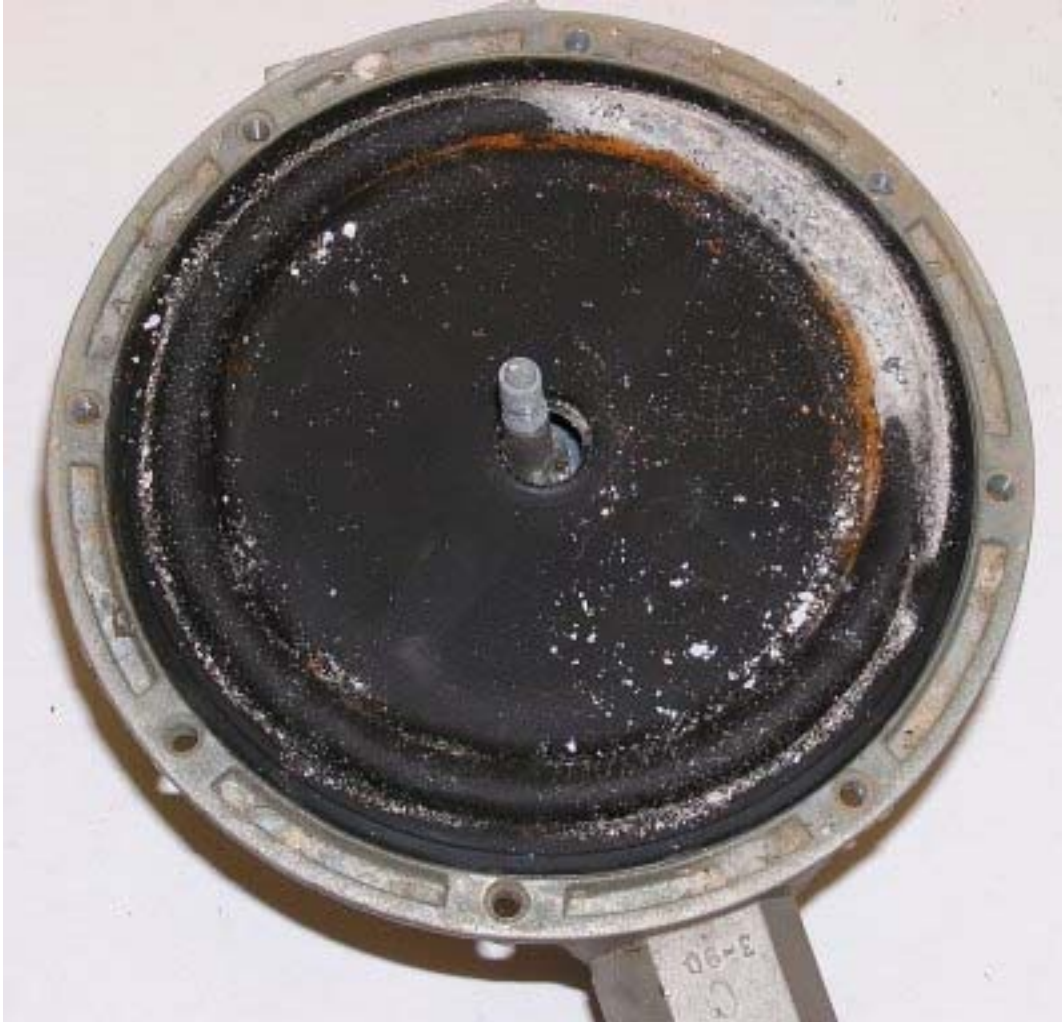
Figure 4: Debris on Diaphragm and PRD Stem (Regulator #353)

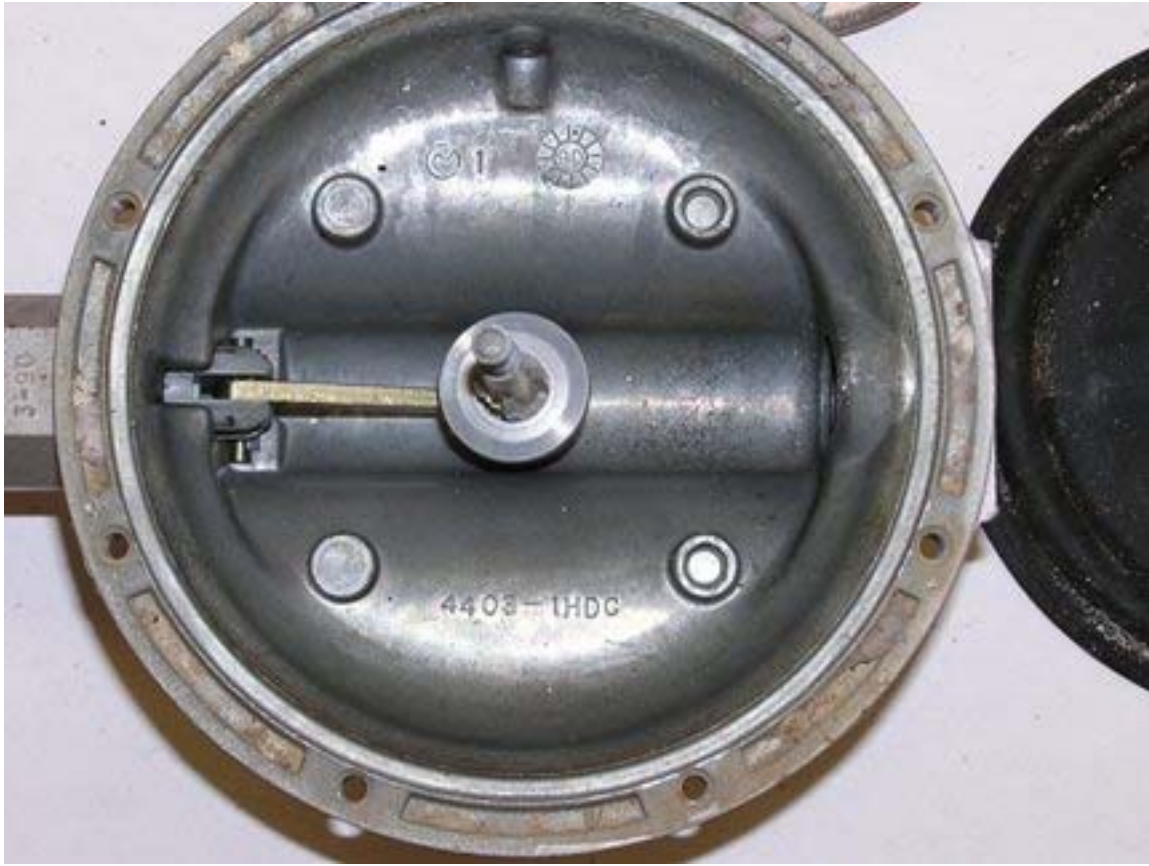
Figure 5: Bottom Half of Body (Regulator #353)

The bottom half of the regulator body was much cleaner, as shown in Figure 5. A few small specks of the white debris/flakes were found, as was a small quantity of some black particulate near the regulator outlet.

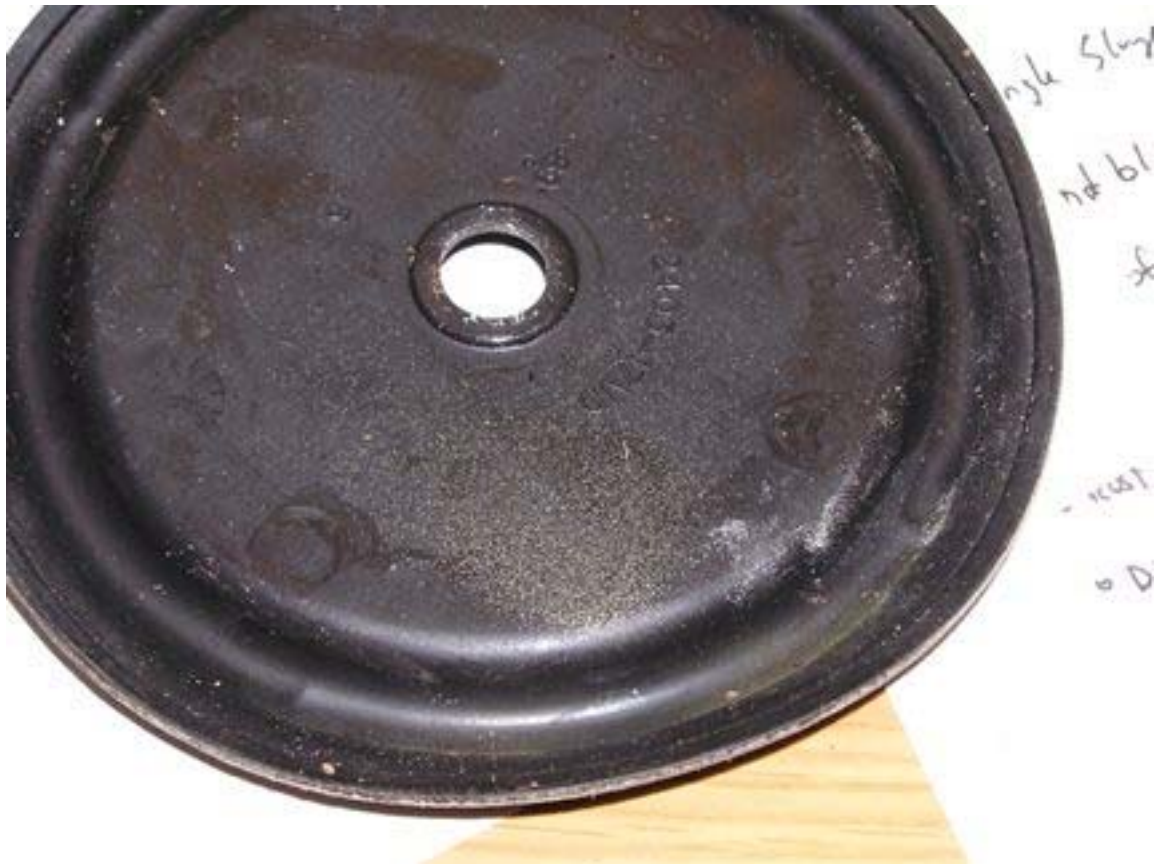
Figure 6: Bottom Side of Diaphragm (Regulator #353)

The bottom side of the diaphragm had a significant amount of debris on it, as shown in Figure 6. For the most part, the debris on the bottom side of the regulator was much smaller in particle size than that on top. There was a significant amount of debris on the sealing face between the diaphragm and the PRD stem, as shown in Figure 7. This debris was more comparable in size to the particles found on top of the diaphragm, and not on the bottom.

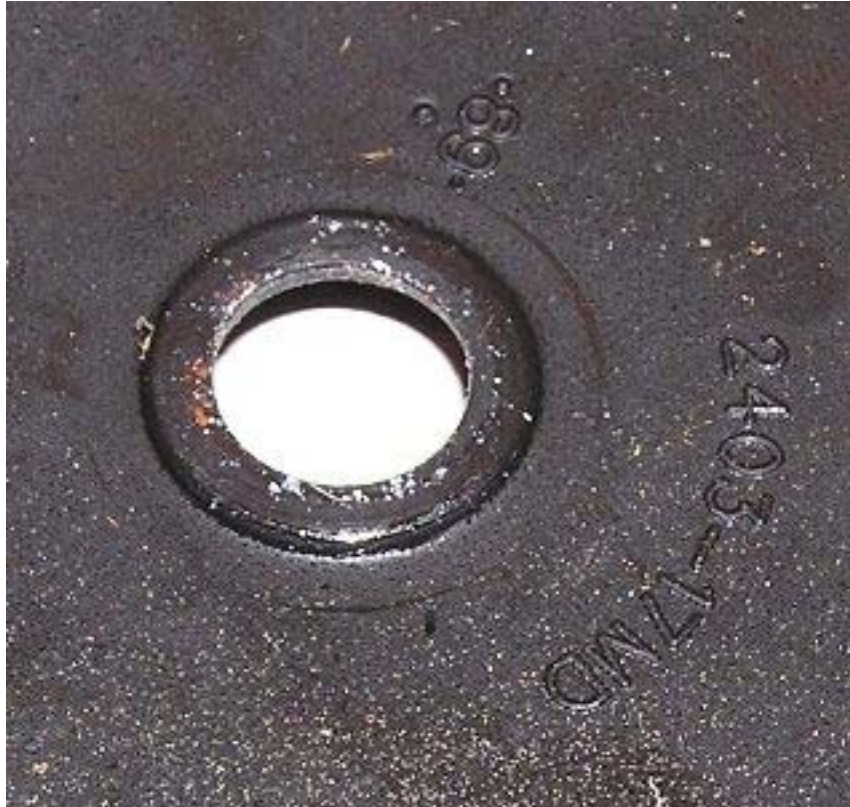
Figure 7: Debris on Sealing Surface Between Diaphragm and PRD Stem

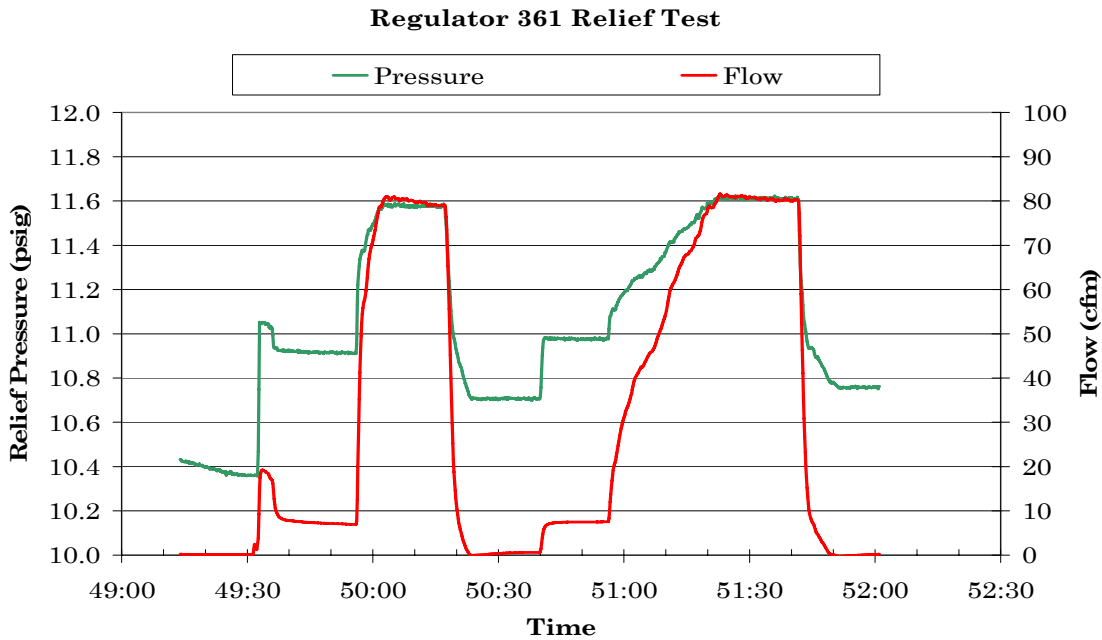
This first stage regulator failed due to a low relief start-to-discharge pressure and a low reseating pressure. The S-T-D pressure was approximately 11 psig and the reseating pressure was 10.8 psig. A plot of two sequential relief tests is shown in Figure 1. During testing it was noted that the adjustment spring was fully compressed and the maximum outlet pressure was about 10 psig.

Figure 1: Regulator #361 Relief Test

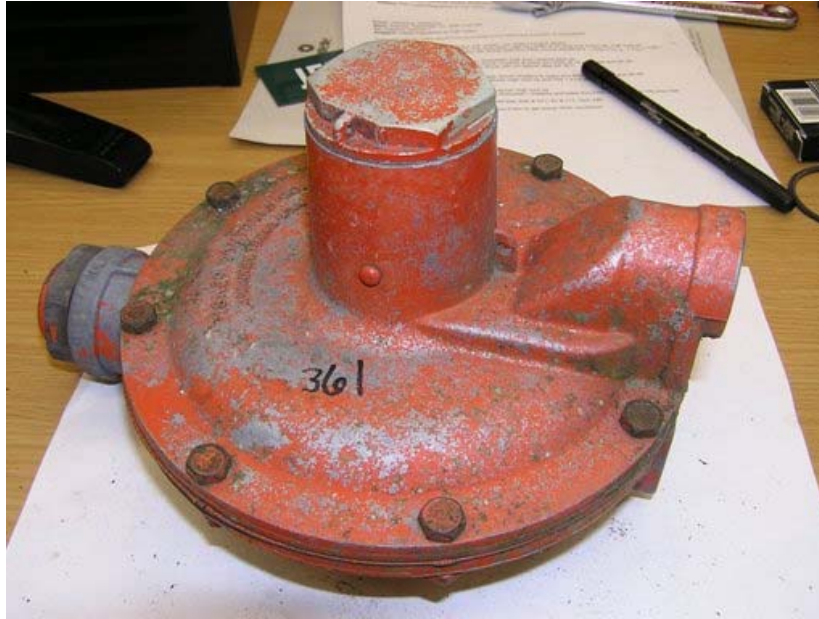
Figure 2: Regulator #361

Regulator #361 is shown below in Figure 1. An inspection of the assembled regulator found it to be in acceptable condition. Paint had started to chip off the regulator body, but no damage to the integrity of the body was found. There was some corrosion of the bolts holding the two halves of the body together. Small amounts of dirt were found on the outside of the regulator body.

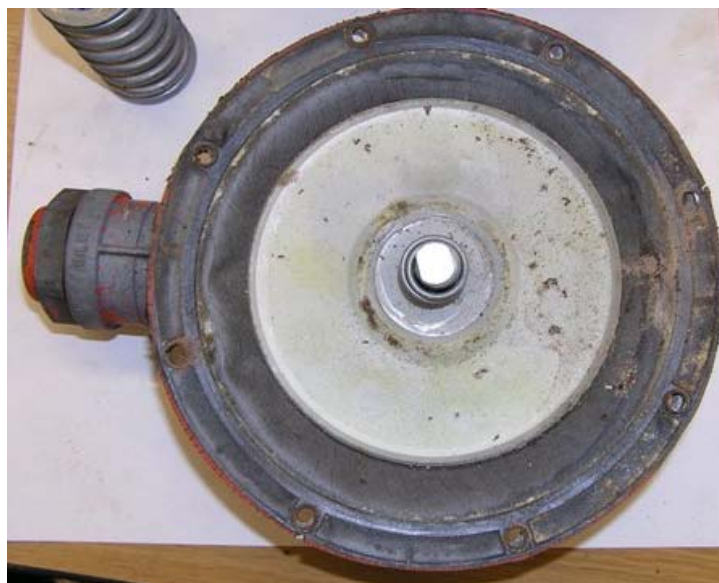
Figure 3: Diaphragm and Diaphragm Plate of Regulator #361

The upper half of the regulator body was removed and the inside of the regulator was inspected (Figure 3). A noticeable amount of dirt and debris were found on the upper surface of the diaphragm and plate. The diaphragm itself appeared to be in good condition. The mark noticeable at 12 o'clock is not indicative of any damage to the diaphragm integrity; it appears to be a stray spot of adhesive used to bond the diaphragm to the plate. The PRD spring was found in good condition.

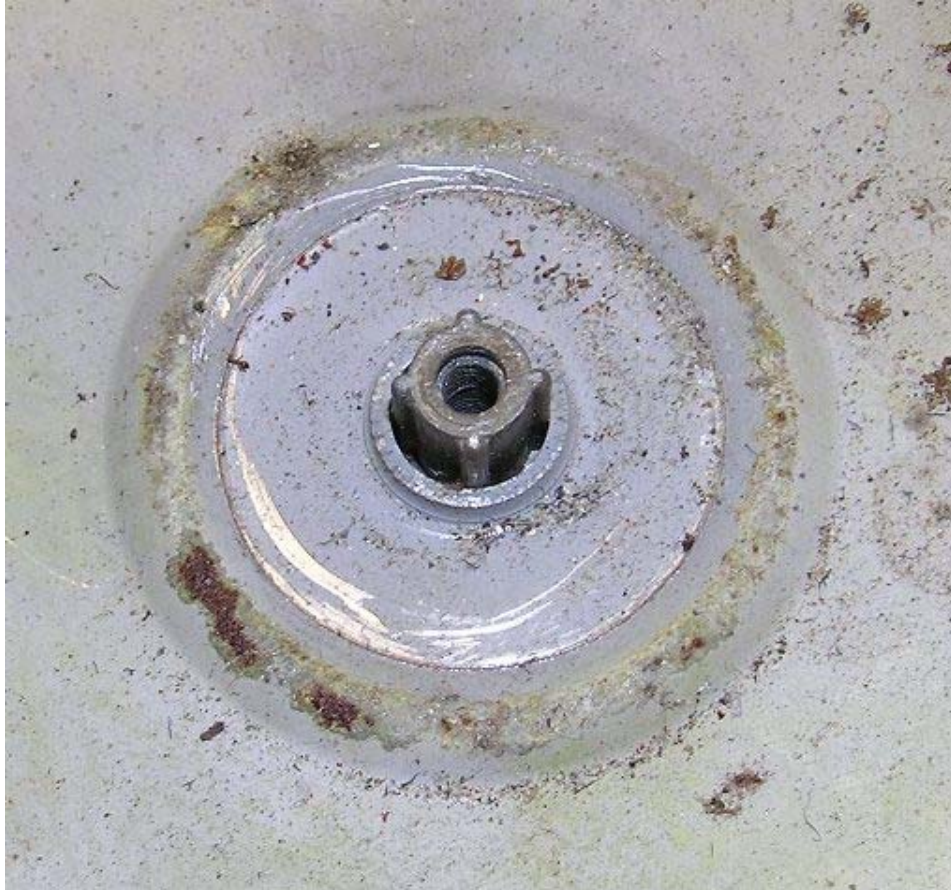
It was noted that marks on the diaphragm plate indicate the set point spring was off center. There are scratches on the raised lip of the plate at approximately 10 o'clock, as shown in Figure 4. Given the freshness of the marks (bright silvery metal is exposed, rather than corrosion) it is likely they were made during disassembly.

Figure 4: Scratches on Regulator #361 Diaphragm Plate

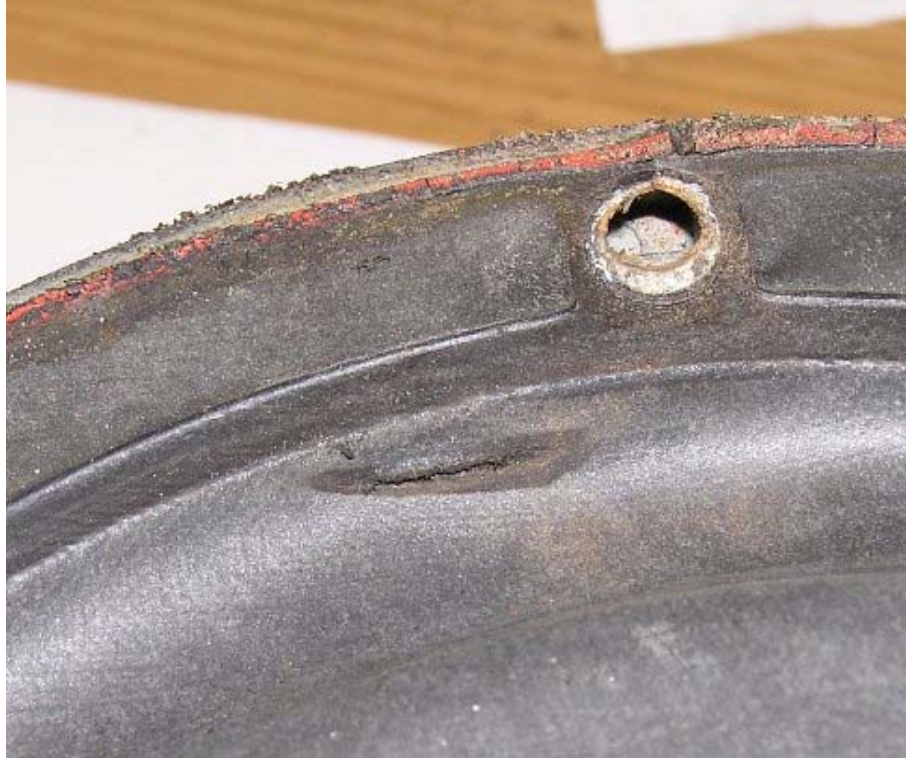
Figure 5: Cut on Bottom of Regulator #361 Diaphragm

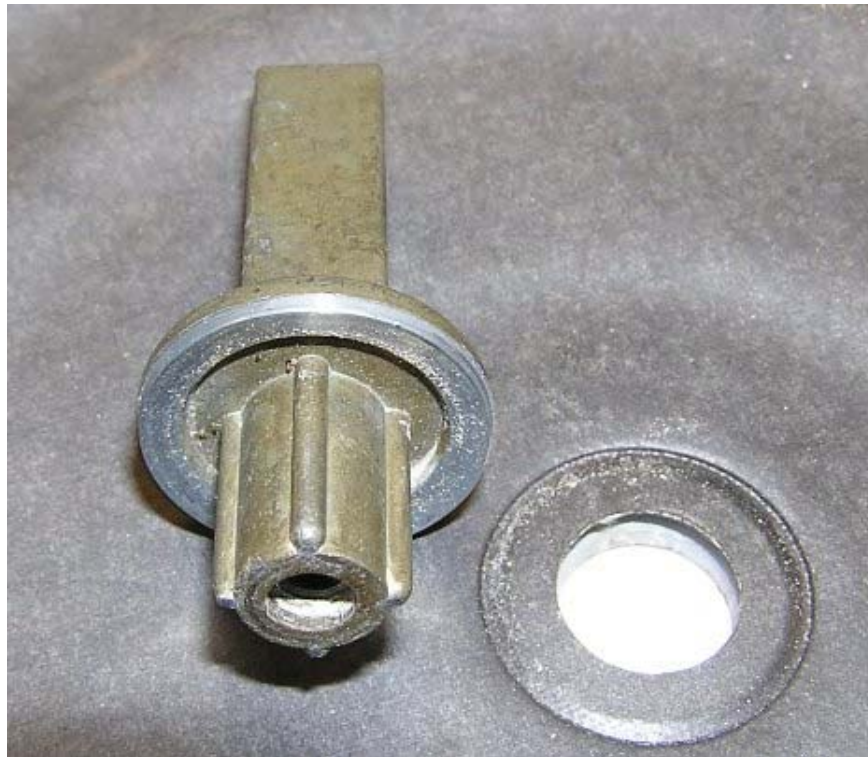
Figure 7: PRD Stem and Seal with Diaphragm

With the exception of the cut, the rest of the diaphragm was in good condition. The seal between the PRD stem and the diaphragm was distinct and uniform in quality, as shown in Figure 7. There were small particles of dirt or other debris, but there was no evidence that these had interfered with the seal. A small nick was noted on the edge of the PRD stem (1 o'clock in Figure 7). It was barely noticeable, and the uniform quality of the impression on the diaphragm indicates that it didn't affect the quality of the seal.

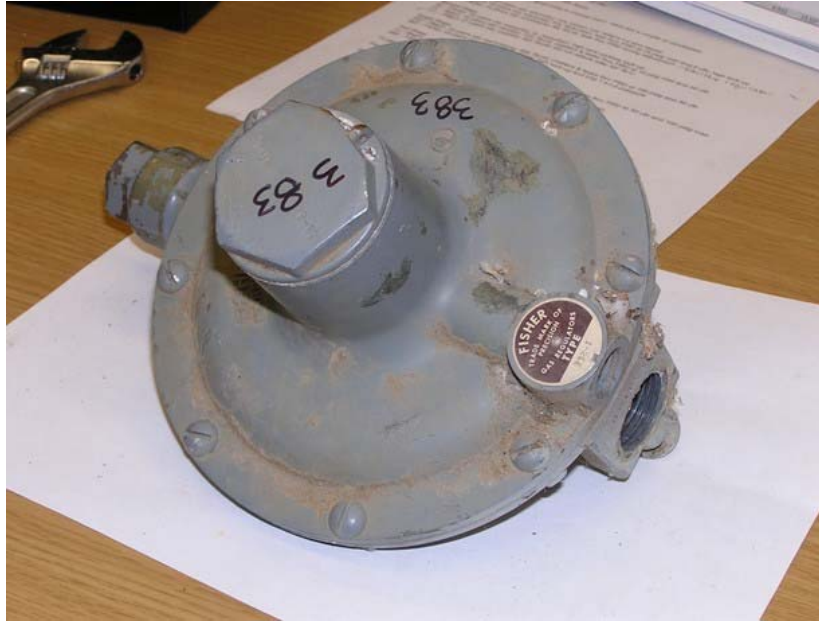
Figure 2: Regulator #383

The outer body of Regulator #383 was found in good condition, as shown in Figure 2. There was some buildup of dirt on the body surfaces, but none appeared to interfere with the functionality of the regulator.

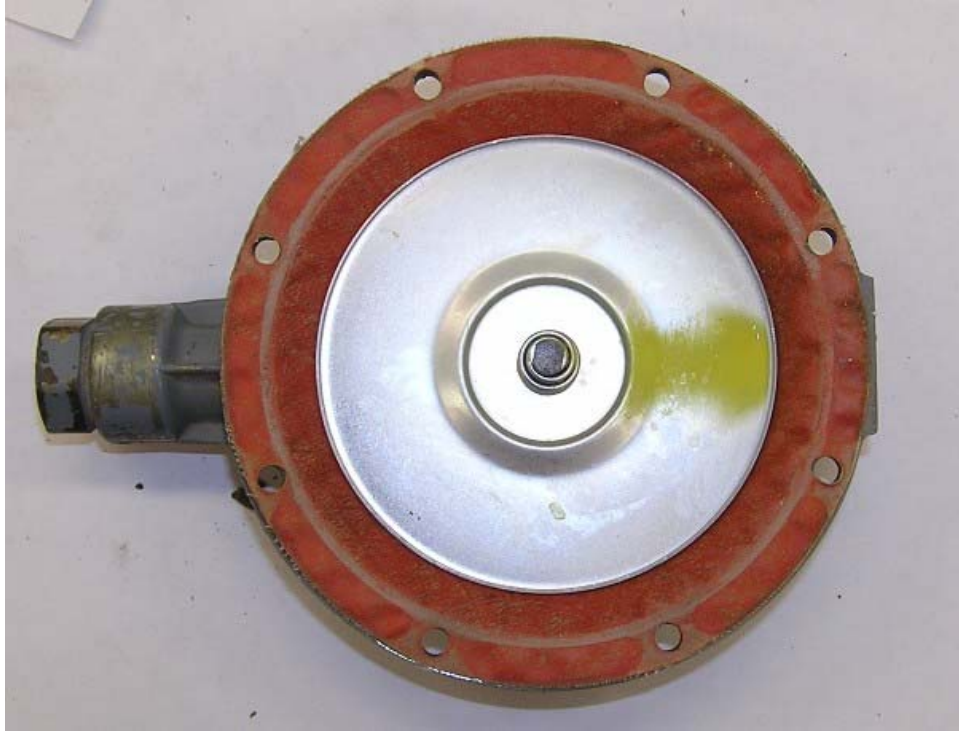
Figure 3: Diaphragm and Plate of Regulator #383

The upper half of the body was removed and the diaphragm was inspected (Figure 3). The inside of the regulator was very clean. The diaphragm was found to be in good condition, with no cuts or scrapes. Yellow paint was noted on the diaphragm plate. This color and location matches the color and location of paint on the set-point spring, indicating the spring was painted during assembly. The diaphragm was thinner than typically noted during the regulator inspections.

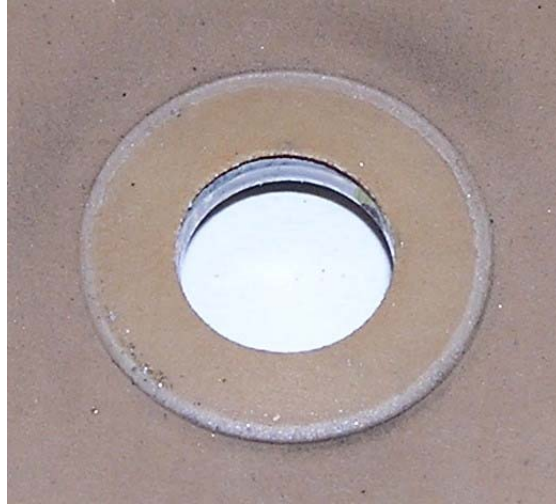
Figure 5: PRD Seal on Bottom of Regulator #383 Diaphragm

The seal between the PRD stem and the diaphragm was in good condition, as shown in Figure 5. Although there was small amounts of dirt and debris in the vicinity of the seal, there was no indication that it prevented a proper seal from occurring.

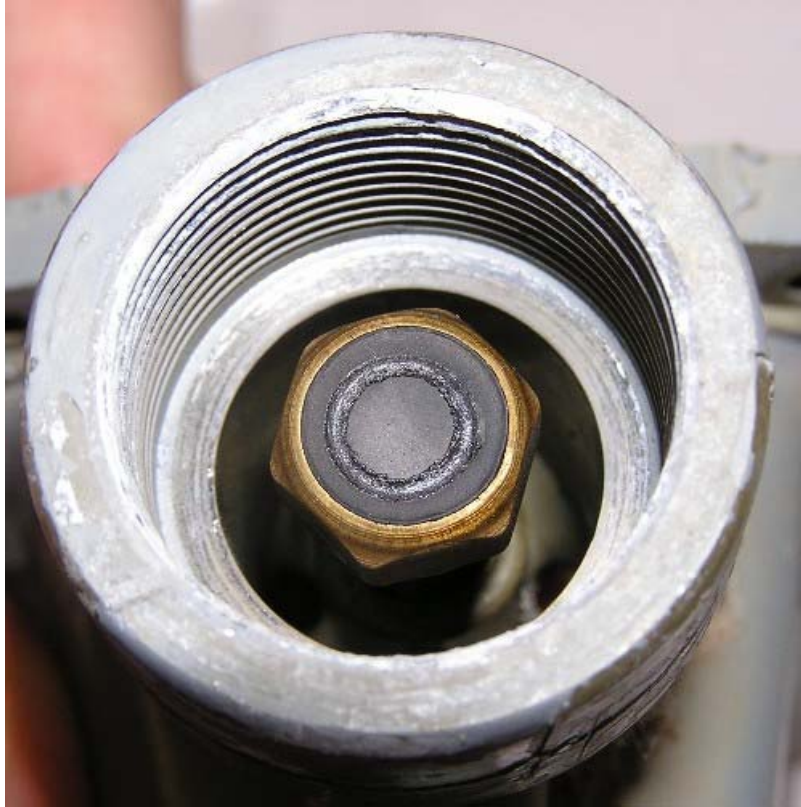
Figure 6: Inlet Seat Disc on Regulator #383

The nozzle orifice was removed from the inlet of the regulator. Substantial degradation of the seat disc was apparent, as shown in Figure 6. It appears the damage is a loss of material from the seat disc (and not solely compression set). A significant amount of debris was found between the orifice and seat disc. The debris was collected in a bag and is shown in Figure 7. It is suspected that some of this debris is material lost from the seat disc.

Based on these observations, the following failure mechanism is proposed. Damage to the seat disc prevents a proper seal between the inlet and outlet from being formed. Under lock-up

conditions, leakage occurs until the outlet pressure is approximately 35 inH₂O. At this pressure enough force is generated to form the seal between the degraded seat disc and the inlet orifice. No physical cause of the damage to the seat disc was found. The dark substance on the orifice fitting may indicate the presence of an impurity in the propane that chemically attacked the seat disc.

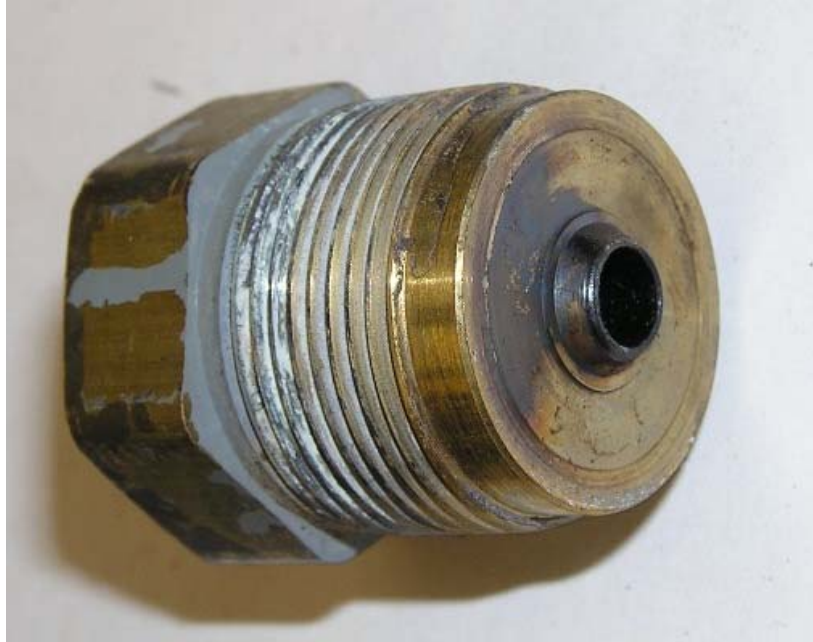
Figure 8: Nozzle Orifice of Regulator #383

The nozzle orifice is shown in Figure 8. The edge of the orifice was smooth and had no sharp edges. This indicates the damage to the seat disc was not caused by the orifice cutting the disc. A dark substance was noted on the large face of the orifice. This may be the same substance that was noted in substantial quantities on the inlet to the orifice (Figure 9). Although the exact rotational

position of the orifice fitting during assembly is unknown, it is probable that the dark substance gravimetrically settled out of the propane.

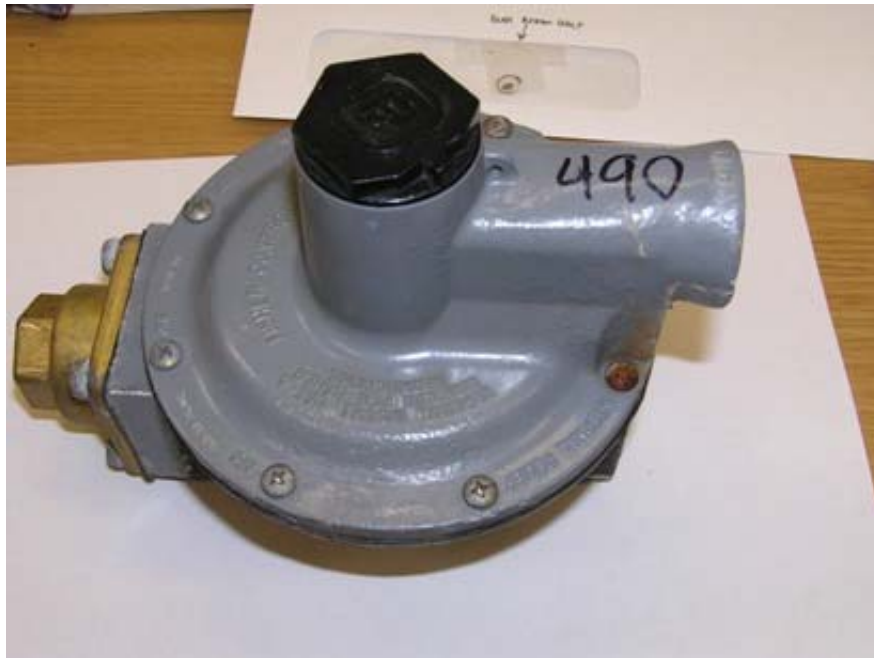
The outside body of Regulator #490 is in good condition, as shown in Figure 1. There is some corrosion on some of the screws holding together the body, but there is no indication that they had corroded to failure or that the body was corroded.

Figure 1: Regulator #490

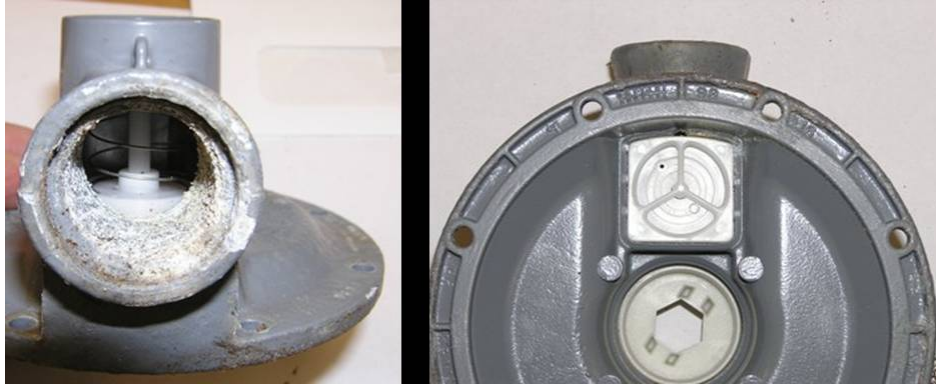
Figure 2: Second-Stage Vent (Regulator #490)

A significant amount of dirt and debris was seen in the second-stage vent. Figure 2 shows the vent from both the outside and inside of the body. The vent screen was in place when the regulator was arrived; it was removed before the pictures of Figure 2 were taken. The outstanding condition of the inside of the body indicates that while there may have been noticeable corrosion or debris on the vent outlet, the vent valve was effective in preventing the majority of it from entering the regulator body.

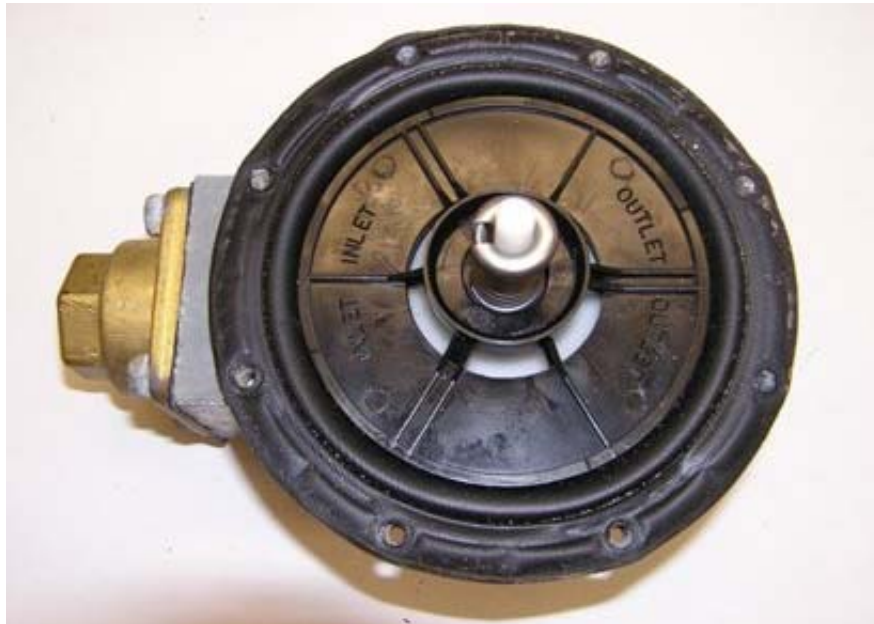
Figure 3: Top Half of Second-Stage (Regulator #490)

The top half of the second-stage of the regulator was in good condition as well (Figure 3). The PRD spring and adjustment spring were in good condition. There was relatively little debris contained within the regulator. No damage to the diaphragm or diaphragm plate was noticed. The diaphragm itself was adhesively bonded to the diaphragm plate. This bond appeared in good condition with no large, detectable failures.

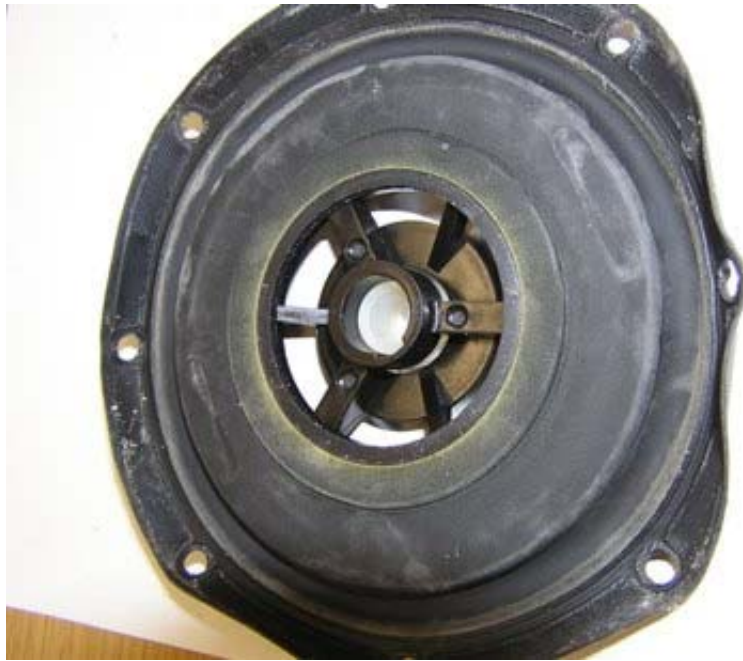
Figure 4: Bottom of Second-Stage Diaphragm (Regulator #490)

The bottom of the diaphragm was in similarly good condition. Two marks where the diaphragm contacted the lower body are visible at 2 o'clock and 8 o'clock in Figure 4. These marks did not cut or damage the diaphragm. The contacting surface between the diaphragm and the PRD stem was in good condition.

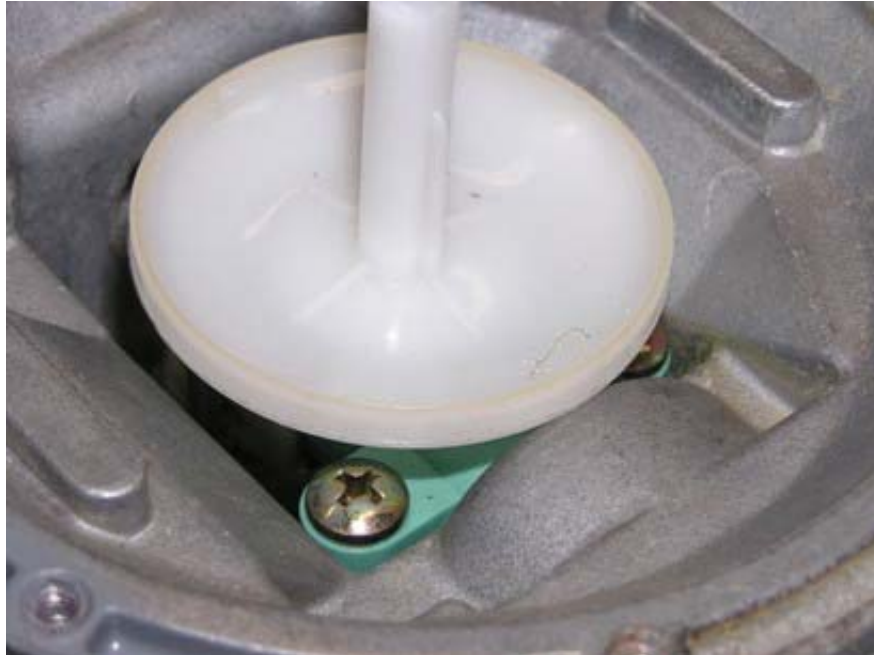
Figure 5: PRD Stem and Bottom of Second-Stage Body (Regulator #490)

The white plastic PRD stem, as well as a portion of the lower half of the second-stage body, is shown in Figure 5. The PRD stem was in good condition. No cracks or chips were observed. The outside edge that creates the seal with the second-stage diaphragm was slightly discolored, but otherwise in good condition.

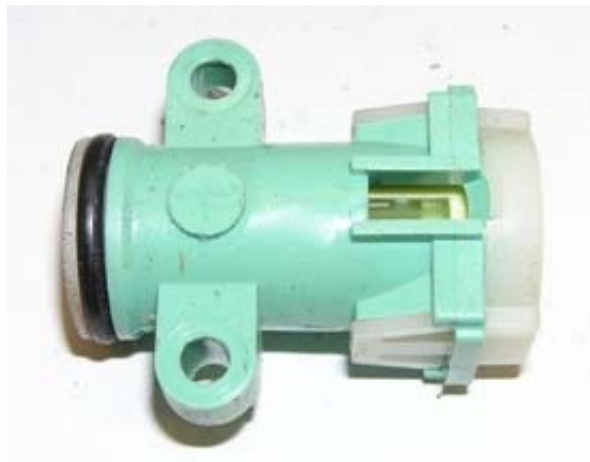
Figure 6: Second-Stage Linkage Assembly (Regulator #490)

The PRD stem was removed and the linkage assembly between the first and second stages was examined. The assembly is shown in Figure 6. The assembly appeared to be in good working order. No debris was found that would prevent proper operation of the linkage. The O-ring appeared in good condition, with no evidence of cracking or cuts.

There have been no apparent leak path from the second-stage inlet to the second-stage outlet.

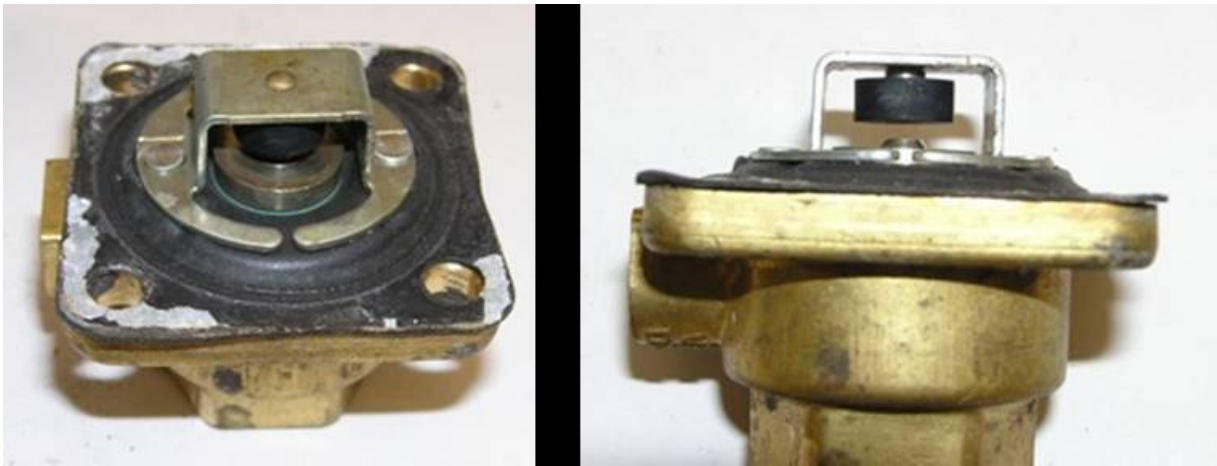
The first-stage portion of the regulator was more difficult to disassemble due to the use of rivets in the construction. The limited disassembly found little evidence of failure. Figure 7 shows the first-stage portion of this regulator. There is some paint on the outer edges of the diaphragm, but none appears to extend into the working seals of the regulator. No significant dirt or debris was found in this portion of the regulator. The diaphragm itself was in good condition; No cracks or cuts were observed. It was impossible to non-destructively disassemble the outlet side of the first-stage of the regulator to examine the sealing surface of the rubber cap.

Figure 7: First-Stage Portion of Regulator #490

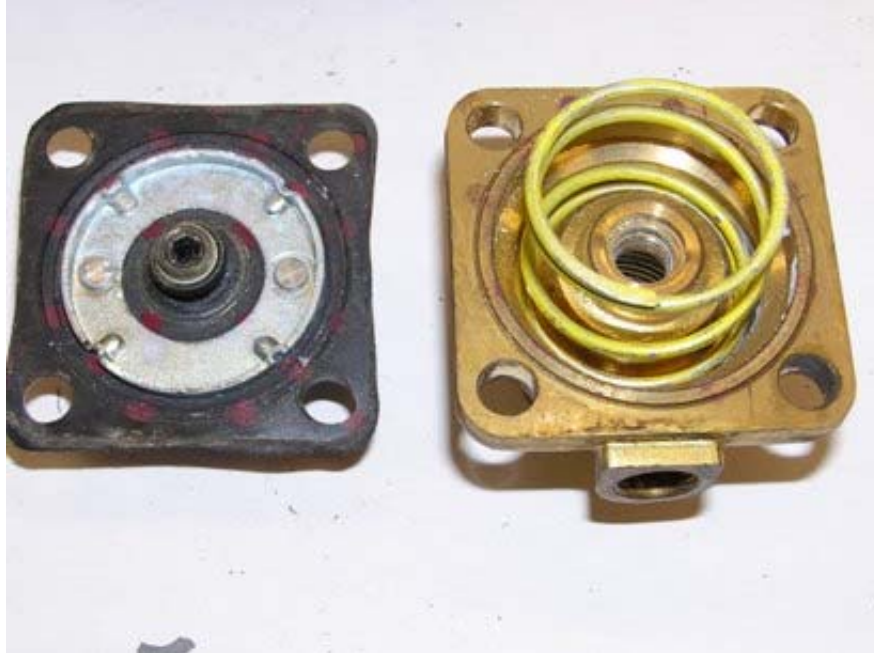
Figure 8: Inlet Side of First-Stage Portion of Regulator #490

Figure 8 shows the inlet side of the first-stage portion of this regulator. The spring was in good condition. No dirt or debris was found in this side of the regulator either. The bond between the diaphragm and the plate was in good condition with no noticeable gaps or leak paths.

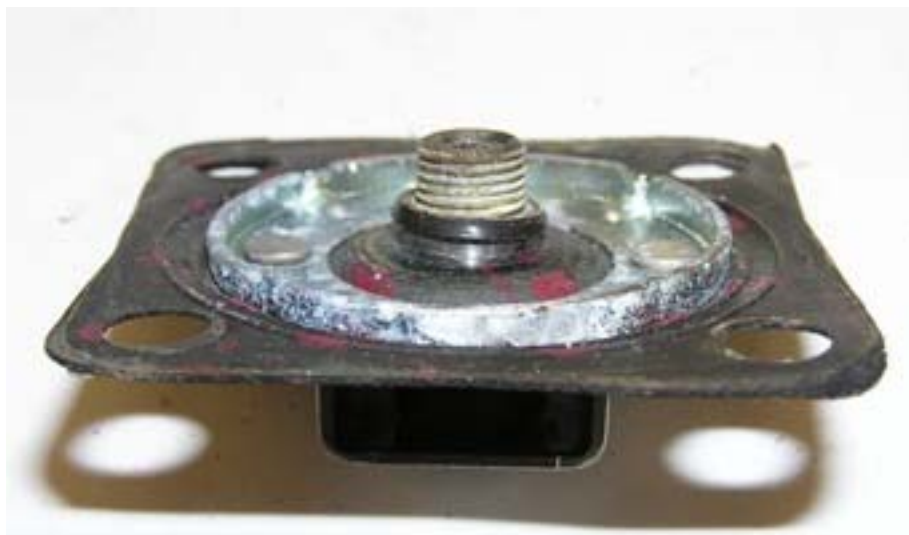
Figure 9: First-Stage Diphragm (Regulator #490)

The O-ring seal on the shaft pass-through from the inlet to the outlet was in good condition. Note that the O-ring shown in Figure 9 has been pushed up during the examination. No leak path was observed around the O-ring. Note that the plate and threads of the shaft show signs of some scale buildup. The scale buildup was generally small in nature, and no significant amounts of loose scale or debris were observed.

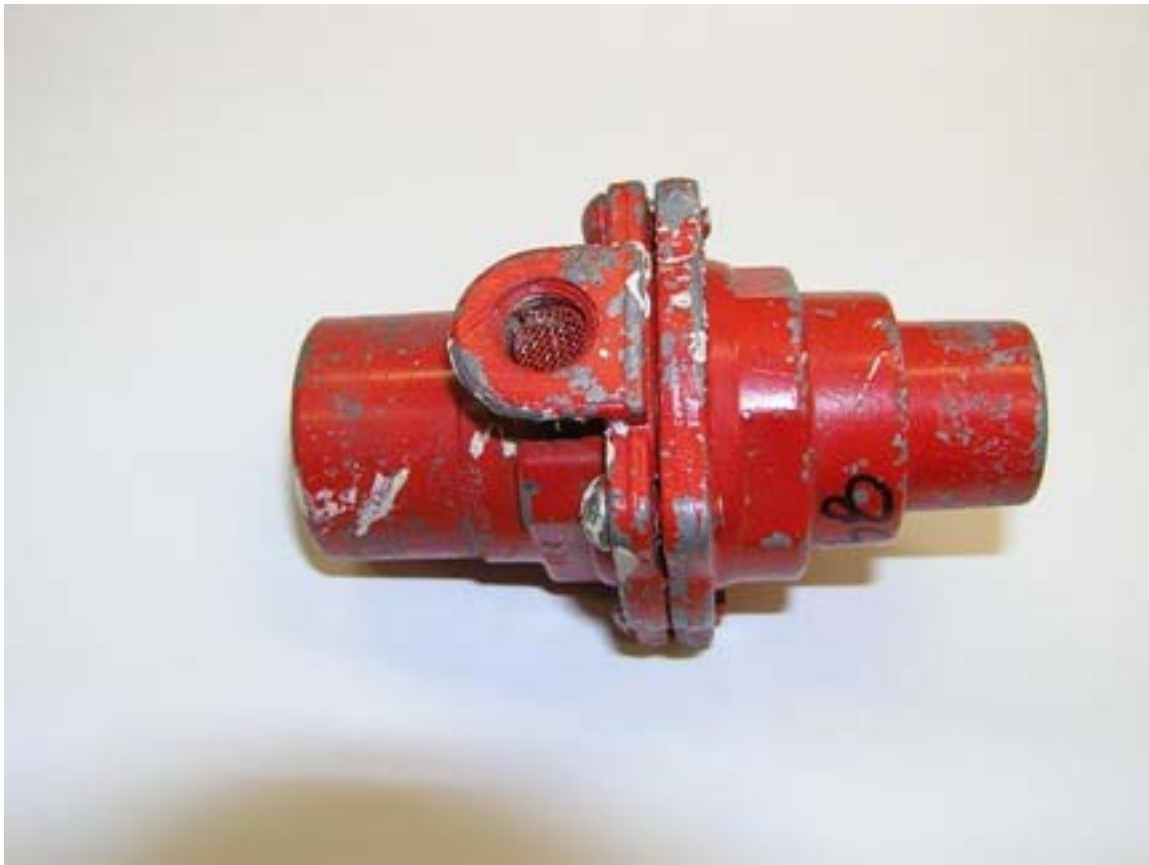
Figure 1: Regulator #538

The outside of the regulator body is in good shape. There are some small bits of dirt and spiderweb on the relief screen, but not enough to cause any significant blockage.

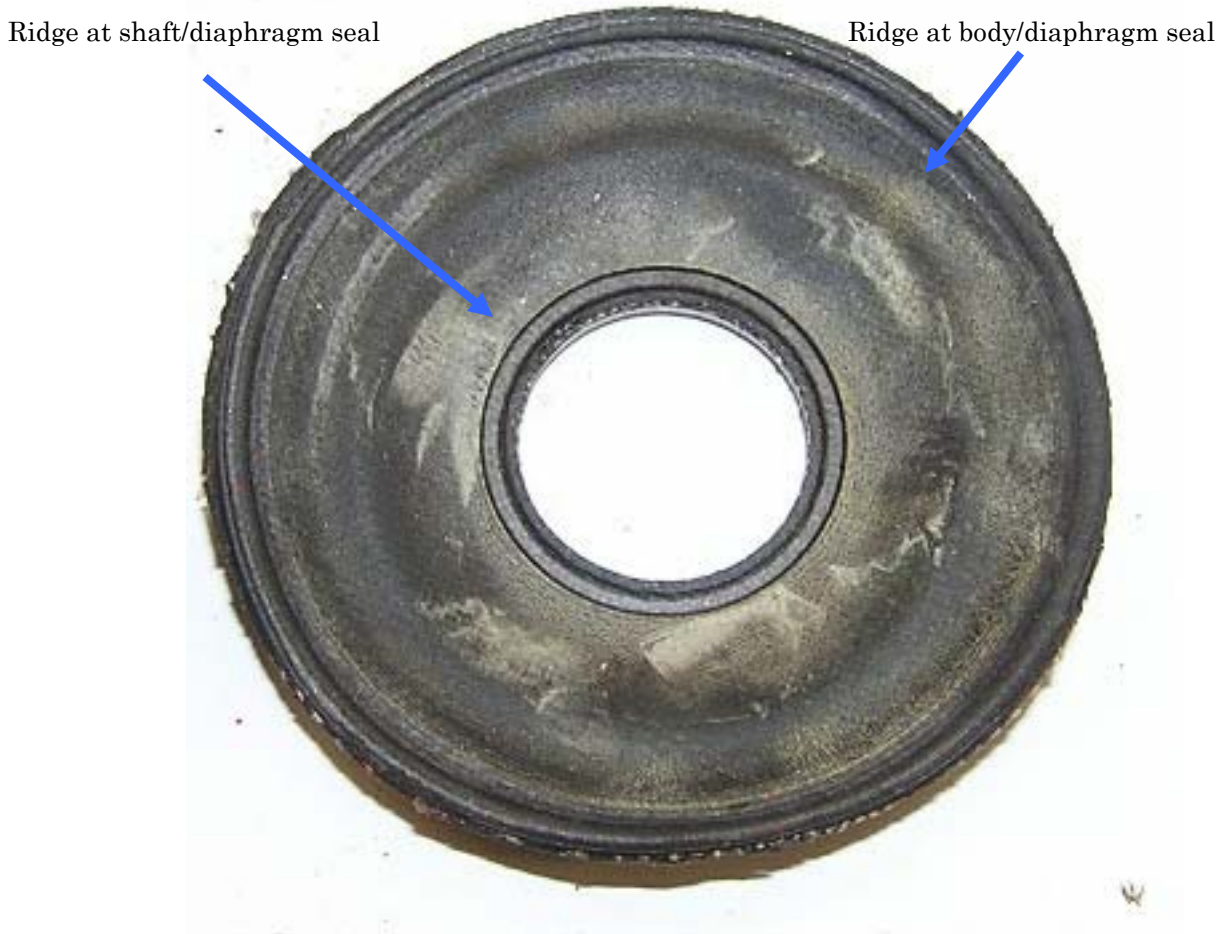
Figure 3: Main Diaphragm of #538. Note the Zig-Zag marks on the surface were put there during disassembly of the diaphragm/shaft.

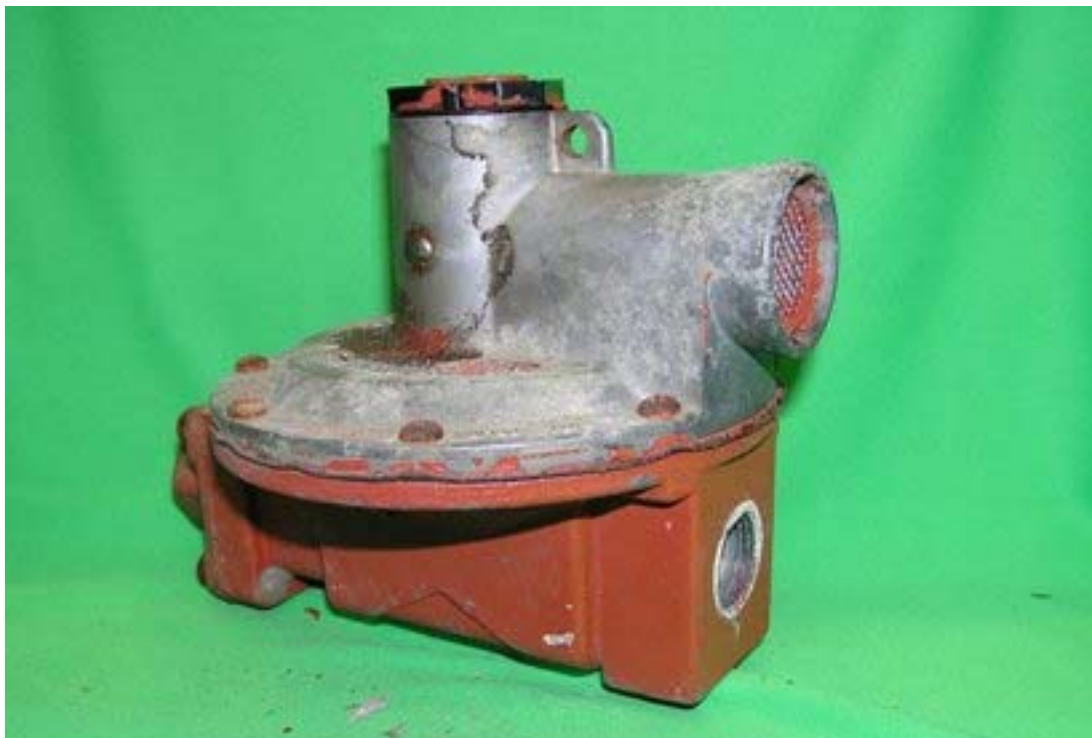
Figure 1: Regulator #571

Regulator 571 is shown below in Figure 1. This regulator arrived painted fully painted. The paint was removed from the top half of the body in order to locate the manufacture date stamp on the regulator.

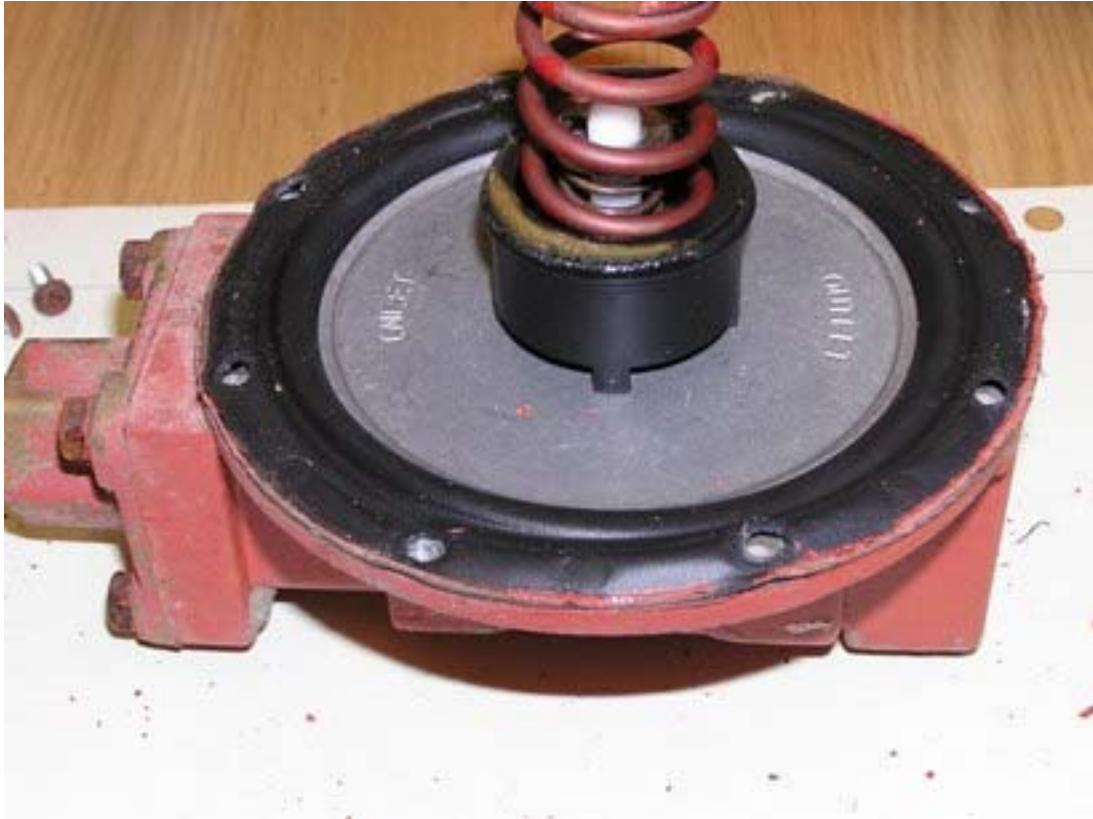
Figure 2: Regulator #571 with Top of Body Removed

The top half of the body was removed and the inside examined. The upper half of the regulator appeared to be in good condition. It was relatively clean and showed no signs of damage.

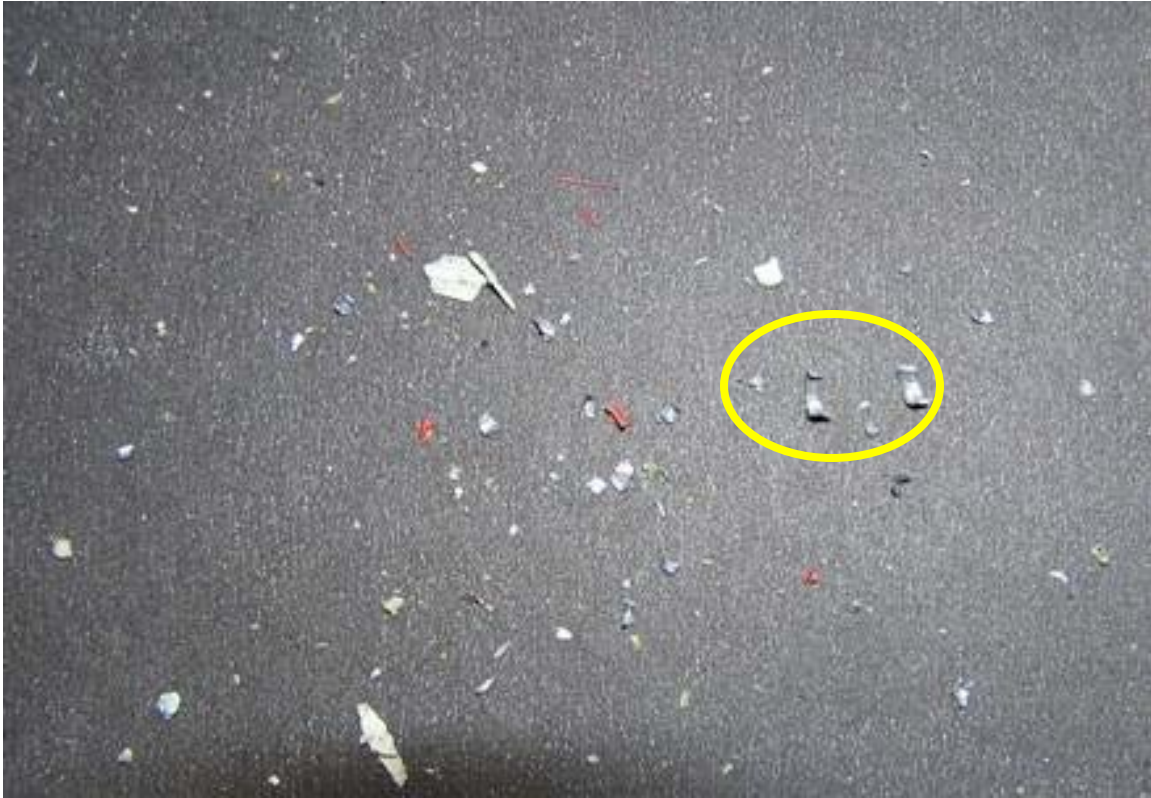
Figure 3: Particles and Shavings (circled) Found inside Bottom of Regulator #571
