Volume 1: Technical Report and Results

PERFORMANCE, DURABILITY, AND SERVICE LIFE OF LOW PRESSURE PROPANE VAPOR REGULATORS

VOLUME 1 – TECHNICAL REPORT AND RESULTS

Battelle Applied Energy Systems
505 King Avenue
Columbus, Ohio 43201-2693

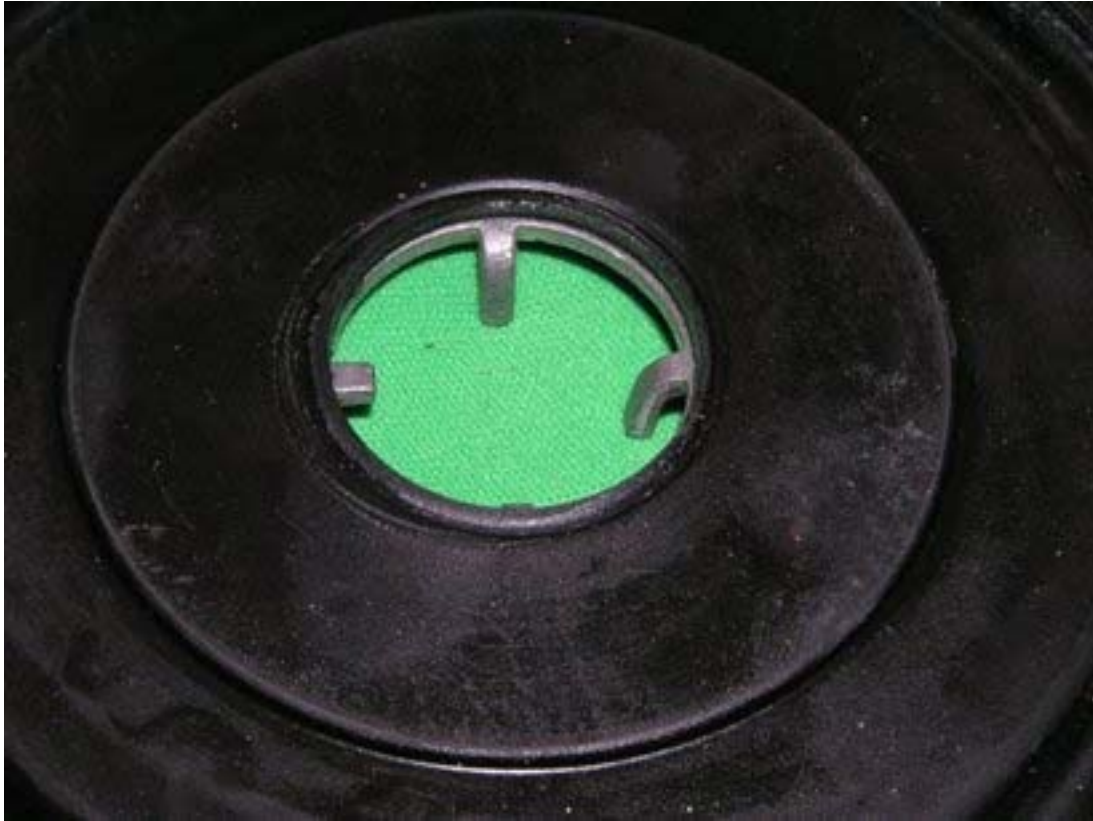
Figure 4: Bottom of Diaphragm (Regulator #571)

The diaphragm was removed and inspected. Overall the diaphragm was in good condition, with no cuts, scrapes, cracks, or other signs of damage. The diaphragm plate was bonded to the diaphragm. The bond appeared to be in good condition with no noticeable gaps in its coverage. The seal with the PRD stem on the underside of the diaphragm was in good condition. There was no debris or evidence of a leak path through the sealing interface.

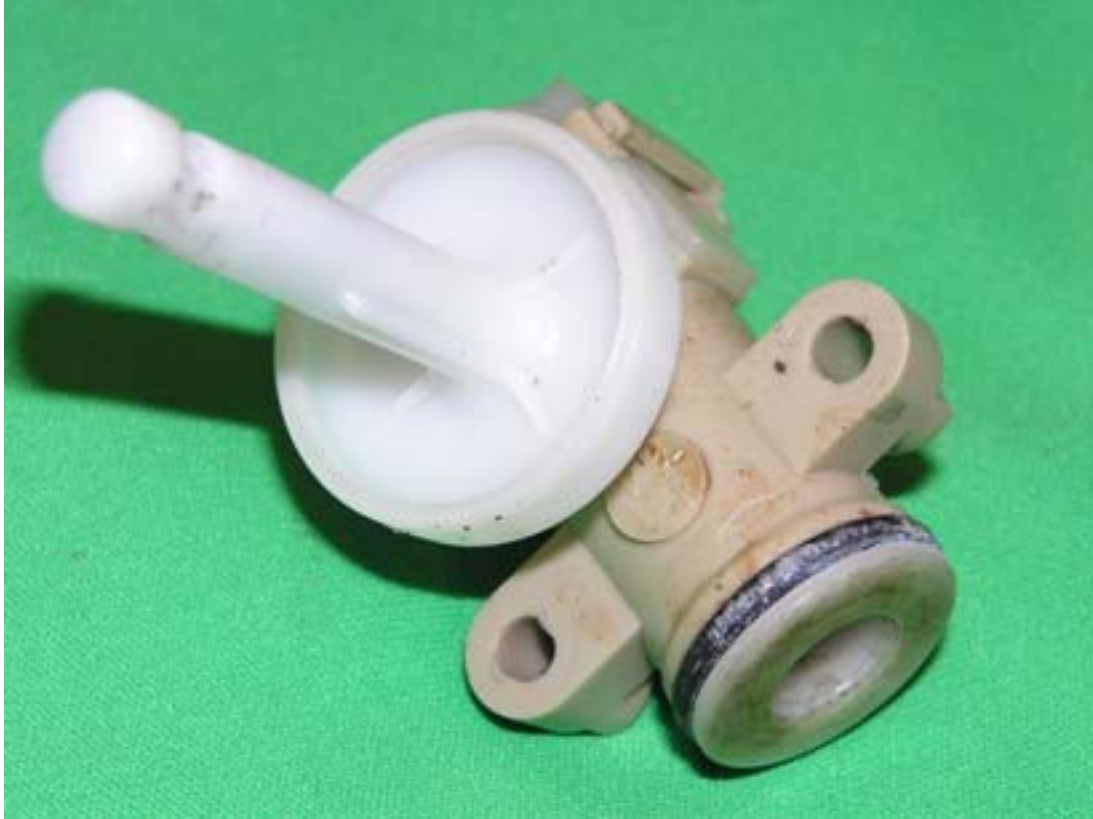
Figure 5: Control Linkage Assembly (Regulator #571)

The control linkage was removed and inspected. The plastic parts of the linkage assembly were in good condition. No chips, breaks, or fractures were observed. There was some white powder observed on the sides of the PRD stem, indicating slight wear. The O-ring on the linkage assembly had a dried white residue on its surface. This did not seem to affect the quality of the O-ring; the outer surface was smooth with no cracks, scrapes, or signs of degradation.

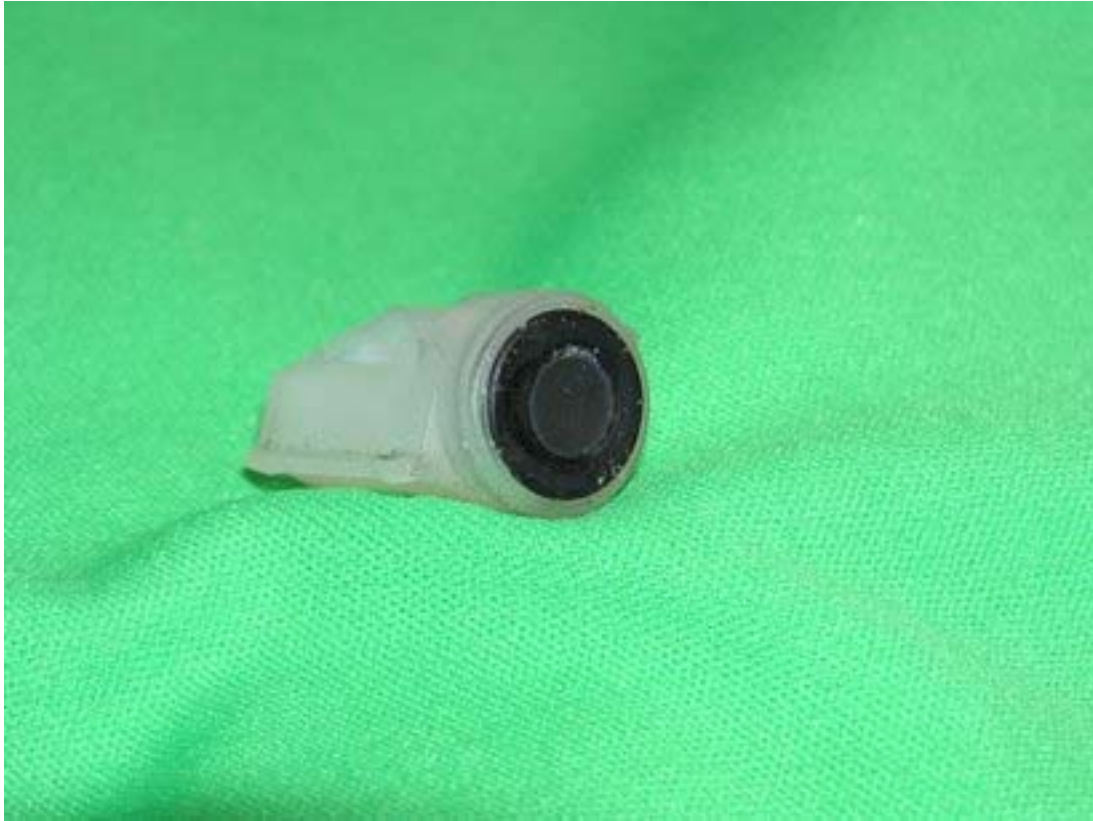
Figure 6: Seat Disc from Control Linkage (Regulator #571)

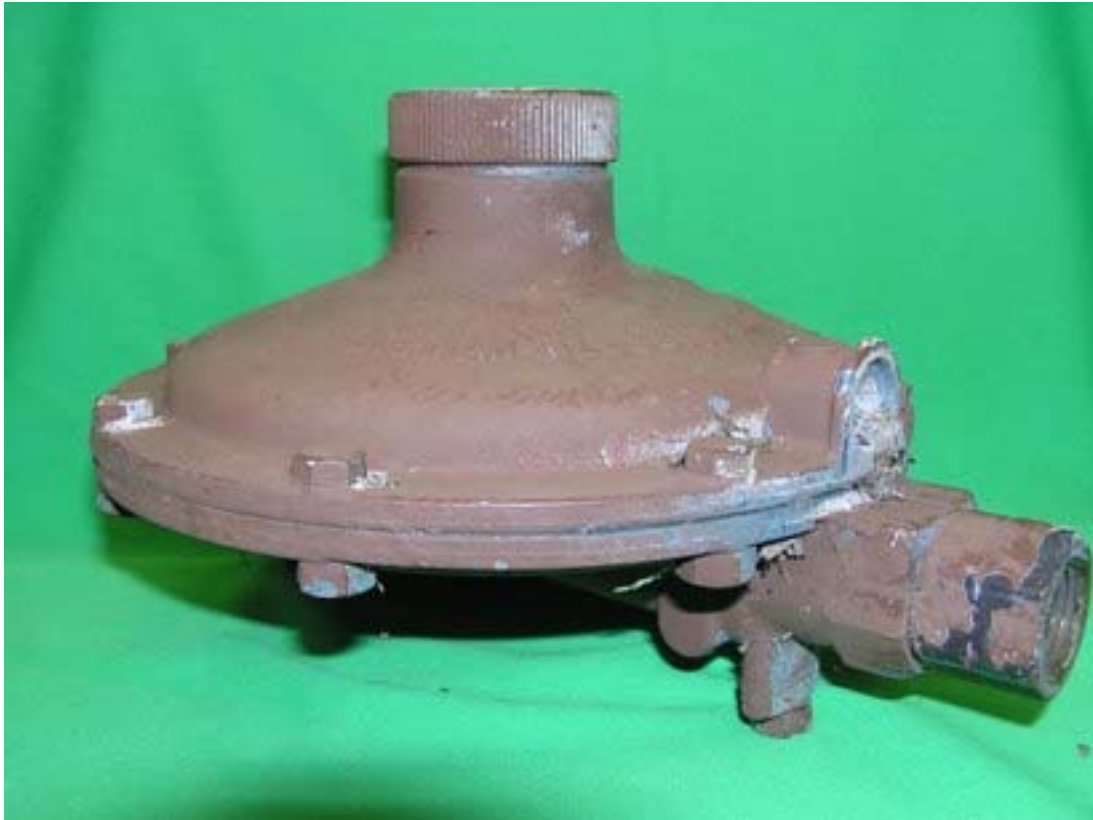
Figure 1: Regulator #711

Regulator 711 is shown in Figure 1. In this picture, it is apparent there are substantial amounts of spider webs in the vent.

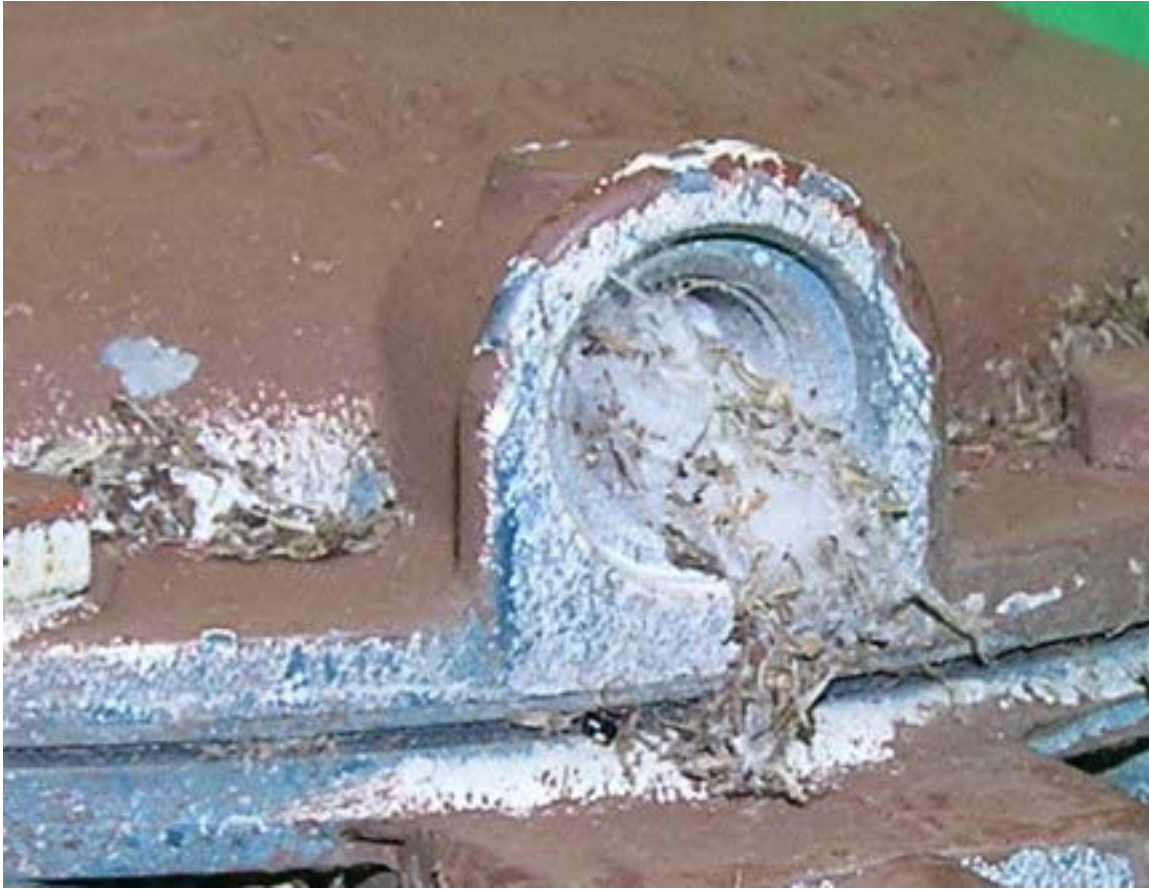
Figure 2: Regulator #711 Vent

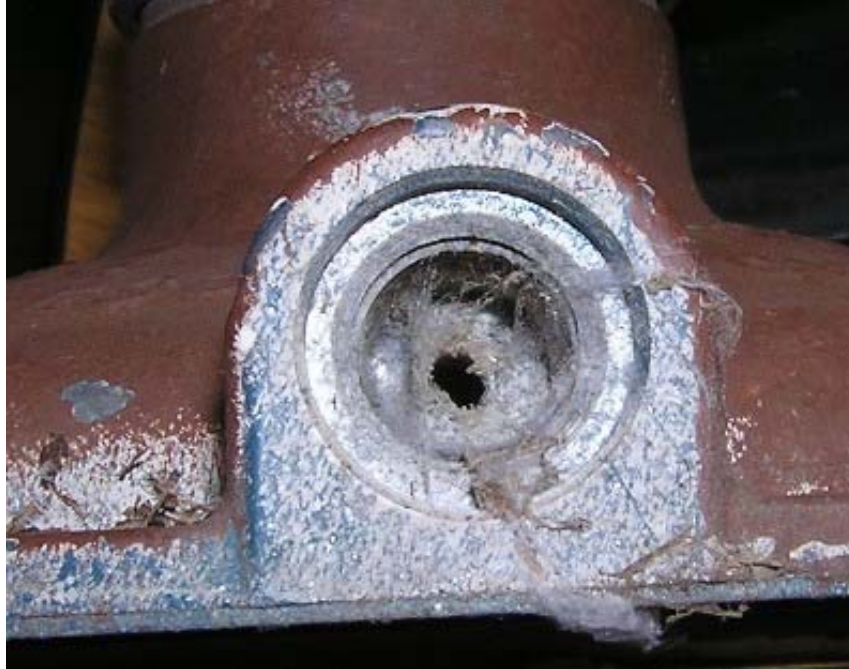
Figure 3: Regulator #711 Vent (After Cleaning)

The spider webs were removed from the vent. The vent passage (approximately 1/8" in diameter) was completely plugged by dirt and old spider webs. Figure 3 shows the vent after the spider webs were removed and the vent path cleared.

It has been determined that this regulator failed the relief test since the vent passage was blocked by mud. There was no indication that the PRD itself failed to actuate to excess pressure.

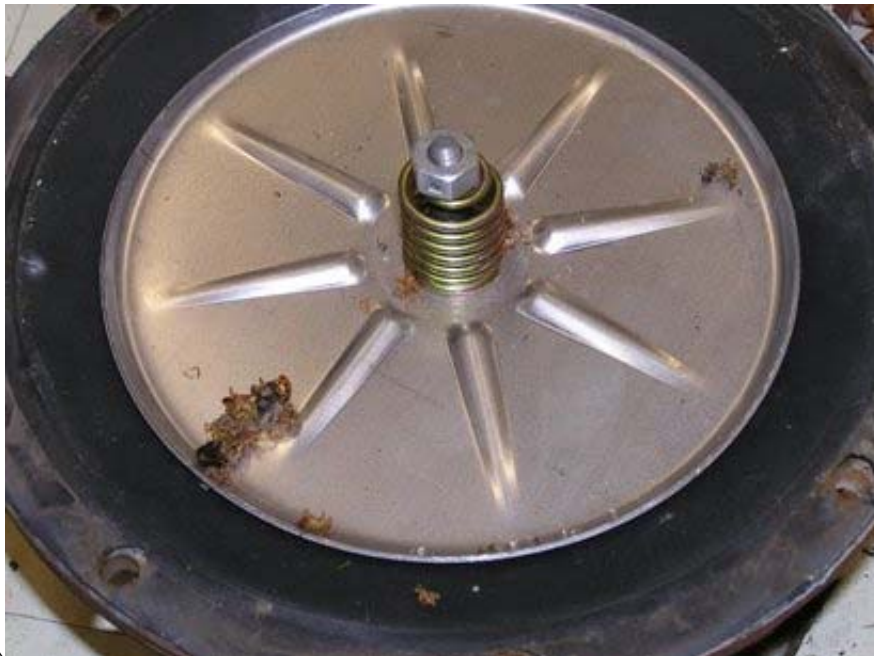
Figure 4: Inside Body of Regulator #711

Several dead insects were found inside the regulator body, as shown in Figure 4. The diaphragm plate, PRD spring, and associated assembly were in good condition. There was no indication that the PRD itself failed to actuate.
